GEOLOGIC HAZARD ASSESSMENT AND RESERVOIR SITE CHARACTERIZATION – REPORTS I & II

August 31, 2018

**PROJECT: GEOLOGICAL ASSESSMENT TO SUPPORT THE PREPARATION OF
THE OPERATION HL-L1135, HAÏTI**

PREPARED FOR:
INTER-AMERICAN DEVELOPMENT BANK

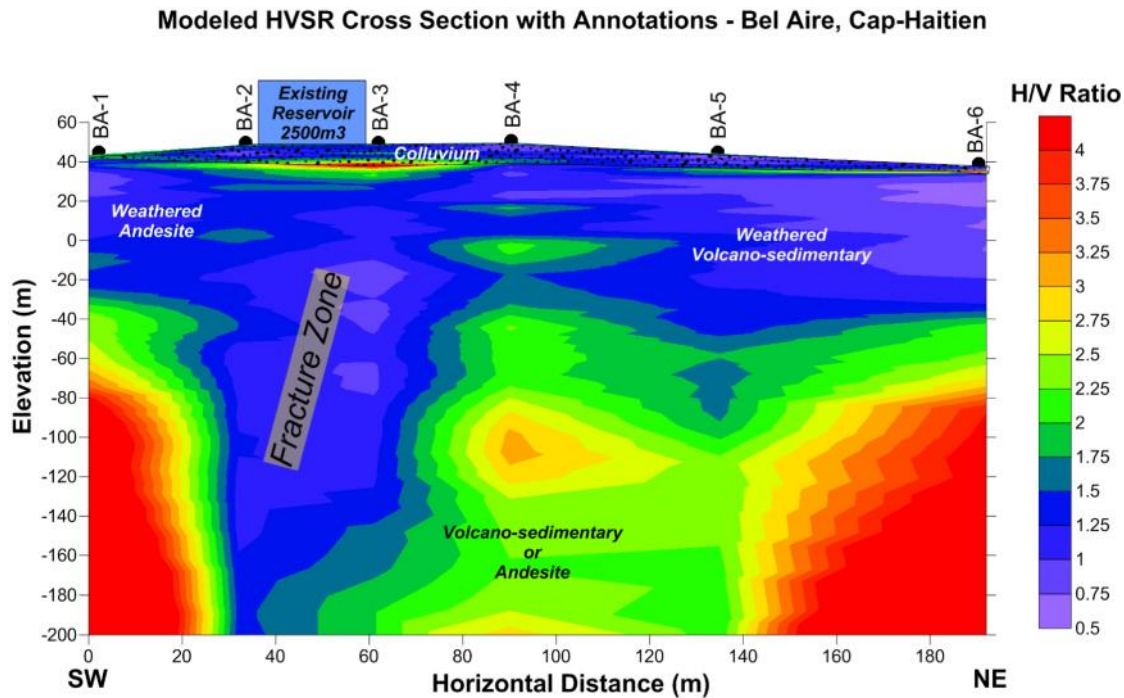
A branch fault to the previously mentioned thrust fault was interpreted by Gilles (2014) near the site of the existing Bel-Aire reservoirs. Geophysical HVSr reconnaissance conducted by the authors across the Bel-Aire valley indicate a likely zone of faulting or fracturing that is buried by recent colluvial deposits. The faulting/fracture zone appears to directly underlie the reservoir site (Figure 5). This observation leads to several possible options, or a combination of options, for the water system:

FIGURE 5 – MODELED HVSR PROFILE ACROSS BEL AIRE VALLEY. BLUE AND PINK ZONES AT DEPTH LIKELY INDICATE HIGHLY FRACTURED BEDROCK, POTENTIALLY DUE TO FAULTING.

- *Setback distance:* If large investments in water storage infrastructure are desired in the Bel-Aire area, establishment of a setback distance from the fracture zone for any further investments in water infrastructure is recommended. Establishment of the set-back distance would benefit from a detailed geologic study to more precisely describe the location and alignment of the potential fault.

- *Seismic retrofit:* Conduct structural assessments of the existing reservoirs in combination with a more detailed geologic study of the fault location and alignment in order to determine the feasibility or design components necessary for seismic *retrofits* which take into account the increased fault rupture hazard. Depending on the feasibility of the retrofits, the existing reservoirs would either be incorporated as the initial storage infrastructure for the water system or as secondary or tertiary storage if alternate locations are selected.

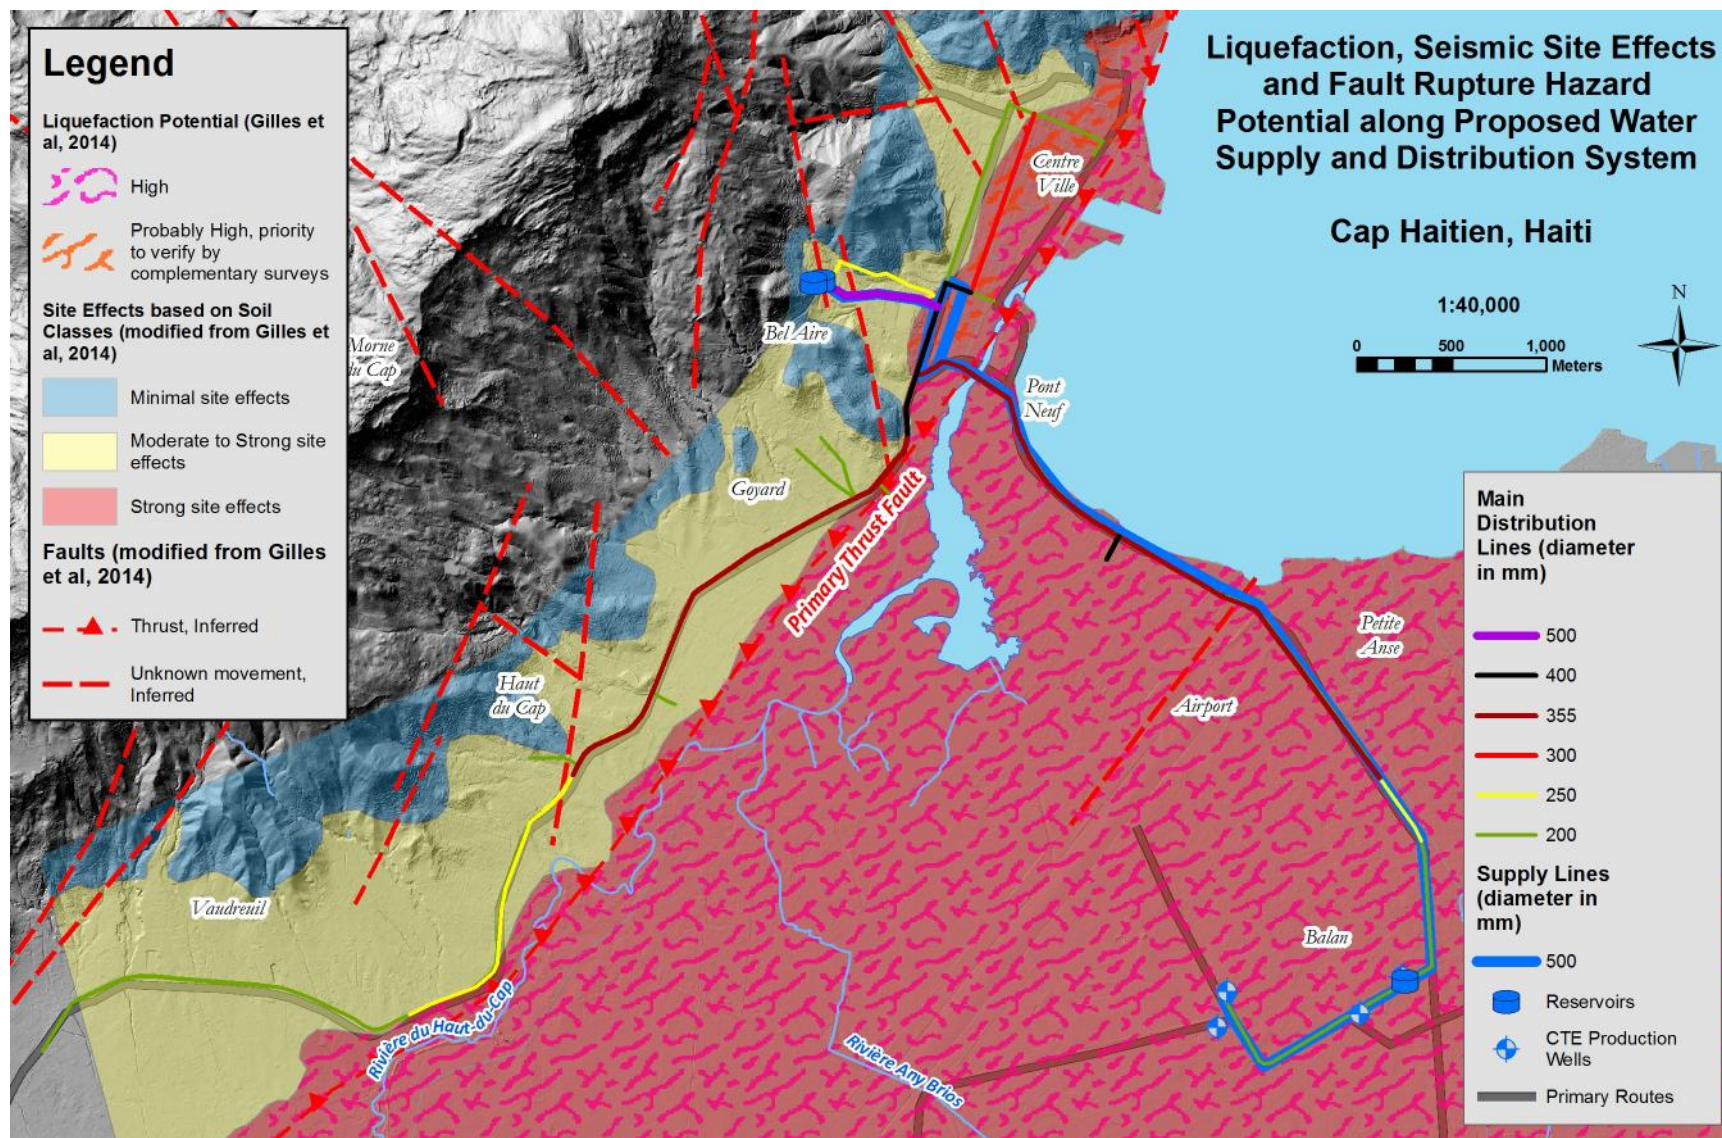
Based on our preliminary understanding of the site geology, potentially the most active fault which crosses the pipeline is a thrust fault which accommodates the transpressional stress caused by the OSFZ. This structure is believed to have contributed to the arching of Morne-du-Cap and is aligned approximately parallel to National Route 1. The supply line crosses this fault near the National Route 3 bridge over the Riviere Haut-du-Cap. The distribution lines likely intersect or are in close proximity to this fault at several locations along National Route 1.

In terms of ground surface rupture, it is our opinion that local faults do present a potential hazard for specific areas associated with the reservoir, supply pipeline and distribution pipeline. Areas of proposed water infrastructure that are underlain by active or potentially active faults require special design considerations which are further discusses in Table 8 at the end of this report.

FIGURE 6 – SEISMIC HAZARDS TO PROPOSED WATER SYSTEM: LIQUEFACTION, SITE EFFECTS AND GROUND SURFACE RUPTURE (FAULTING)

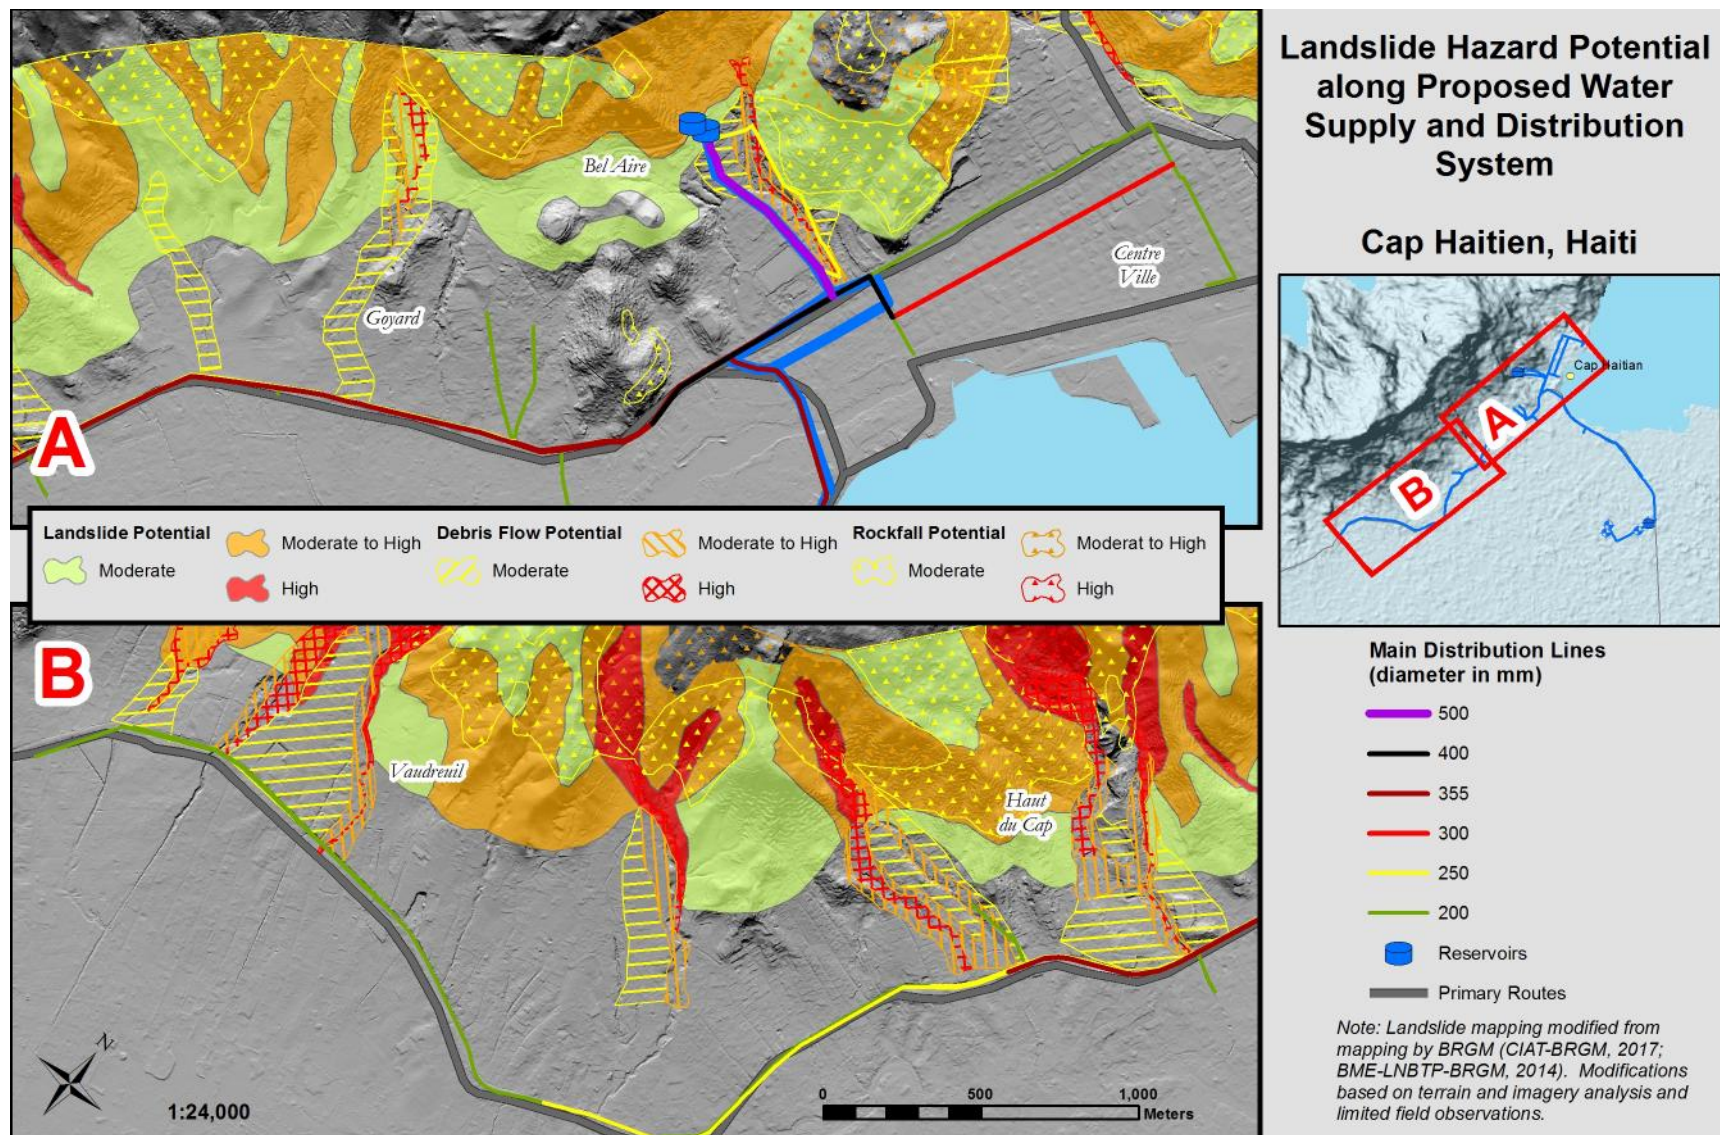
This particular area was the focus of a recent landslide mapping activity (BME-LNBTP-BRGM, 2014, reproduced in CIAT-BME, 2017). This landslide mapping was applied to delineate various levels of geologic hazard along the pipeline routes, and at the reservoir site which are illustrated and documented in Figure 7.

Based on our evaluation, we regard slope stability hazards, especially debris flows, as an important design consideration for defined sections of the pipelines and the reservoir site. Investigation and mitigation recommendations are provided in Table 8 at the end of this report.

FIGURE 7 – SLOPE STABILITY HAZARDS TO PROPOSED WATER SYSTEM: LANDSLIDE, DEBRIS FLOW AND ROCK FALL

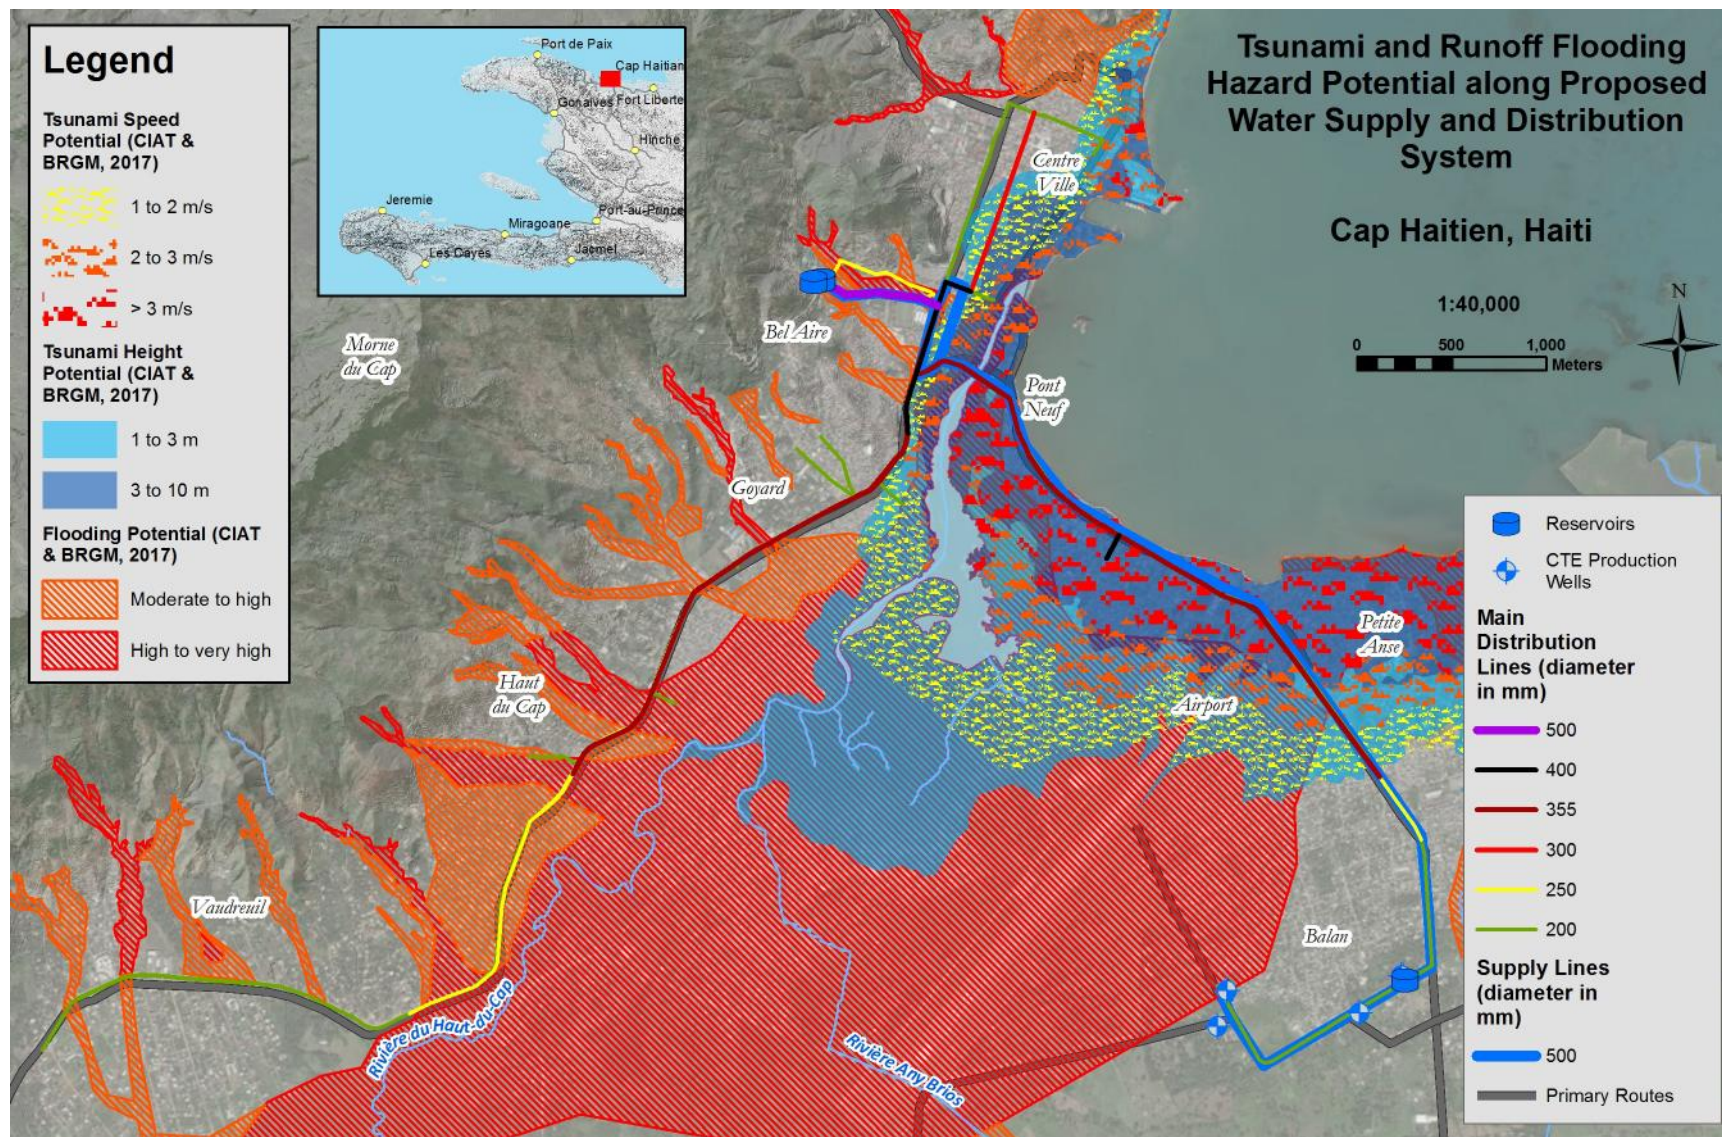
Based on our evaluation, we regard the scouring and erosion related to flooding and tsunamis to be a low to moderate hazard in the bedrock and colluvial sections of the line and a moderate hazard in the plain. We recommend that final designs incorporate mitigation techniques in specific zones which are described in Section 7.

FIGURE 8 – SURFACE WATER HAZARDS TO PROPOSED WATER SYSTEM: TSUNAMI AND RUNOFF FLOODING

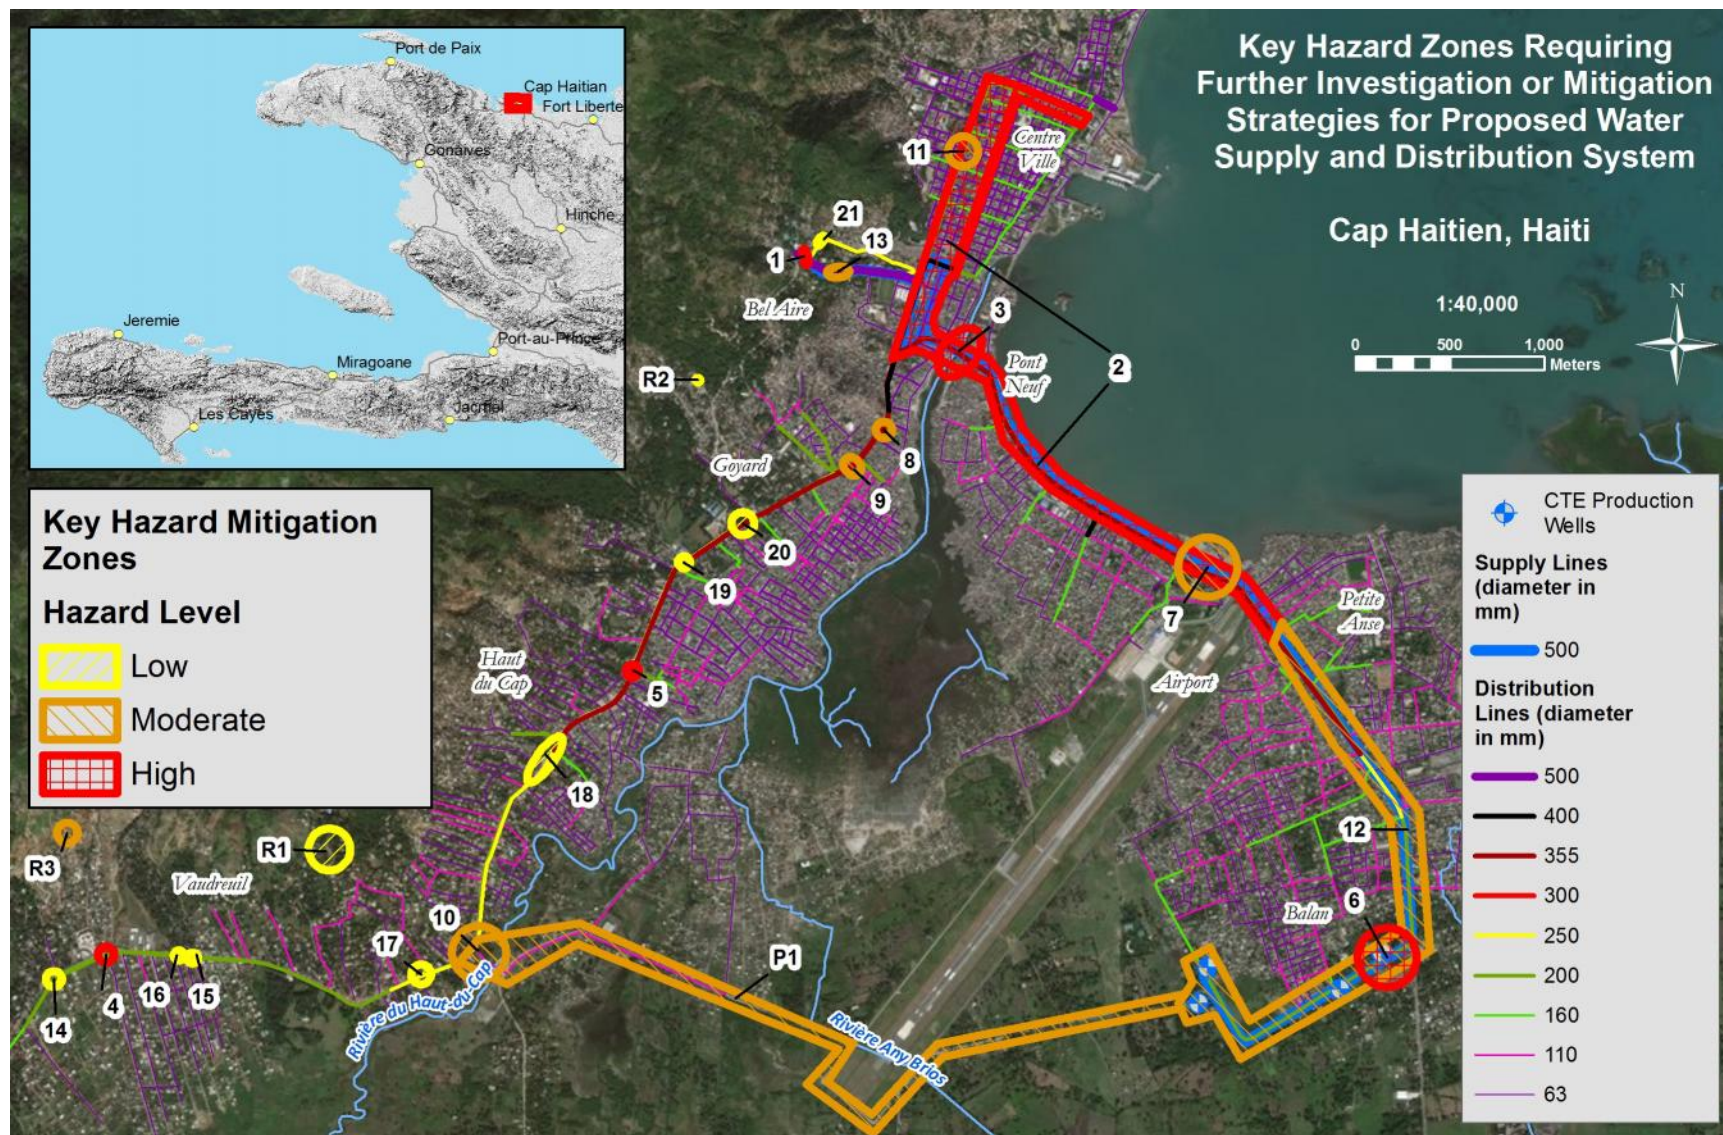
Key hazard zones and associated potential mitigation and assessment options are presented in this section. Figure 9 shows the location of each of the primary hazard zones and Table 8 defines our opinion of the hazard level and a summary of recommendations. Appendix A provides a more detailed discussion of the recommendations.

FIGURE 9 – KEY HAZARD ZONES TO BE CONSIDERED DURING DESIGN AND CONSTRUCTION
