**Consulting Service for the Supervision of Works for the George Price Highway Rehabilitation Project
Design Review Report Addendum – Lot 3 BoQ Review**

7.3 Section III (Lot 3) Review of Quantities

Consulting Service for the Supervision of Works for the George Price Highway Rehabilitation Project

Design Review Report February 2018

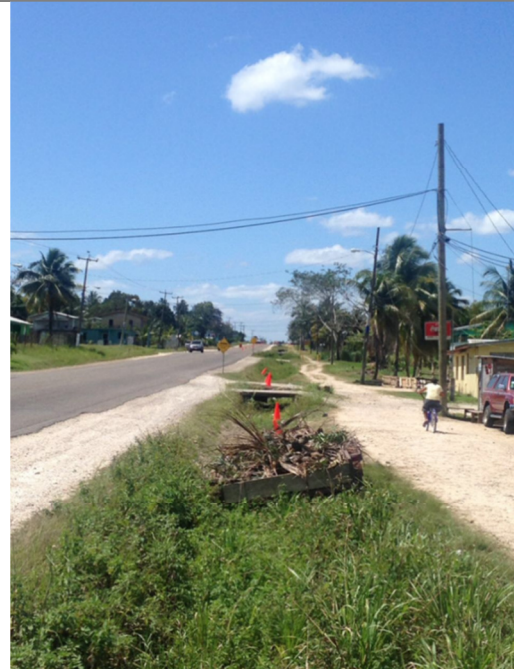
However it is noticeable from the design drawings and the centreline set out on site that there is a significant difference to the cadastral boundary used in the design drawings compared to actual surveyed positions of the fences. The existing survey unfortunately does not pick out clearly all the existing fence lines and CP (concrete post) points along the road which would verify these boundaries. Sections between km3+000 to 5+000 show a significant variance between the existing and the cadastral survey and when the centreline is set out on site the road encroaches onto properties boundaries and the BEL poles within Camolote.

Photo 1. Centreline set out in Camolote Lot 2

The key issue would seem to be that the designer has not checked the Cadastral overlay with existing CP points on the ground and then seems to have used this as the governing factor for the horizontal alignment.

The recommendation is that CP points need to be picked up on site and the horizontal alignment modified in accordance with the actual boundaries verified on site and not a theoretical line.

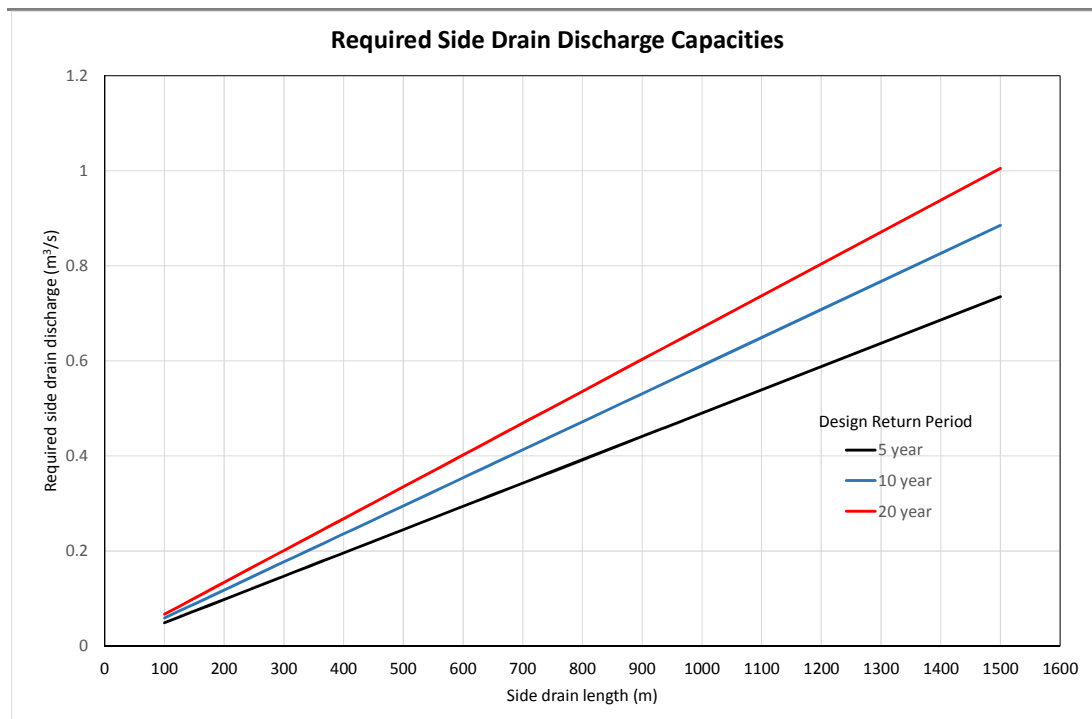
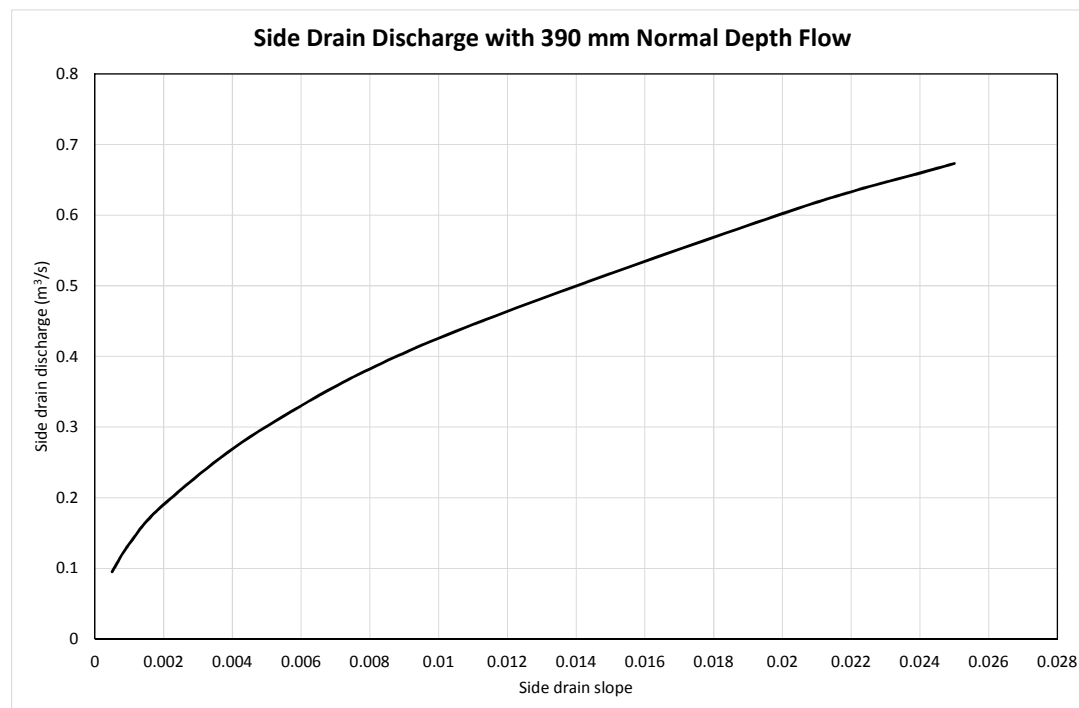
Figure 3.5 Required roadside drain discharge capacity

Figure 3.6 Available roadside drain discharge capacity

The analysis undertaken indicates that the roadside drain on the western reach between culverts 203 and 204 is undersized, as is the roadside drain on the western reach between culverts 209 and 210 for a 20 year return period, and the roadside drain on the eastern reach between culverts 321 and 322.

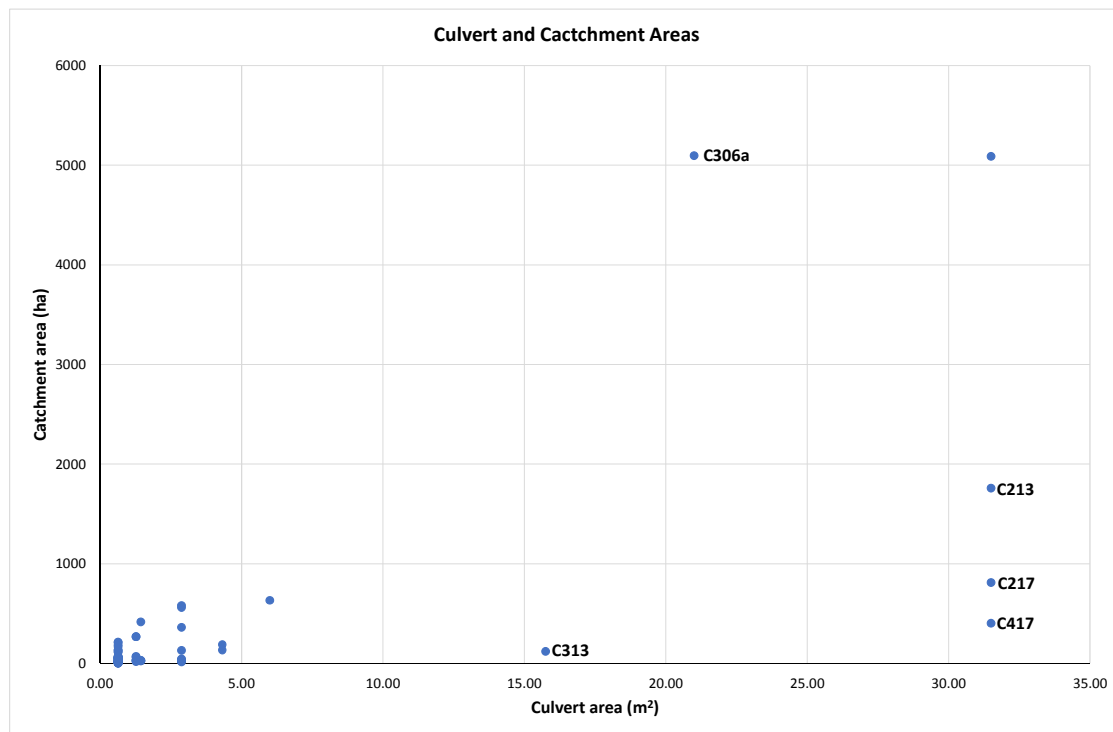
A site visit by the team leader and Client raised questions over the recommended sizing of replacement culverts C213, C217 and C306a. As part of the current review, no hydrological or hydraulic analysis has been carried out, but culverts cross sectional areas have been plotted against their catchment areas. Catchment areas were estimated from the SRTM90 DEM using ArcHYDRO tools. For large catchments the areas estimated will be reliable, but for micro-catchments they will not be. Figure 3.7 presents the plot of culvert areas against estimated catchment area. It would appear that C213, C217, C417 and C313 may be over-sized. C306a does not appear to be over-sized.

Figure 3.7 Plot of culvert areas against catchment areas

It is recommended that the designs of C213, C217, C313 and C417 be revised. In order to do this channel cross sectional survey will have to be undertaken and ideally revised design storm rainfall data.
