CONCEPT DESIGN FOR THE REHABILITATION OF GEORGE PRICE HIGHWAY
SEGMENT: BELMOPAN – GUATEMALA BORDER

Prepared by: Cesar Castellon

July 30, 2014

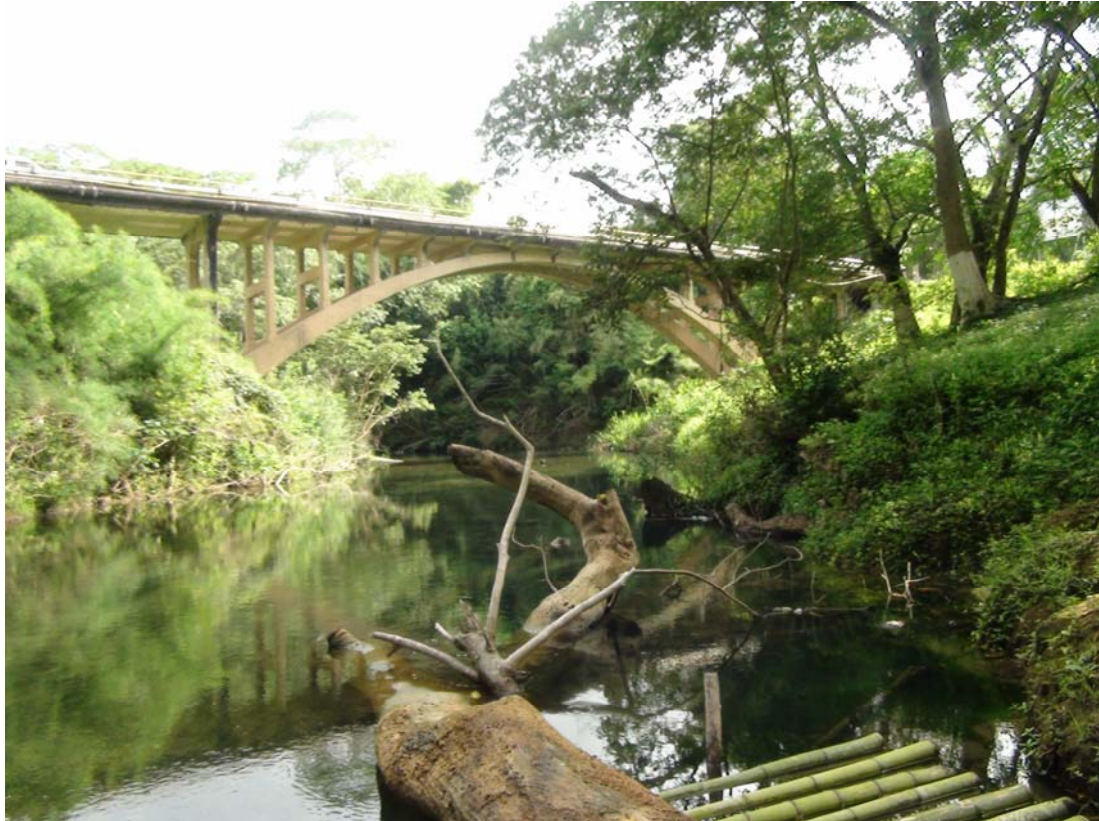
The Roaring Creek Bridge reportedly constructed in the 1940's is a fairly complicated reinforced concrete structure comprised of a compression arch structure in the middle and two unequal end spans, one consisting of three bays and the other consisting of two. Reinforced concrete portal frame bents are located at 10-ft. 10-in. along the compression arch as shown in the figure below.

Figure 12: Roaring Creek Bridge. View from upstream to downstream.

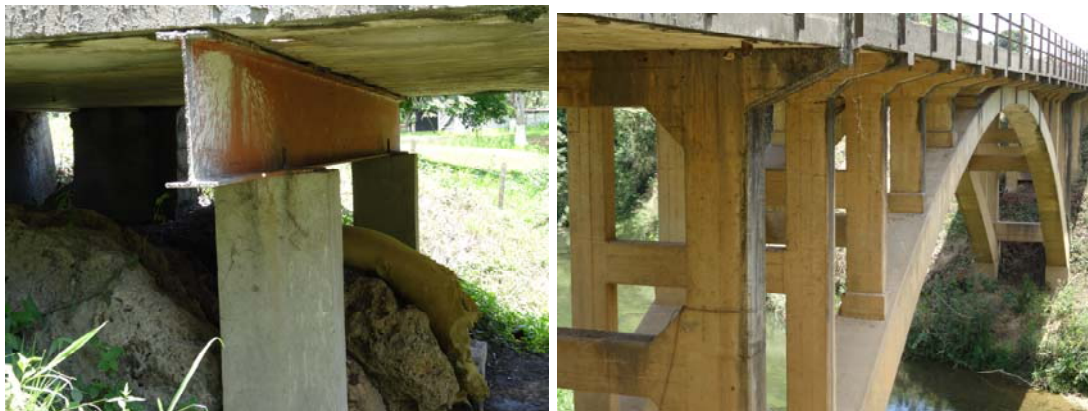
This bridge currently experiences the following deficiencies: (i) insufficient hydraulic section which was evident in many occasions over the past several years where its structure was practically found under water levels, clearly not designed to undergo this type of condition; (ii) deficient horizontal alignment which increases the lack of safety that this bridge provides to its users; (iii) insufficient lane width and lack of sidewalks that prevents normal two-way vehicle traffic as well as pedestrian traffic along its sides; and (iv) structural deficiencies that prevent adequate support for existing traffic loads.

Figure 13: Structural deficiencies.

Ideally, the rehabilitation of a structure of these characteristics would consist of raising the bridge structure at least three (3) meters and widening the width of the structure between 6 to 11 meters. This is not feasible because it is a structure that cannot be expanded in any of the senses at the same time (ie, transverse and longitudinal, vertical).

For this reason, it is recommended to replace the existing structure and build a new bridge following under adequate parameters. The construction of a new bridge structure can be possible with minimal impacts on private property, particularly at the entrance of the bridge (left side). A greater degree of impact on public property (Showground Agricultural) could be experienced at the entrance of the bridge (right side). This realignment will not affect the Guanacaste National Park.

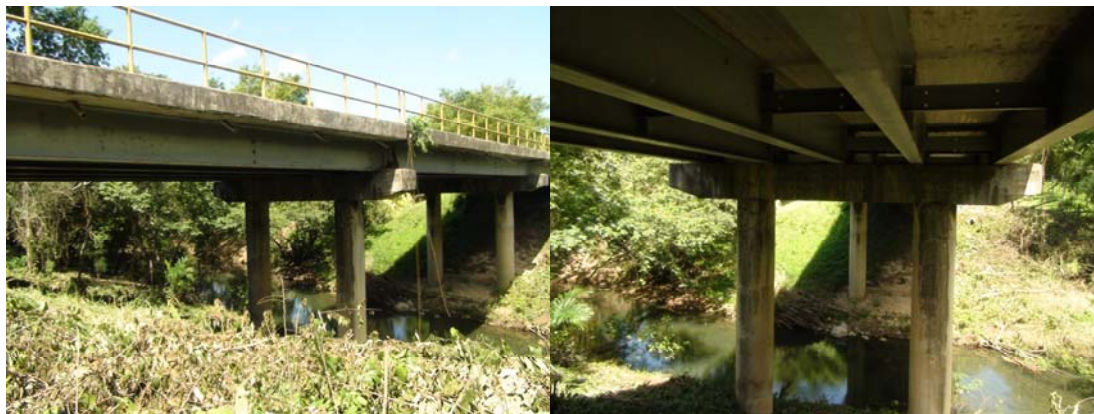
Figure 14: View from downstream to upstream.

The overall visual assessment of this bridge is that it is in acceptable condition. However, the following issues have been identified: (i) The exit of the bridge is in close proximity of the sharp angled curve which impacts the safety of motorists crossing the bridge; (ii) the width of the deck is less than 11 meters (currently 6.6 meters). Additional studies must be performed to identify safety flaws that could be addressed to improve the overall traffic safety for motorists. Both recommended studies must be accounted for in the overall project cost budget. With respect to increasing the width of the deck, additional structural studies must be performed. Should this result in a recommendation to widen the existing deck, measures to standardize the dimensions of this bridge with Macal Bridge must be taken. It is also recommended to study possible improvements to both access sides of the bridge. It also recommended to study the drainage capacity of the drain structures crossings the road near both access side of the bridge. An improvement of these drain structures crossings will alleviate extraordinary flooding conditions in the areas near the bridge access side.

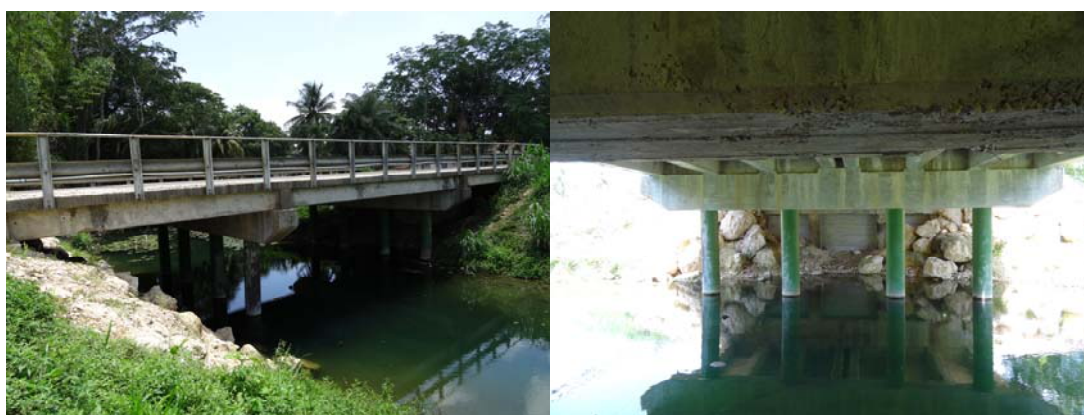
Figure 15: General view of the bridge and the reinforce abutment west side of the bridge.

The overall visual assessment of this bridge is that it is in acceptable condition. However, the exit side of the bridge has been eroded due to rising of water levels of the river, provisional repairs have been performed. It has been identified that an adequate material removal in the river upstream will benefit the overall condition of this bridge. It is estimated that the cost associated with the efforts to perform this work would be effective toward the total investment of the project. Similarly to Puente Barton, a study must be performed to determine the need to widen the deck. If so, the new deck width dimension should be standardized with Macal Bridge. Additionally, further studies must be performed to determine the stability of both access side of the bridge.

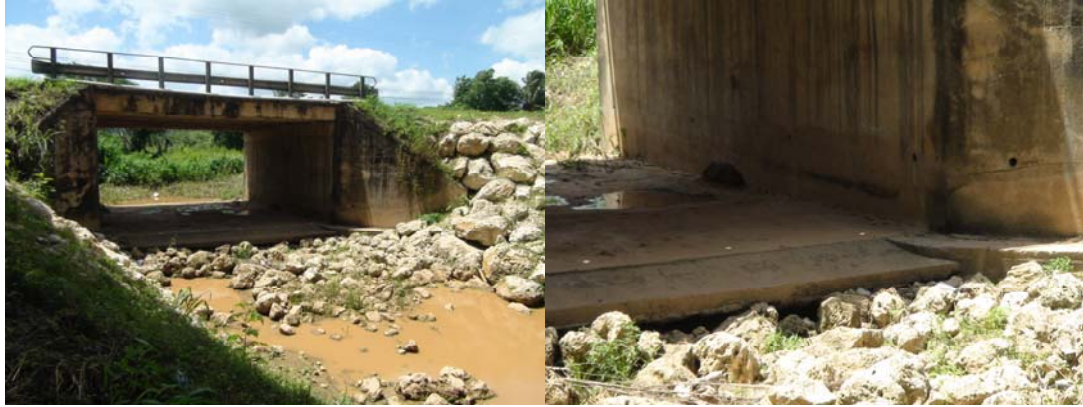
Figure 16: View from downstream to upstream.

The Red Creek Bridge spans a very short distance at around 30 feet and is expected to be able to sustain the design loads for the project.

This box structure bridge is in acceptable conditions. Similarly to Puente Barton, a study must be performed to determine the need to widen the deck, if so; the new deck width dimension should be standardized with Macal Bridge.

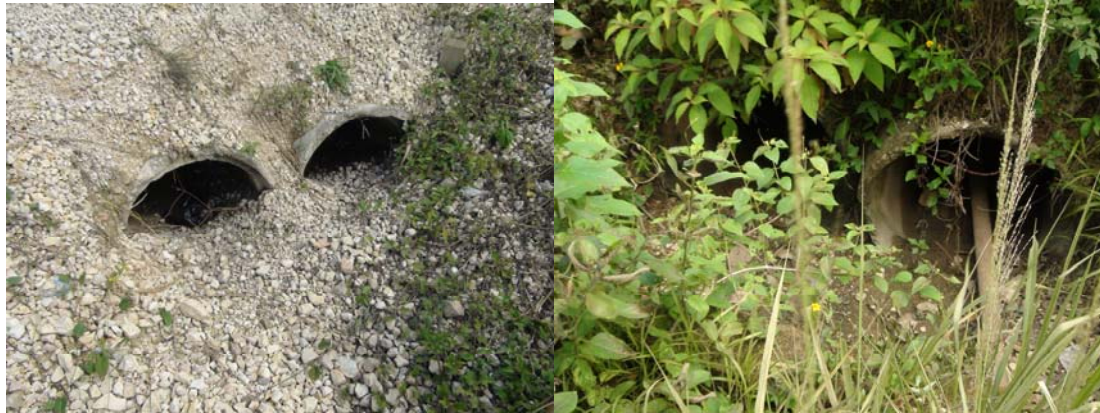
Figure 17: Culverts blocked by sediments or by the vegetation. It is an indication of lack of maintenance.

The pipes constructed with an opening diameter less than 1 meter are practically impossible to be maintained. For this reason, it is recommended to install concrete pipes with an opening

diameter greater than 1 meter. Actually, installing concrete pipes with an opening diameter of 1.5 meters is preferred provided there is enough clearance between the top of the pipe and the subgrade of the road. Having the preferred 1.5 meters diameter pipe installed along the road will facilitate the removal of debris and sedimentation during periodic maintenance activities.

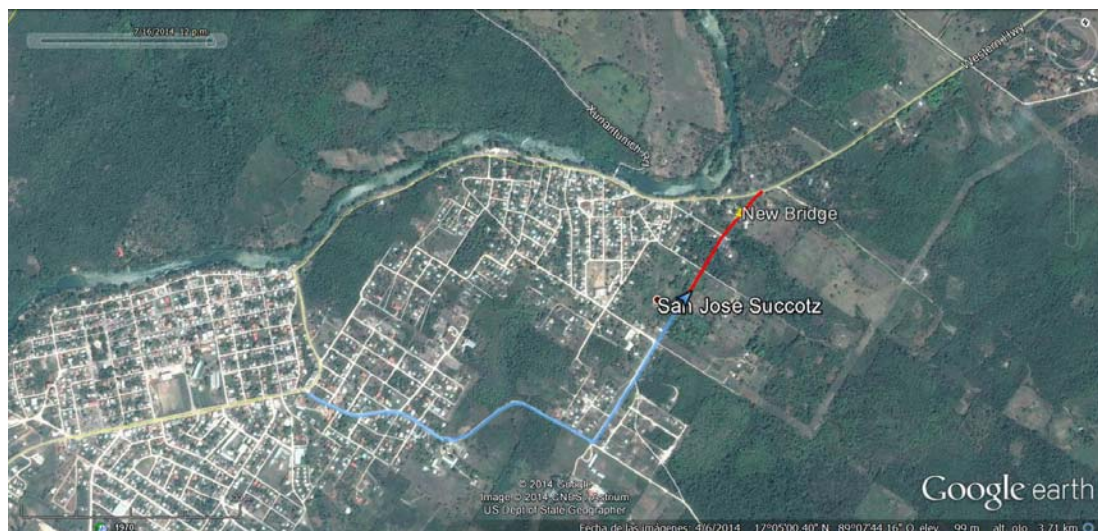
Figure 20: Street in Benque Viejo to be upgraded. In red the extension of the street.

The Consultant agrees with the solution proposed by the ATA Consultant. The only adjustment would be to upgrade the existing street in the Benque Viejo, as shown in the next figure. This will include extending the existing street to reach the GPH. This additional work will include new street construction in a length of 200 meters and the construction of a bridge 20 meters long.
