**Community-based Coastal Environmental Monitoring,
Toledo District, Belize**

Third (Final) Report

**Training and Full Implementation of
the Coastal Monitoring Programme**

**MARIDEV International Limited
Halifax, Nova Scotia, Canada**

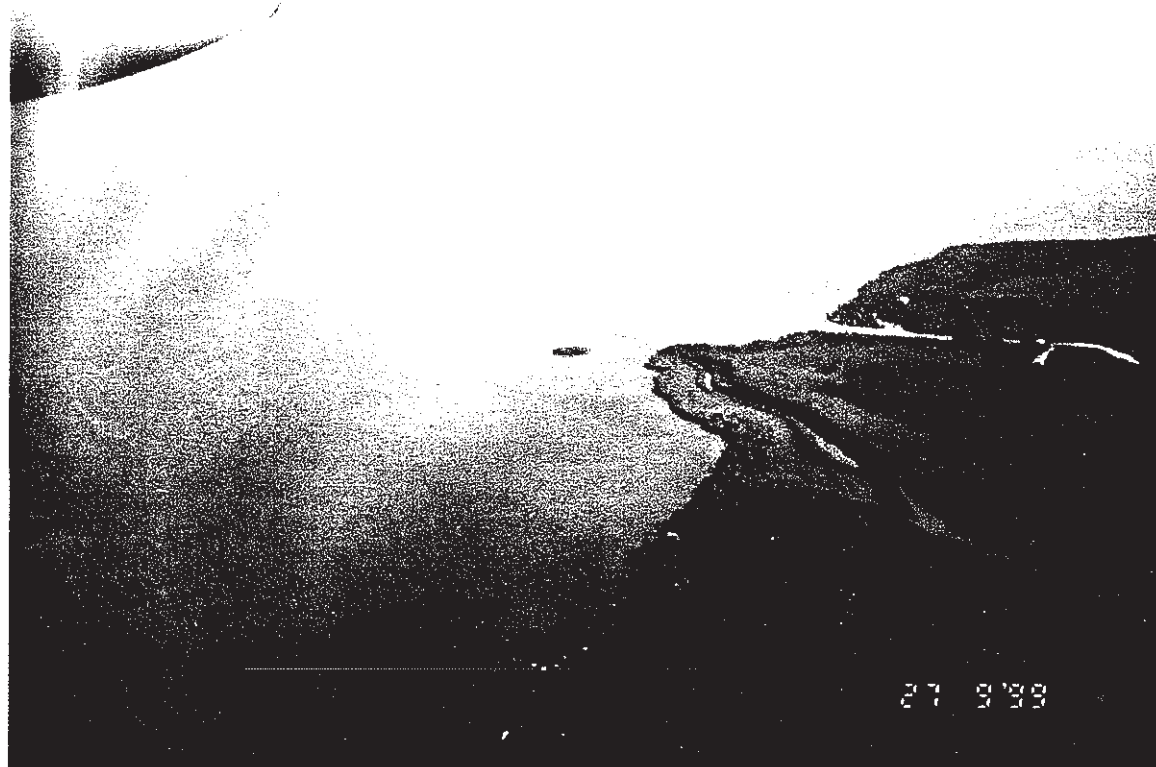
Extensive freshwater plume from Monkey River, running south - September, 1999.

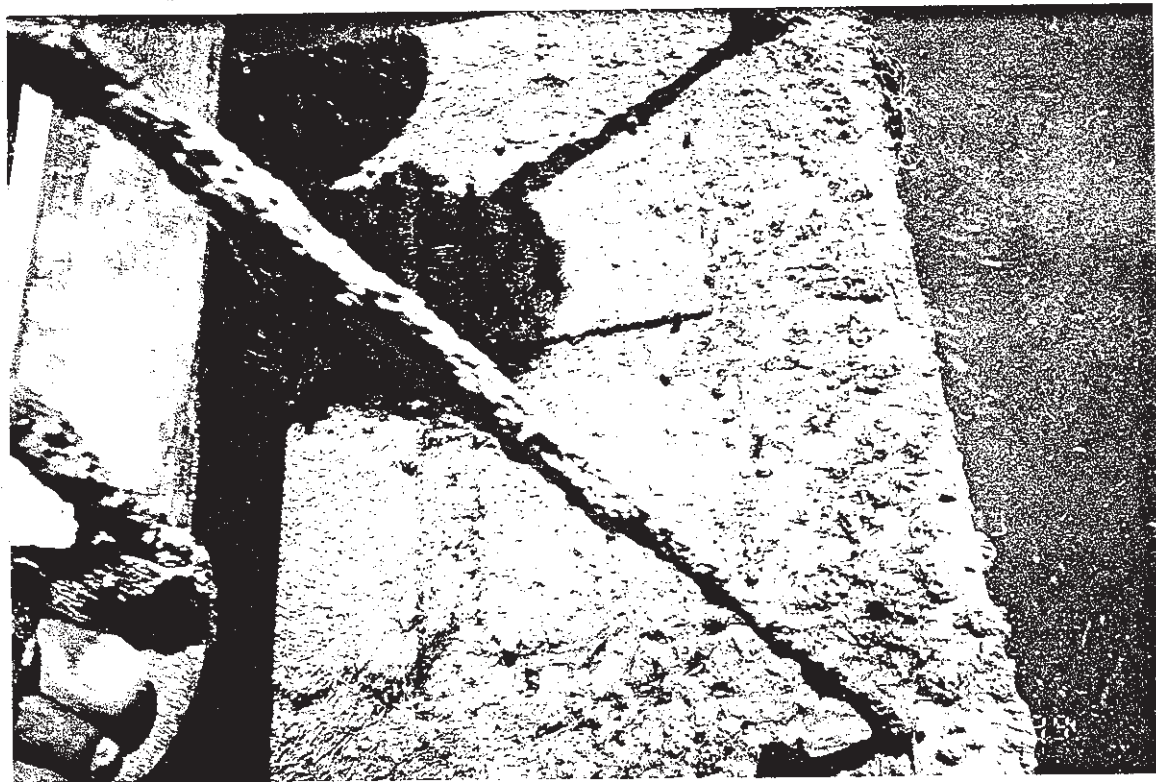
Recruitment plates at Station 1 Rio Grande - August 31, 1999.

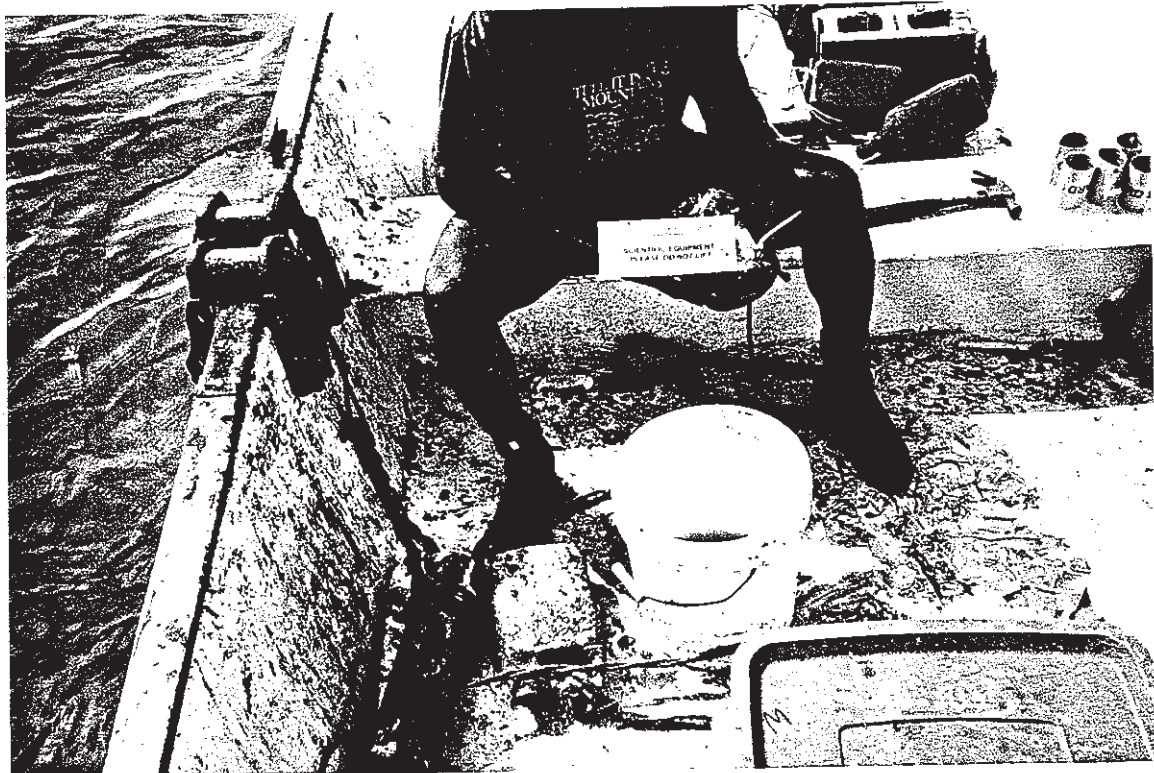
Marking of the moored equipment with tags.

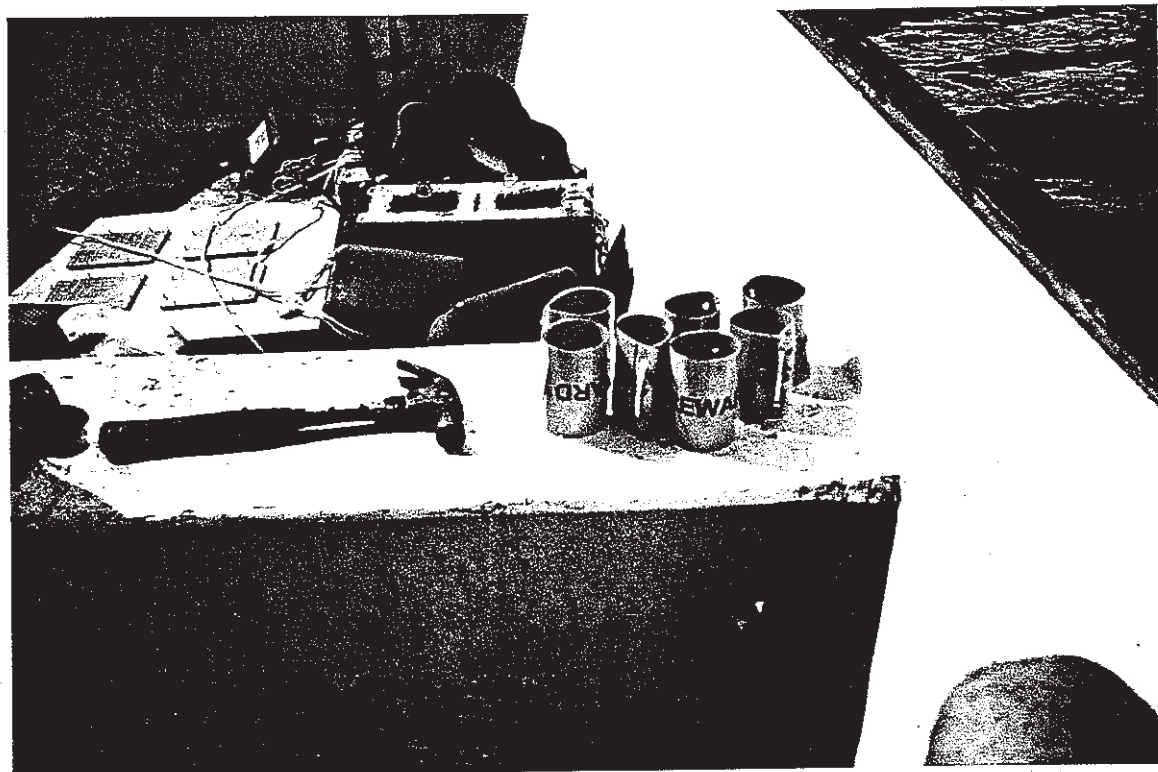
The bottom drifter cards released at Monkey River.

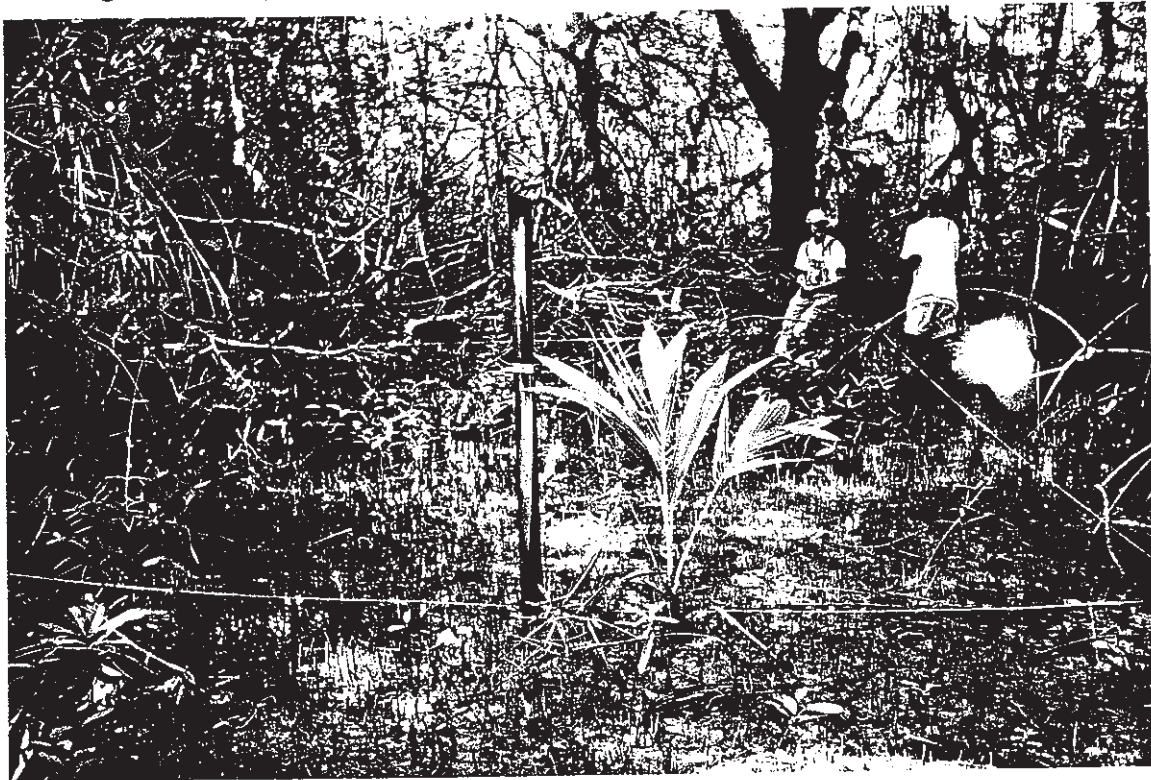
Marking of the mangrove plots and tagging of seedlings.

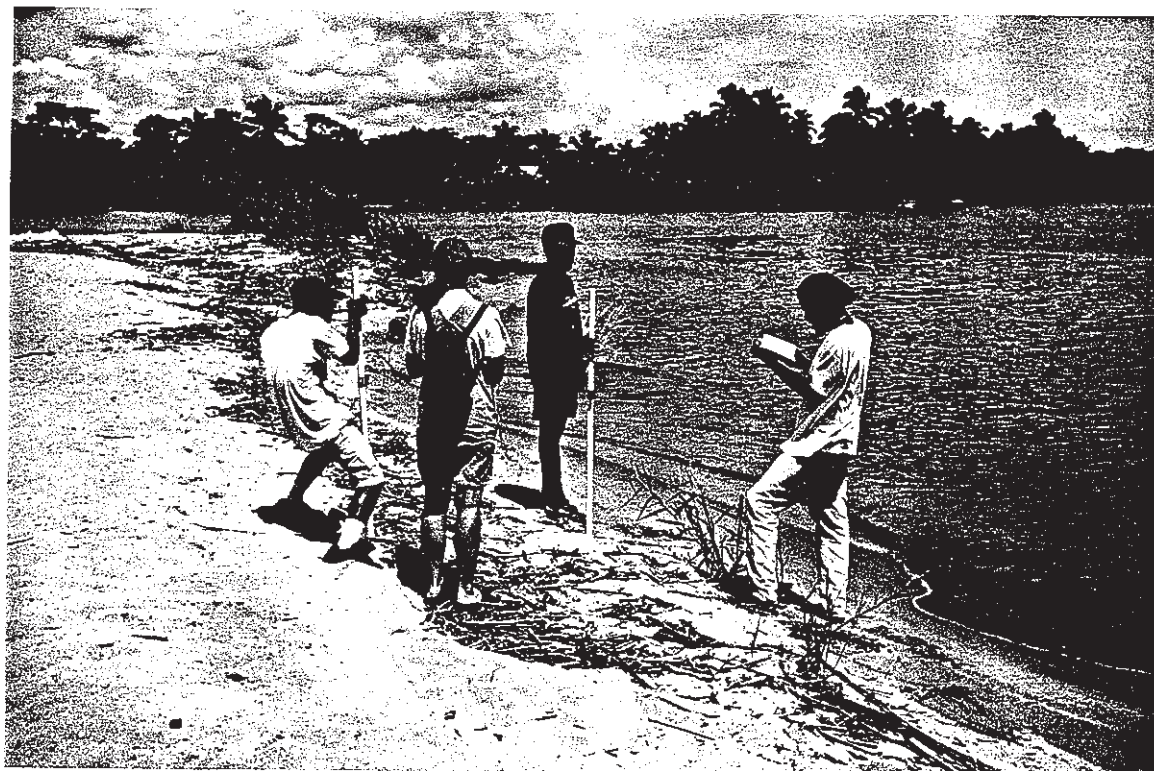
Beach profile training at Monkey River.

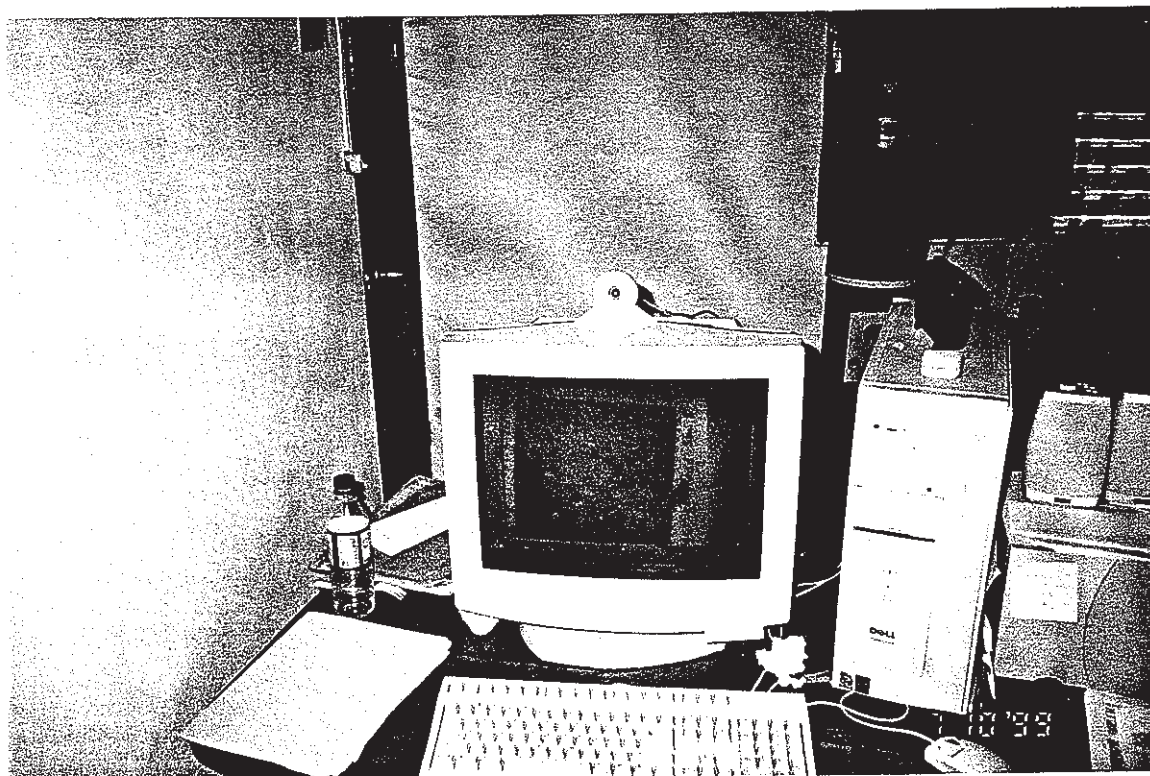
The Connectix digital camera (on top of the computer monitor), used for recruitment plates.
