# Investment Grade Audits of Schools and Hospitals in Jamaica

Jamaica Ministry of Science, Energy and Technology

Date: September 14, 2016

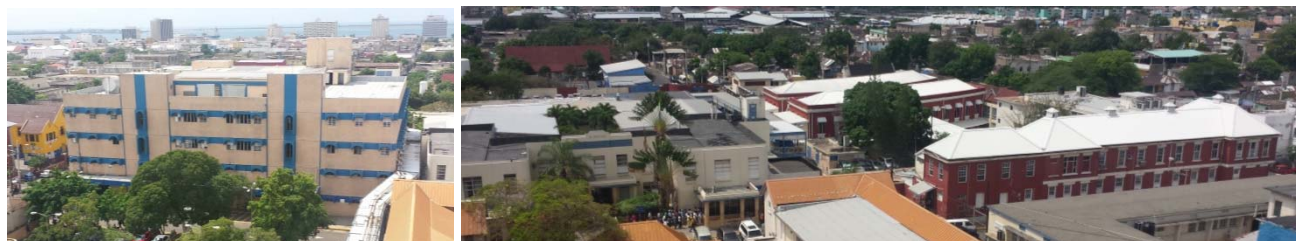
**Various Campus Building Types**

The typical exterior walls throughout the campus are concrete, which is preferable for energy efficient, resilient facilities. The material is extremely durable, fire-resistant, and able to withstand severe weather conditions. The mass of the concrete could insulate the interior and have the ability to limit air leakage, but no areas of the hospital appear to be sealed. There is no insulation on the concrete walls. On the interior, wood-framed walls are commonly used to separate spaces.

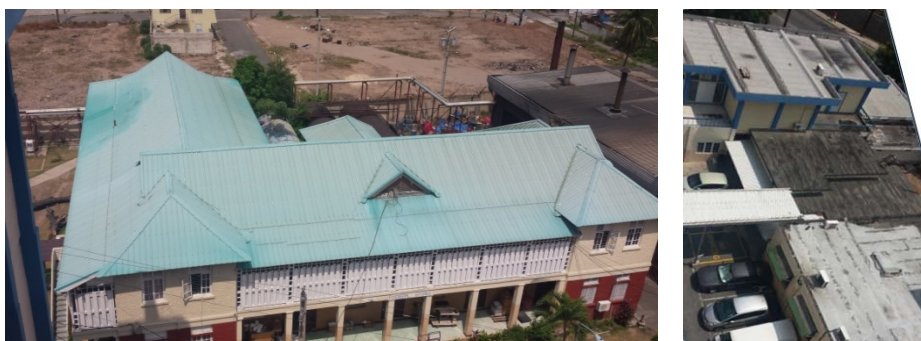
**Rooftop Examples: Multiple types and materials throughout the campus**

Rooftops are a combination of concrete construction and metal roofing panels or different colors. Some of the flat roofs had membranes installed to limit leakage. The temperatures measured on each roof type varied greatly, with the black membrane reaching as high as 137°F, and the white roofs at 87°F. (The ambient temperature was recorded at 86°F). Maintenance staff report that many roofs require some ongoing maintenance as leaking membranes are a regular occurrence.

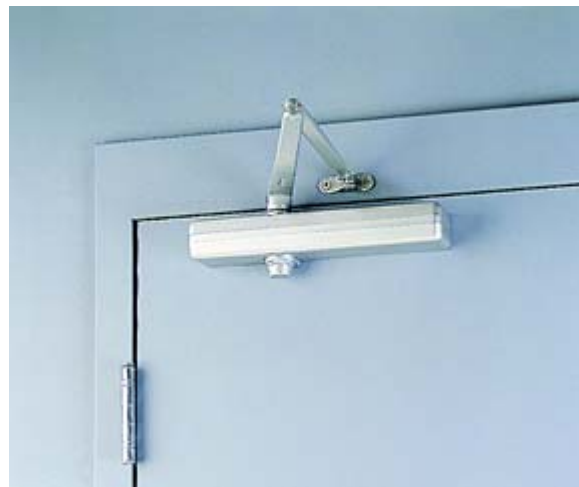
## 3. Air Seals on Doors / Windows

Improperly sealed doors often are a significant source for leakage of conditioned air, causing excess energy use. A 0.125-inch gap around a typical entryway door is the equivalent of drilling a 5.5-inch-diameter hole through an outside wall. A weather seal system includes weather stripping, which covers the sides and top of the door, and a sweep, which fills the space between the threshold and the door bottom. Foam, felt, plastic, or tubular silicone weather stripping products are designed for this purpose.

Where ventilated block is used structurally and replacement is infeasible, a border should be installed to retain an insulated window pane firmly against the border material, thus creating an airtight seal between the existing block, the border material and the new pane with appropriate adhesive and sealing compounds applied to ensure an airtight seal.

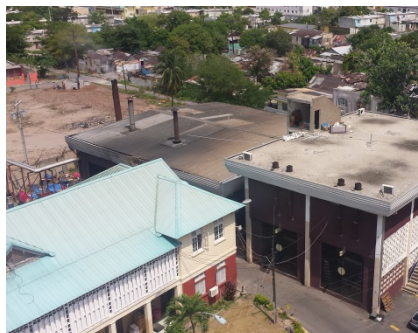
**Steam Plant: -Two Cleaver Brooks Boilers**

A central steam plant is in place, but its network has been reduced in scale to support only a sterilization facility. Surgical and delivery facilities require large amounts of sterile equipment, and use large steam autoclaves fed by the facilities' boiler systems. The live steam injected into the pressure chamber is held for a period of time to ensure sterilization, with fifteen to twenty loads be sterilized per day.

- 1) 10,461 MBH**
- 2) 8,368 MBH**

The steam plant consists of equipment that uses a large quantity of high combustion-emission fuel oil, and the installation of a system with reduced-size boilers adjacent to the autoclaves will result in improved response to load variation, high efficiency operation, and reduced maintenance. Upgrading this system will result in mechanical efficiency savings, steam leak savings, and air emissions savings.

This recommendation is not feasible at present; however discussions indicated that Kingston was in the process of upgrading from heavy oil to a natural gas system, which is a preferred fuel source. A conversion from these Intermediate Fuel boilers to a localized condensing natural-gas fired steam boiler will provide a significant savings annually. Staged gas-fired boiler can scale production up or down in response to demand. Should this fuel become available, this investment is highly recommended.

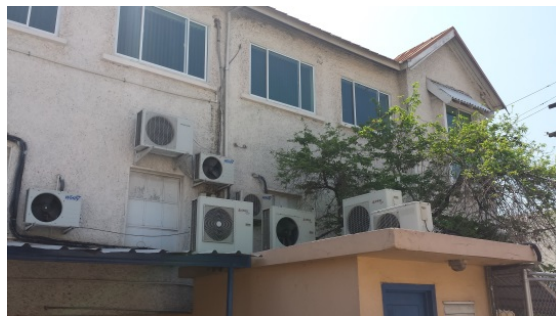
Hundreds of mini-split AC units have been installed in wards, offices, and treatment rooms. There are a variety of manufacturers and unit capacities. All of the systems used basic remote-control systems with no temporal programming capabilities. Many of the condensing units have not been installed with manufacturer recommended spacing, limiting their effectiveness. In addition, numerous condensing units were observed to have been placed either near open windows or directly above the extremely hot steam transfer line.

These systems placed a heavy toll on the maintenance staff, and a substantial number of the units were out of service. It was repeatedly observed that staff were requesting repairs to their cooling systems throughout the walkthrough.

**Mini-Split AC Units are the primary cooling source**

In addition, it is recommended that programmable setback thermostats be installed to better manage internal environments according to scheduling. Each individual unit can be controlled by a programmable thermostat, or a centralized control option would enable facility management to monitor and control the entire system from a single location.

It is recommended that VRF systems should replace the existing split systems where a large number of split units are concentrated through the facilities. Maintenance cost of the VRF system should be similar to a DX unitary system where consistent preventive maintenance to change filters and clean coil are recommended. Savings are based on the VRF typical efficiency of 18 EER in comparison to a typical split system efficiency (based on ASHRAE 90.1 2007) of 9.2 EER.

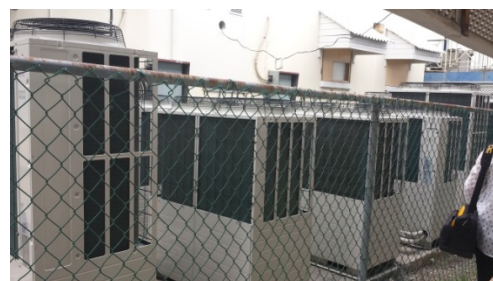
In 2015, the first Variable Refrigerant Flow (VRF) Systems on the campus were installed to service a clinics area and wards, with condenser bank capacities of between 60-100 tons. Individual units ranged from 40-70kW cooling output. The systems appear to be intentionally oversized for future expansion. The staff expressed interest in expanding the systems to reduce the HVAC maintenance burden.

**Clinics: VRF System**

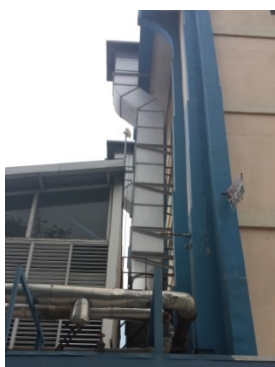
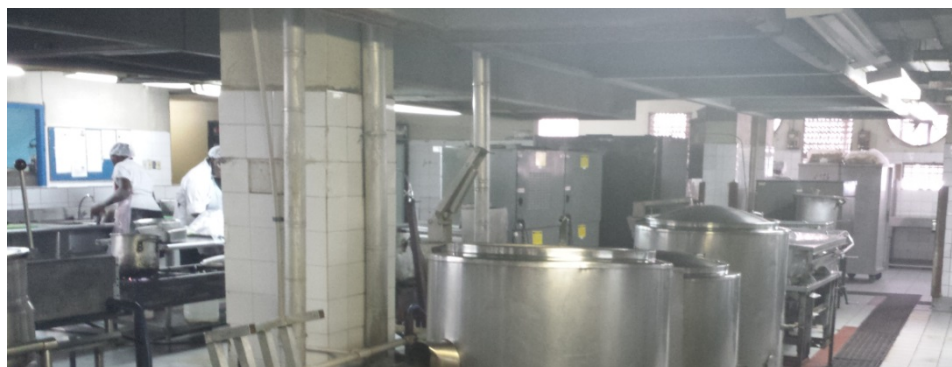
**Two Kitchen Exhaust Fans (CV)**

There are two large exhaust vents (one functioning at the time of the site visit) that are constantly running for kitchen services. These fans are estimated to be 10 HP each, and run ~12 hours per day. Makeup air is provided by open-air windows and large window fans.

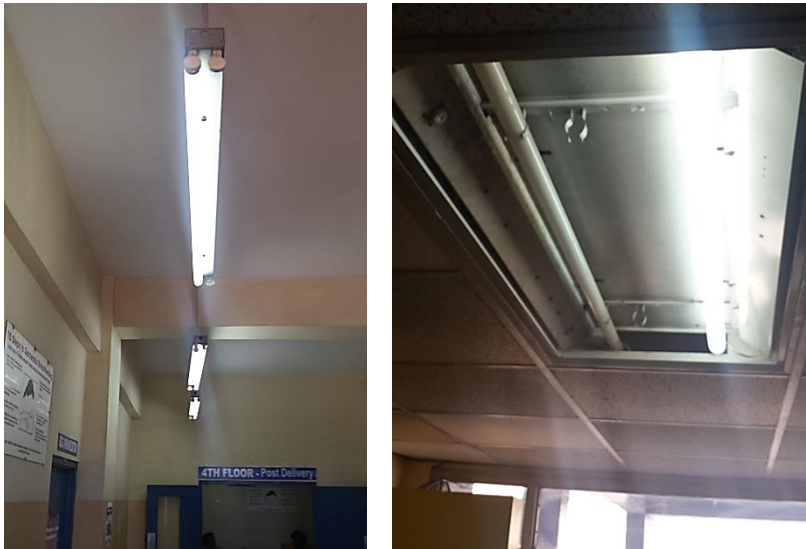
**Typical Interior Fixtures**

The typical interior lighting configuration in KPH and VJH is a manual-switch controlled set of T12 linear fluorescent fixtures (4ft and 6ft). While most of the lamps were T12 In many rooms, very few of the fixtures were filled to their capacity. It was also observed that often the lamps were left off due to sufficient natural lighting.

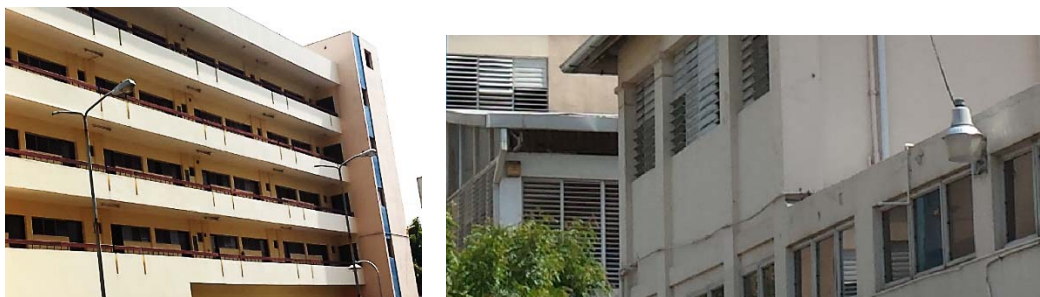
**Typical Exterior Fixtures**

Exterior lighting is a mixture of pole and wall-mounted fixtures, with fluorescent tubes, CFLs, mercury vapor and metal halide lamps. These lamps were in various levels of repair.

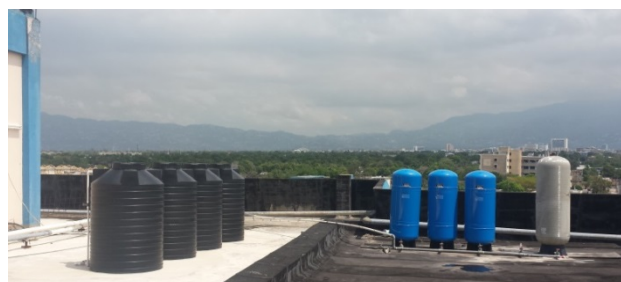
**Rainwater Collection System**

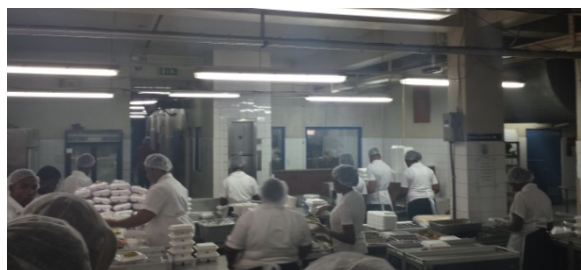
The primary use of hot water in the facility is limited to the main Kitchen on the first floor. The kitchen is able to provide 2100-2500 meals per day. Water had previously been heated using the central steam plant, but due to large leaks, the system was capped, and all hot water is provided through propane stoves.

**Kitchen Operations**

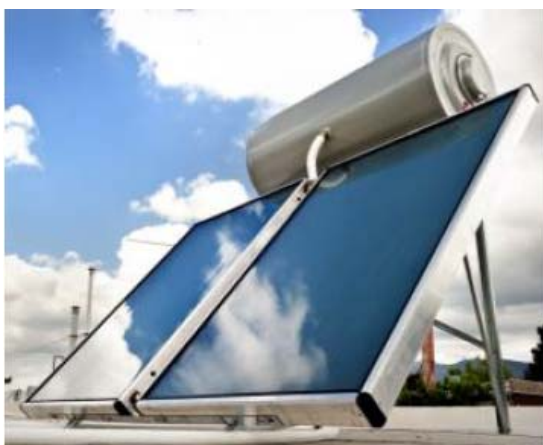
A typical solar water heating system consists of solar collectors, piping, and insulated water storage tanks. Heat is generated from incoming solar radiation energy transferred to water or glycol circulating through the panel and back to a storage tank. The heated fluid is either directly used, or a heat exchanger is used with potable water. The fluid can either be actively pumped, or use gravity and a density/pressure differential in a passive flow.

Glazed Flat Plate Collector with Storage

Hospitals have a high hot water load due to a number of medical water using processes. Significant reduction in fossil energy consumption can occur if a solar thermal system is installed to meet the hospital's hot water demand. The hospital's hot water consumption was unable to be obtained and therefore calculations on the solar thermal savings could not be performed at this time. It is recommended that the sizing of the solar thermal system is conducted once realistic data on hot water usage in the facility is obtained.

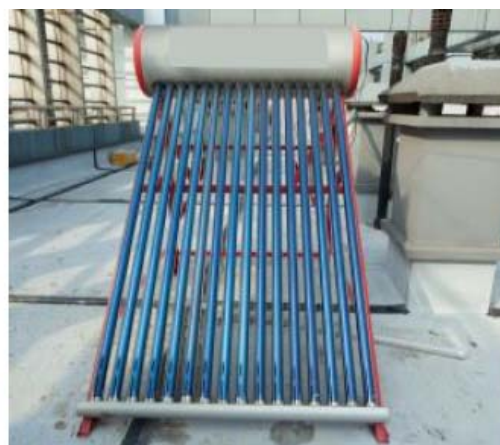
Evacuated Tube Collector with Storage

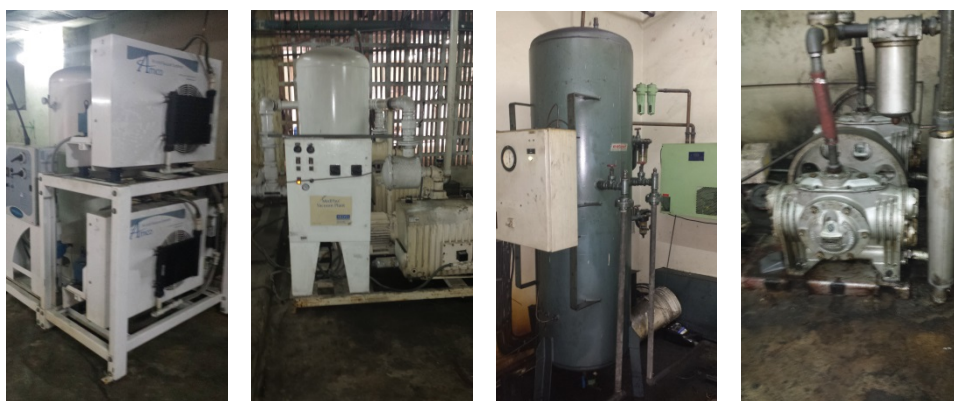
**Compressed Gasses and Vacuum Systems**

The hospital employs multiple high-energy process systems for medical uses. Medical equipment requires reliable compressor and vacuum systems for highly sensitive applications. The compressor system was noted to activate approximately every minute during the site visit, indicating a potential leak in the system.

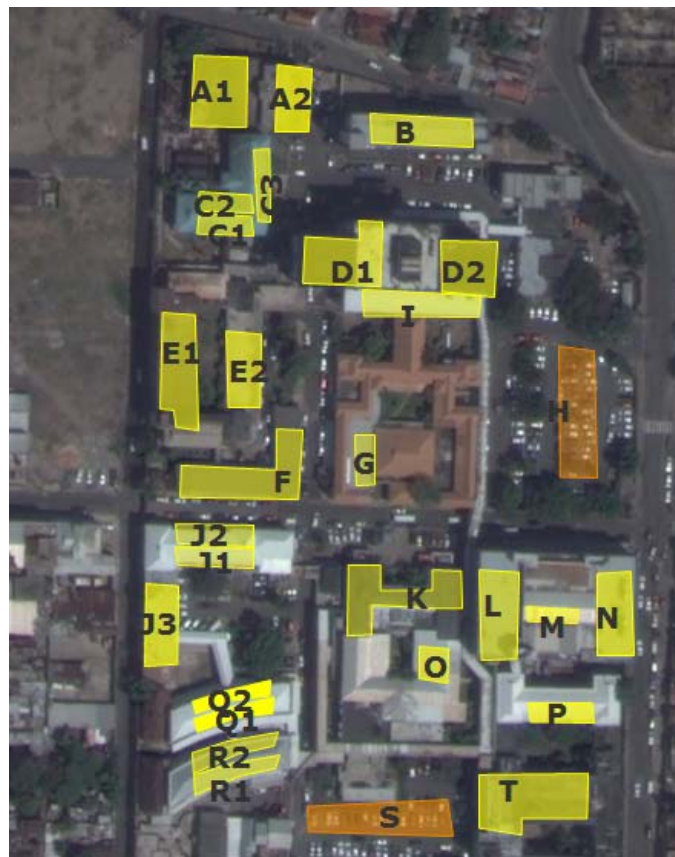
The following map shows the roof areas considered in the solar analysis and the table shows the results of the solar feasibility study conducted for the site.

Area	Azimuth	Collector Area (square meters)	Collector Area (square feet)	KWdc	Capital Cost (USD)	Annual Energy Generation (kWh)	Annual Cost Savings
A1	180	397	4273	59.6	\$178,800	100,199	\$25,357
A2	180	227	2443	34.1	\$102,300	57,329	\$14,508
B	180	305	3283	45.8	\$137,400	76,999	\$19,486
C1	180	91	980	13.7	\$41,100	23,032	\$5,829
C2	0	91	980	13.7	\$41,100	18,528	\$4,689
C3	90	57	614	8.5	\$25,500	13,105	\$3,316
D1	180	441	4,747	66.1	\$198,300	111,127	\$28,123
D2	180	223	2,400	33.5	\$100,500	56,320	\$14,253
E1	180	343	3,692	51.5	\$154,500	86,582	\$21,911
E2	180	321	3,455	48.2	\$144,600	81,034	\$20,507
F	180	401	4,316	60.1	\$180,300	101,040	\$25,570
G	180	124	1,335	18.6	\$55,800	31,270	\$7,913
H	180	364	3,918	54.6	\$163,800	91,793	\$23,230
I	180	311	3,348	46.6	\$139,800	78,344	\$19,826
J1	180	155	1,668	23.2	\$69,600	39,004	\$9,871
J2	0	155	1,668	23.2	\$69,600	31,376	\$7,940
J3	180	255	2,745	38.3	\$114,900	64,390	\$16,295

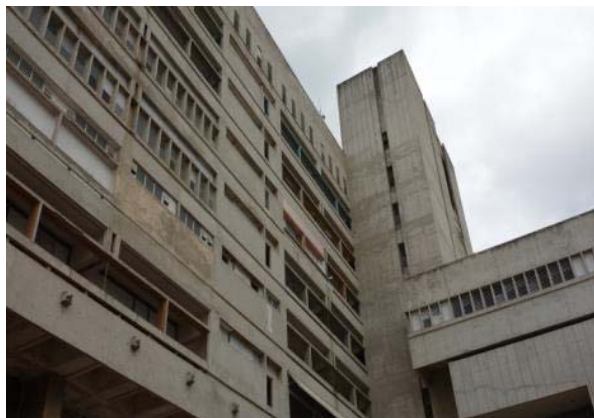
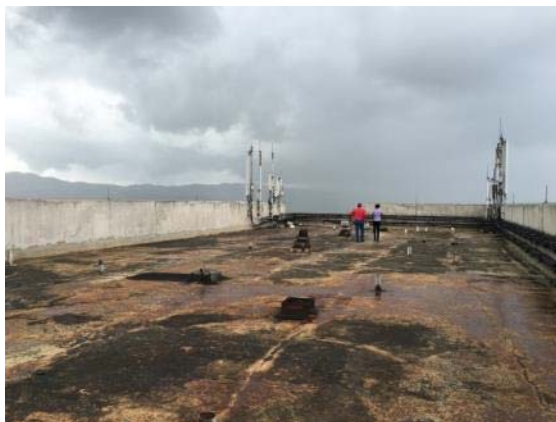
The exterior walls are composed of concrete with no insulation and the roof is concrete with membrane and asphalt on the exterior. The roof requires some ongoing maintenance as there were portions of the membrane completely removed from the surface. Pools of water were observed on some areas of the roof which indicate inadequate drainage. Due to the high demand for patient care, additional rooms have been added within the atriums using wood-framed walls. A two story addition to the South side is currently underway.

**Exterior wall and roof of hospital**

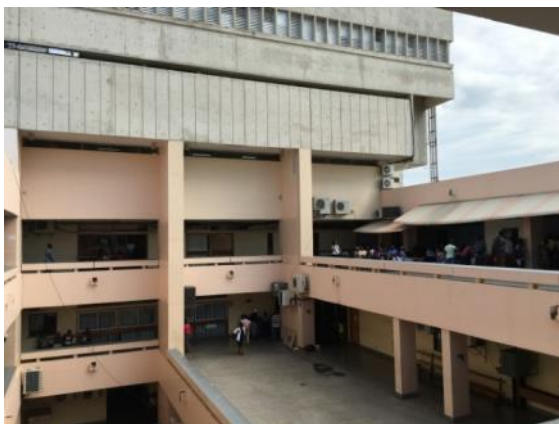
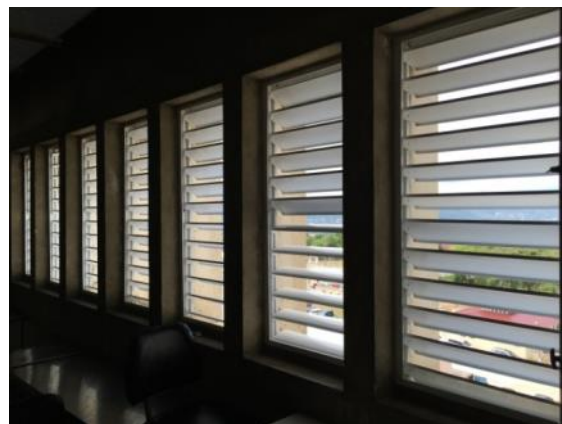
Most of the windows in the hospital were unglazed 'jalousie' louver type. These metal louvers are present in most of the window openings in place of panes of glass. As a result, natural ventilation (both cross-flow and stack strategies) is the predominant cooling method for most of the perimeter spaces and the open air atrium.

**Open atrium and metal louver windows**

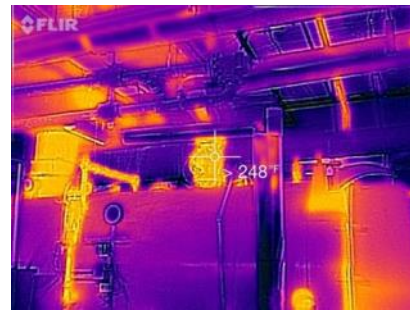
A central boiler plant provides steam for the autoclaves, kitchen, and adjacent laundry building. Recently, the boiler was upgraded to a 2013 CleaverBrooks natural gas fired boiler with a specified gross output of 8369 MBH and thermal efficiency of 82%. It was noted that the steam was

being provided supplied at 350F. The infrared photo shown below shows the exterior of this steam pipe at >248F. The old CleaverBrooks boiler of 1993 vintage is still installed on site but not in use.

**Steam Plant: -One Cleaver Brooks Boilers  
(8369 MBH)**

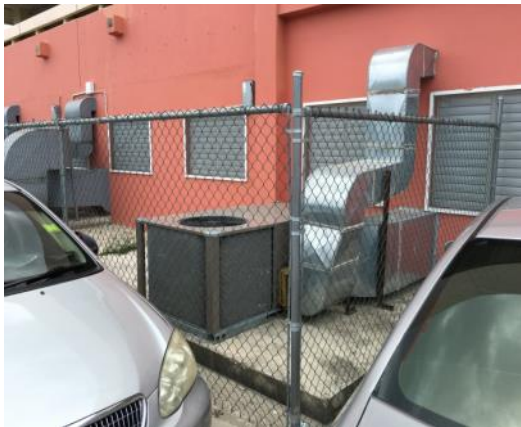
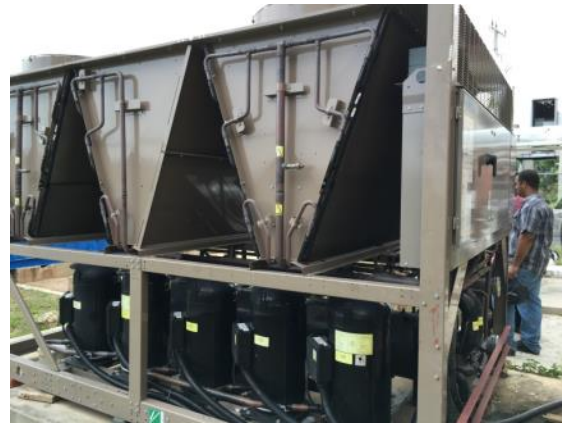
In a concentrated effort to modernize to international medical standards, a new chilled water system was designed for critical care areas specifically ensure appropriate outside fresh air levels and establish infection control protocols. Recently a York chiller was installed to supply the 4th and 5th floors, and was purposely oversized for future expansion. Another York chiller has also been installed to serve the ICU, which is currently under construction. There are 4 constant speed chilled water pumps installed for the chiller system (2 per chiller). For the chilled water system's air loop, 3 York air handlers (AHU-5, 6 and 7) were installed to serve the 4th and 5th floors and the new ICU. This is the only central cooling system installed in the building.

**Air handlers serving the ICU and one of the air cooled chillers.**

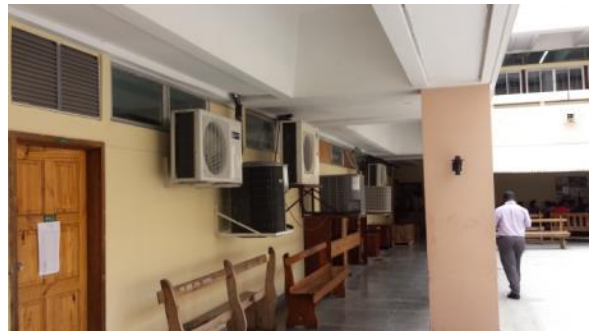
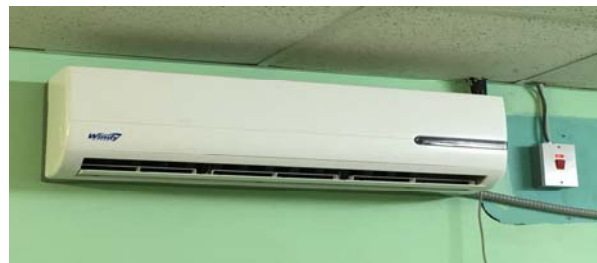
Over 400 mini-split AC units have been installed in wards, offices, and treatment rooms. There are a variety of manufacturers and unit capacities. All of the systems used basic remote-control systems with no temporal programming capabilities. Many of the condensing units have not been installed with manufacturer recommended spacing, limiting their effectiveness. In addition, numerous condensing units were observed to have been placed near open windows.

These systems placed a heavy toll on the maintenance staff, and a substantial number of the units were out of service. It was repeatedly observed that medical staff were requesting repairs to their cooling systems throughout the walkthrough.

**Mini-Split AC Units are the primary cooling source**

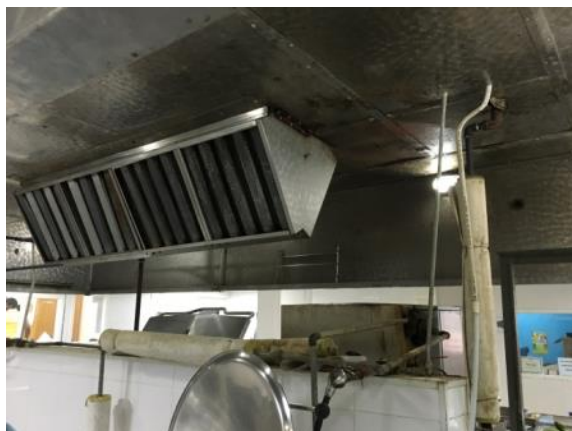
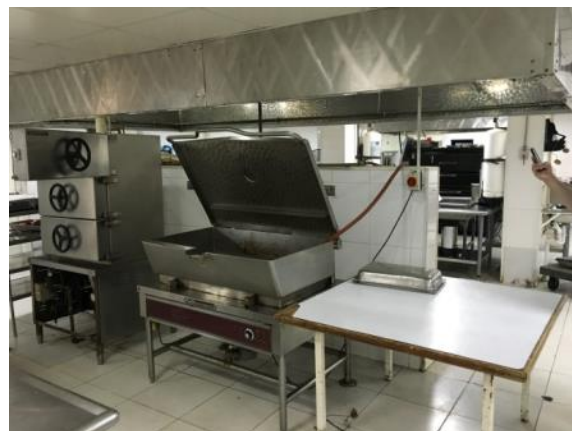
**Kitchen exhaust hoods (CV)**

Installing a demand control controlled ventilation system to operate the exhaust fan is recommended. This system would include the VFD to control the exhaust fan motor, a digital controller, temperature probe, and smoke probe in the cooking hood to control the exhaust fan. Existing exhaust fan motor may need to be replaced with inverter duty motor.

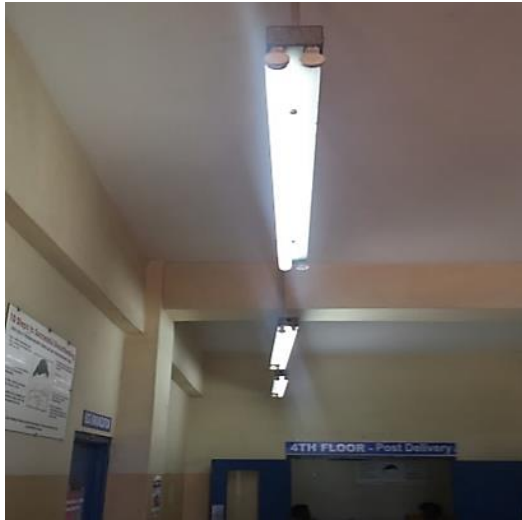
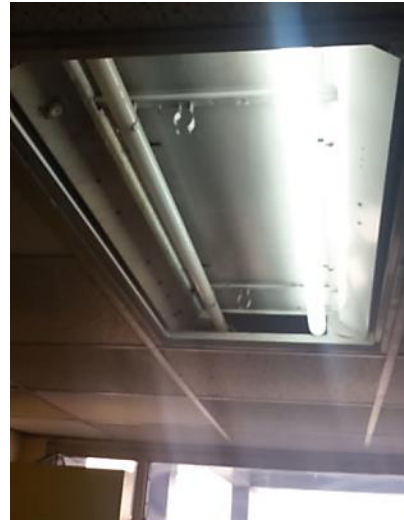
Lighting fixtures for the hospital were typically T12 or T8 fluorescent tubes with no reflectors or diffusers, causing inefficient and poor lighting. There is an ongoing phase out of T12 ballast technology by the maintenance team.

### Typical Interior Fixtures

Most spaces in the building are not adequately lit with an illuminance range of 12 to 20 footcandles (FC) for the patient and administration areas. In the operating rooms and the examination areas an illuminance of 32 FC was recorded however; these spaces were not occupied at the time so not all fixtures were turned on. The Illuminating Engineering Society of North America (IESNA) Lighting Handbook Reference & Application recommends an illuminance of 28 FC for general ward lighting, 46 FC for simple examination areas and 93 FC for examination and treatment.

It is recommended to replace all existing fluorescent fixtures to dimmable LED fixtures with an LED lighting retrofit kit. Alternatively, simply installing LED tubes with a ballast bypass into the existing fixture can be more cost-effective with a simple wiring change. T12 fixtures already have a non-shunted rapid start lamp holder, and T8 fixtures need a replacement lamp holder for use with the LED tube.

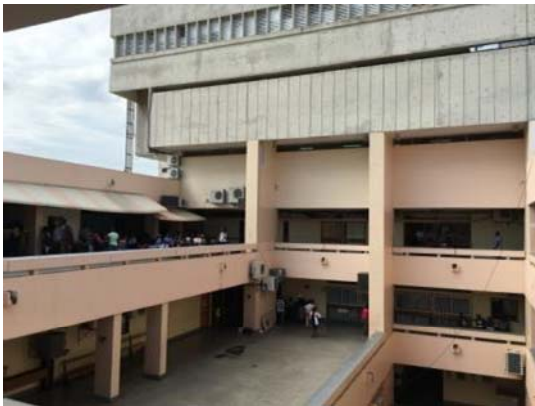
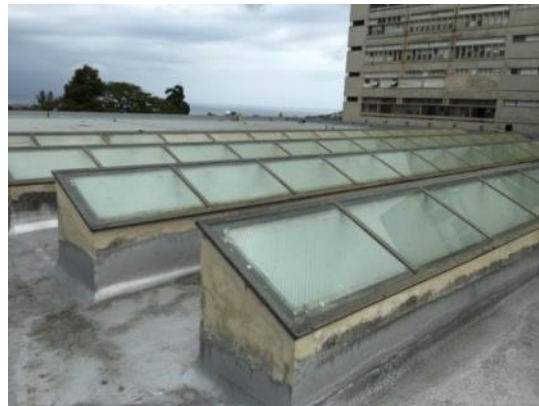
There were roof monitors installed to top light the outpatient clinics and waiting rooms. Although require cleaning, these monitors still provide some day light for the areas below on a sunny day. The atrium also allows for an abundance of natural light for the central transition areas.

### Existing natural daylighting (multi storey atrium and roof monitors)

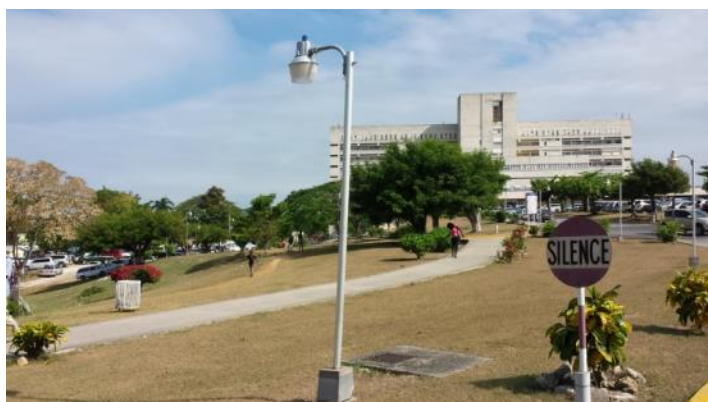
**Typical Exterior Fixtures**

Exterior lighting is a mixture of pole and wall-mounted fixtures, with fluorescent tubes, CFLs, mercury vapor and metal halide lamps. These lamps were in various levels of repair.

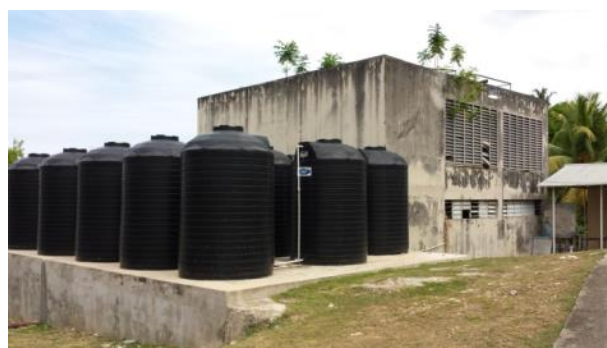
**Rainwater Collection System**

The typical site weather pattern reveals that precipitation occurs for approximately 25% of the year, presenting an opportunity to collect the water independently on site. There are several methods to collect rain water such as rooftop capture to rain barrels, collection from fog through nets, or using a reservoir. It is recommended that rain barrels be used to collect the rainwater from gutters and the roofs where the first flush occurs for the first 2 inches of rainwater. Typically, rainwater is used for irrigation and toilet flushing. However, we recommend additional proper filtration and treatment system is added to make the water potable and meet drinking water standards.

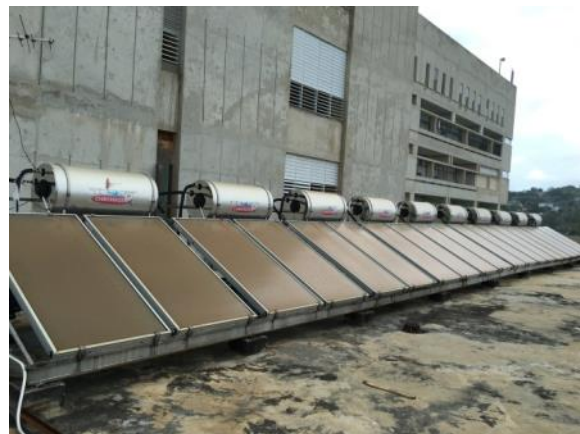
There are 70 Chromagen solar thermal panels installed on site that are not in operation on two separate roofs (4<sup>th</sup> and 6<sup>th</sup> floor).

Cornwall was part of a demonstration initiative from which other hospitals were meant to be modelled in which the installation of the solar water heaters was completed July 2007. The system was originally designed to be connectable to the steam boiler system. It is unknown why the solar thermal system does not currently operate.

**Chromagen solar thermal system on site**

Hospitals have a high hot water load due to a number of medical water using processes. Significant reduction in fossil energy consumption can occur if a solar thermal system is installed to meet the hospital's hot water demand. The hospital's hot water consumption was unable to be obtained and therefore calculations on the solar thermal savings could not be performed at this time. It is recommended that the sizing of the solar thermal system is conducted once realistic data on hot water usage in the facility is obtained.

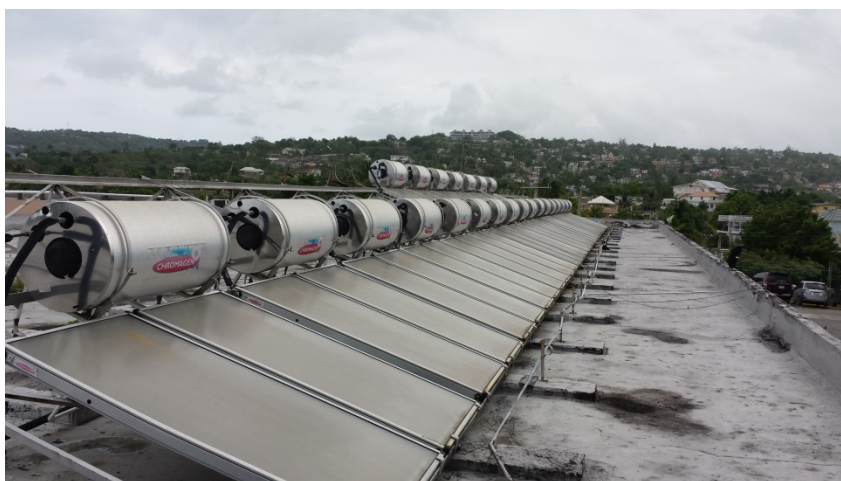
**INACTIVE: Significant solar thermal system in place**

A typical solar water heating system consists of solar collectors, piping, and insulated water storage tanks. Heat is generated from incoming solar radiation energy transferred to water or glycol circulating through the panel and back to a storage tank. The heated fluid is either directly used, or a heat exchanger is used with potable water. The fluid can either be actively pumped, or use gravity and a density/pressure differential in a passive flow.

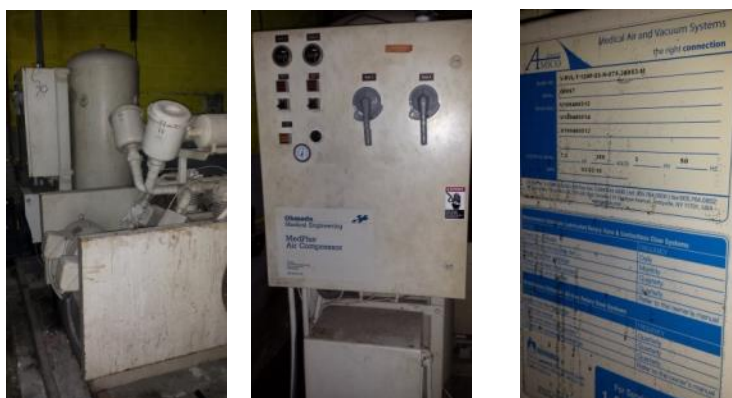
**Compressed Air and Vacuum Systems**

The hospital employs multiple high-energy process systems for medical uses. Medical equipment requires reliable compressor and vacuum systems for highly sensitive applications. The central vacuum and medical air system were both located in the plant room of the hospital and were of Amico and Omeda type. The compressors had 2 x 15 HP motors.

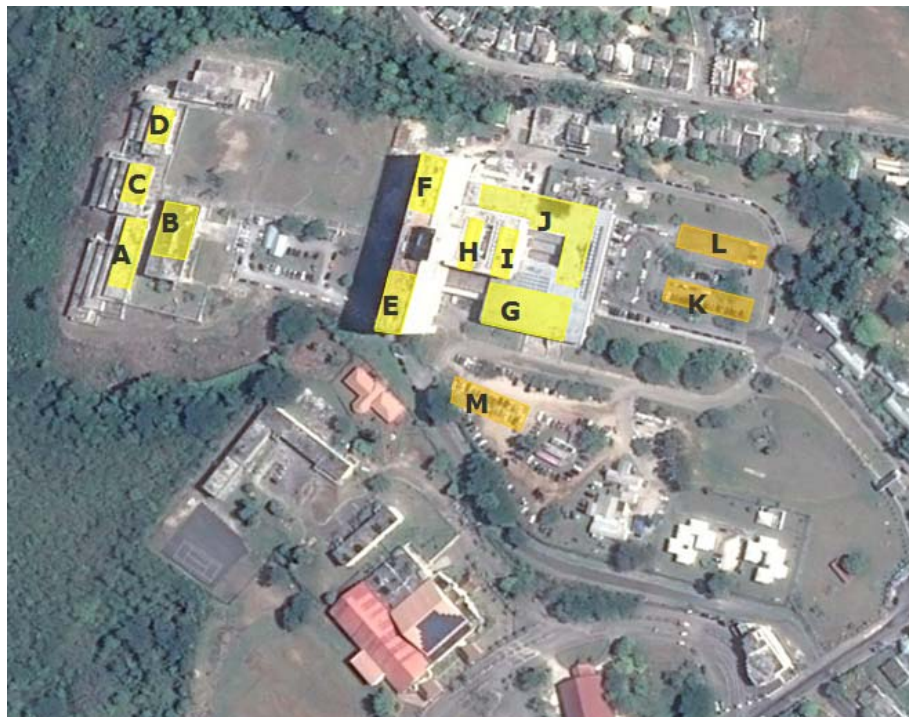
The following map shows the roof areas considered in the solar analysis and the table shows the results of the solar feasibility study conducted for the site.

**Map of Potential Solar Array Opportunities on Site**

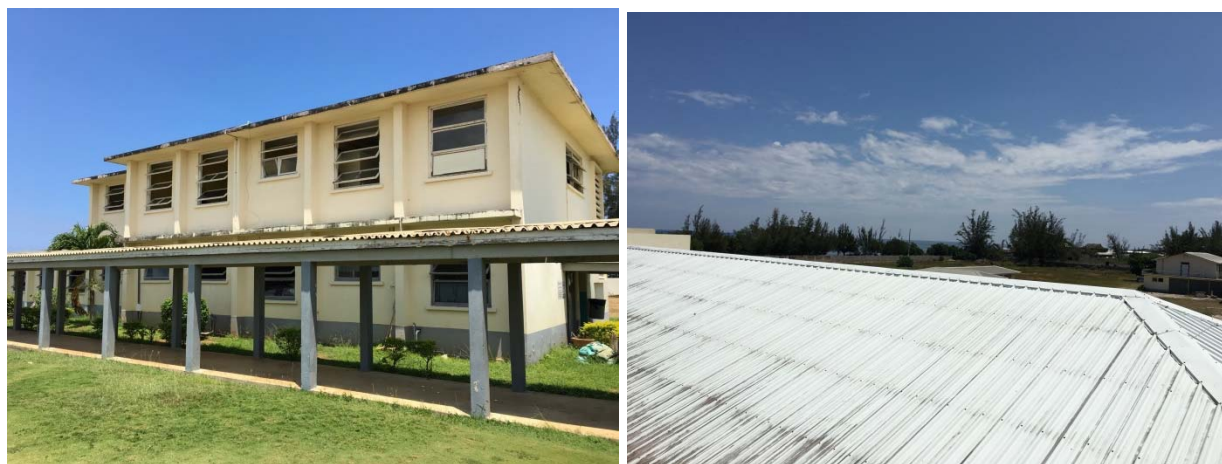
There are 9 main buildings that are concrete block constructed, with mostly corrugated roofs. The two newly-constructed buildings house the operating theatre and accident/emergency, and have an insulated concrete roof with gravel. The kitchen and laundry are both located in standalone wood frame, single-story structures. There is no ceiling or insulation in either the roof or wall constructions. The temperature of the underside of the laundry room roof was recorded to be 102°F at time of visit.

**Exterior wall and roof of hospital**

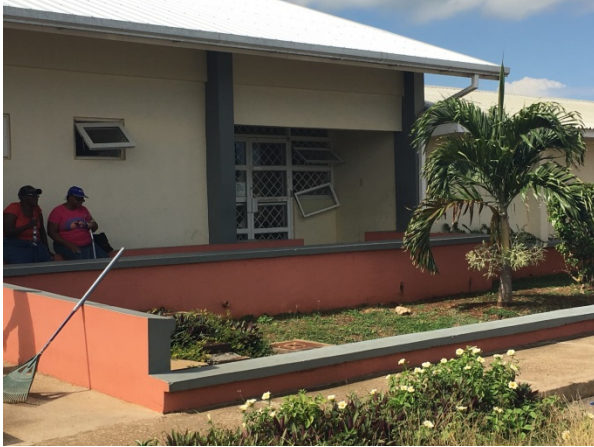
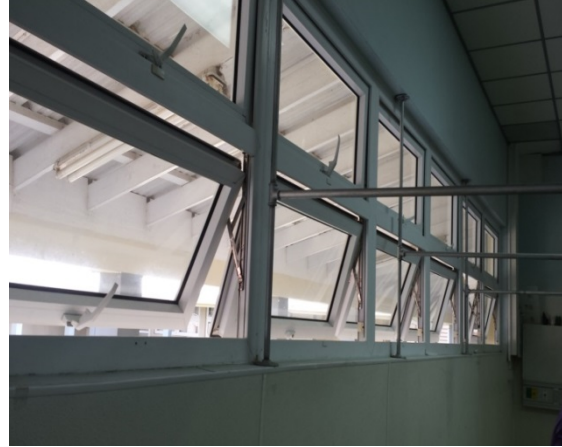
Most of the windows in the hospital are single pane and of the operable 'awning' type. As a result, natural ventilation (cross-flow strategy) is the predominant cooling method for most of the perimeter spaces and the open air atrium. There were a number of windows that were broken throughout the site. The common cause observed was a broken crank operator or sagging window hinge.

### **Awning windows**

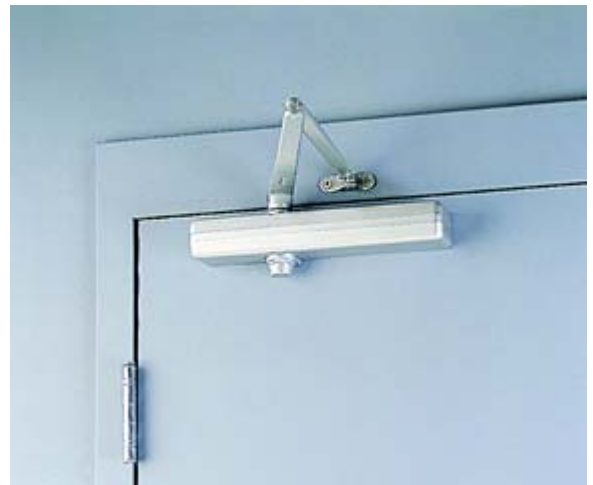
### 7. Air Seals on Doors / Windows

Improperly sealed doors often are a significant source for leakage of conditioned air, causing excess energy use. A 0.125-inch gap around a typical entryway door is the equivalent of drilling a 5.5-inch-diameter hole through an outside wall. A weather seal system includes weather stripping, which covers the sides and top of the door, and a sweep, which fills the space between the threshold and the door bottom. Foam, felt, plastic, or tubular silicone weather stripping products are designed for this purpose.

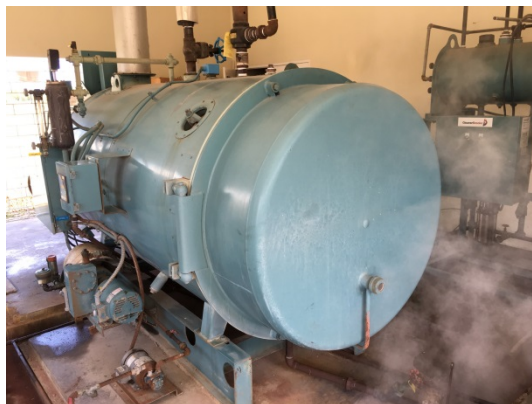
**Steam Plant: - One Cleaver Brooks Boiler (1674 MBH)**

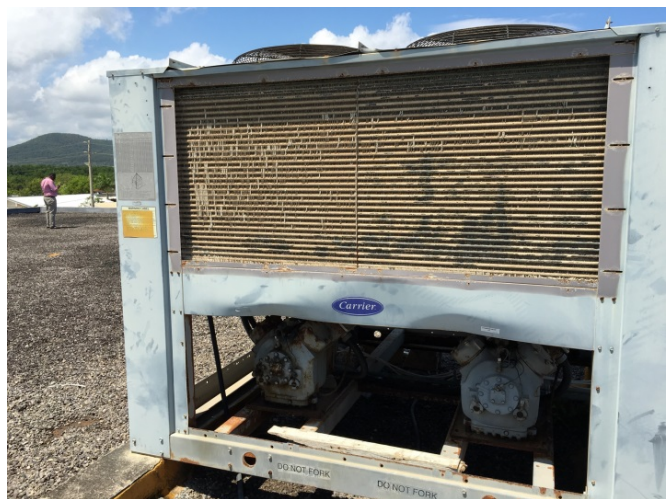
**Carrier rooftop condenser**

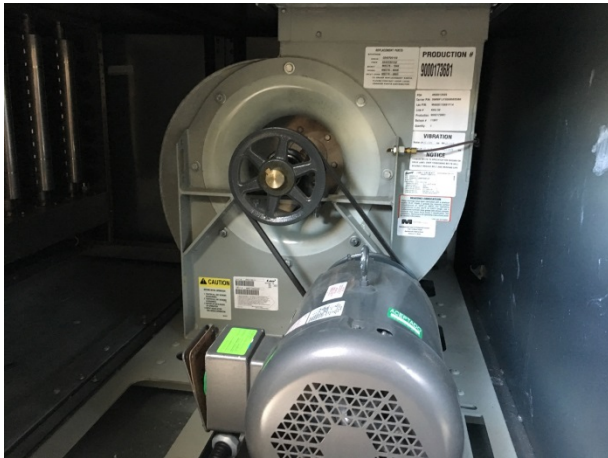
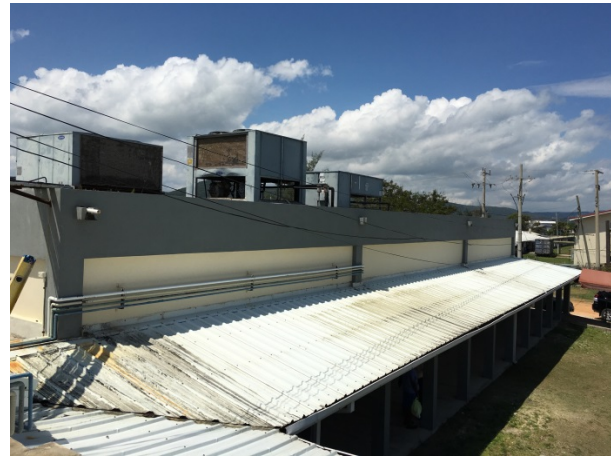
**Supply fan and condenser units on the roof**

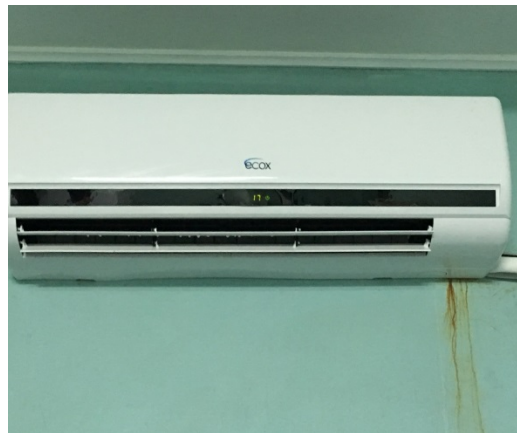
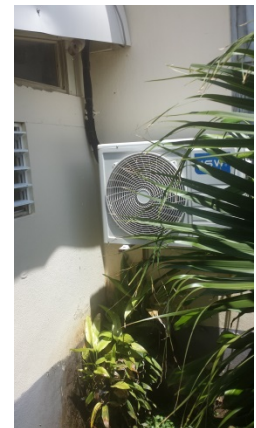
Approximately 25 mini-split AC units have been installed in wards, offices, and treatment rooms. There are a variety of manufacturers and unit capacities. All of the systems used basic remote-control systems with no temporal programming capabilities.

Many of the condensing units have not been installed with manufacturer recommended spacing, limiting their effectiveness. In addition, numerous condensing units were observed to have been placed either near open windows or directly above the extremely hot steam transfer line.

These systems placed a heavy toll on the maintenance staff, and a substantial number of the units were out of service. It was repeatedly observed that the staff were requesting repairs to their cooling systems throughout the walkthrough.

**Mini-Split AC Units**

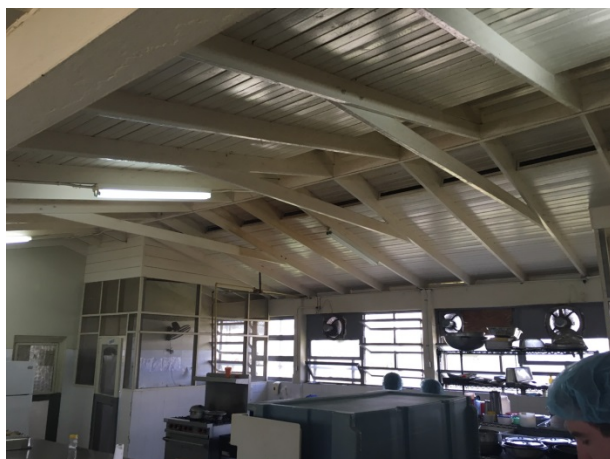
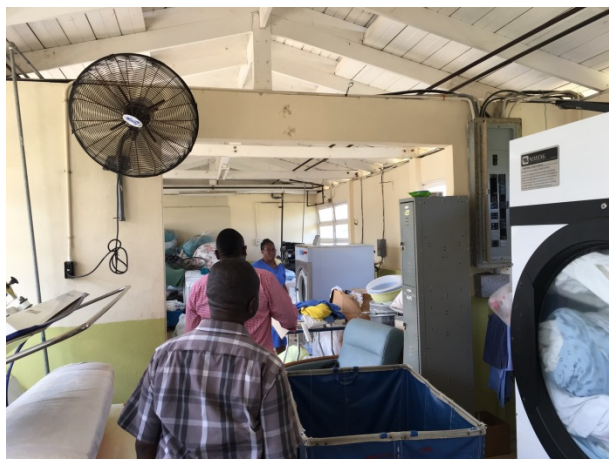
**Kitchen exhausts and pedestal fan in the laundry**

There are 3 constant volume exhaust fans that exhaust air from kitchen. These units were extremely old with no nameplate data evident. The kitchen exhaust fans are operated continuously from 6am – 7pm daily. No make-up air is provided to the kitchen. Pedestal standing fans are used to provide comfort to the occupants in the unconditioned laundry. On the interior surface of the laundry roof, a radiant temperature of 102F was observed.

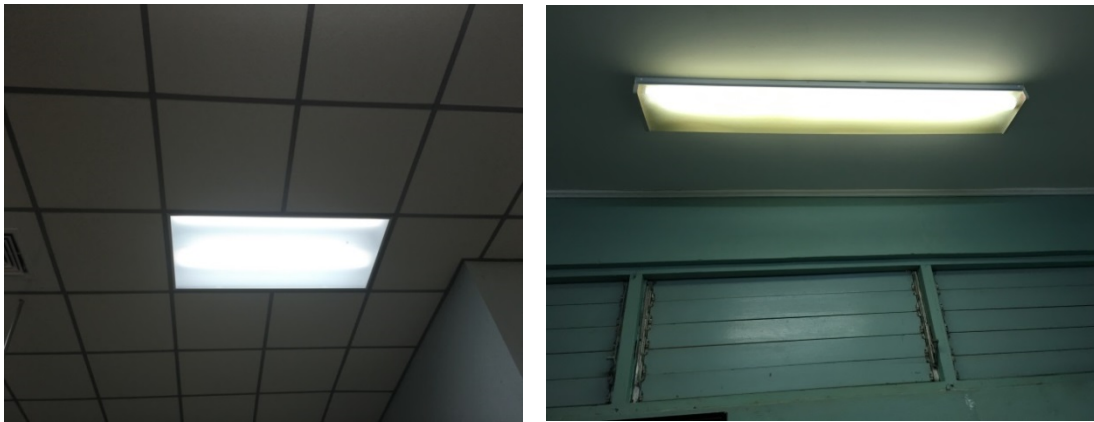
**Typical Interior Fixtures**

Lighting fixtures for the hospital were typically T12 or T8 fluorescent tubes with no reflectors or diffusers, causing inefficient and poor lighting. There is an ongoing phase out of T12 ballast technology by the maintenance team.

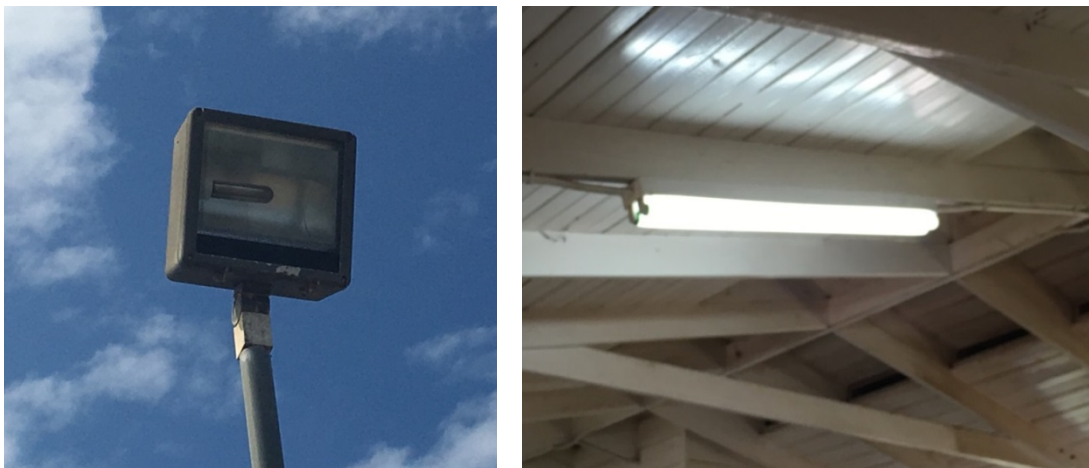
**Typical Exterior Fixtures**

For the exterior hallways, mostly fluorescent tubes were installed. Magnetic induction, fluorescent fixtures were evident for the parking lot lighting. These lamps have similar performance to LED in terms of efficiency.

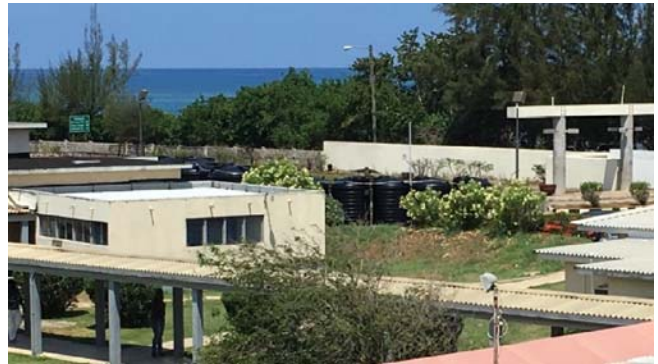
**Rainwater Collection System**

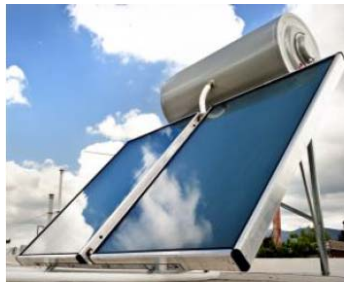
A typical solar water heating system consists of solar collectors, piping, and insulated water storage tanks. Heat is generated from incoming solar radiation energy transferred to water or glycol circulating through the panel and back to a storage tank. The heated fluid is either directly used, or a heat exchanger is used with potable water. The fluid can either be actively pumped, or use gravity and a density/pressure differential in a passive flow.

Glazed Flat Plate Collector with Storage

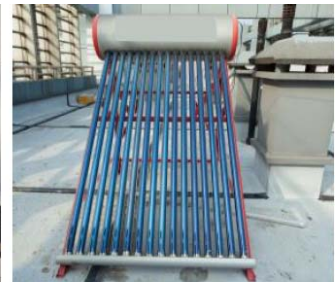
Evacuated Tube Collector with Storage

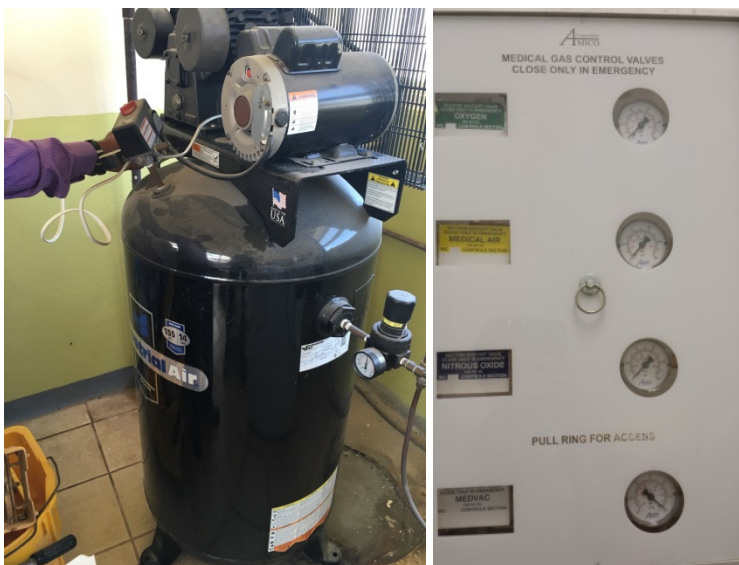
The hospital employs multiple high-energy process systems for medical uses. Medical equipment requires reliable compressor and vacuum systems for highly sensitive applications. There was an Industrial USA air compressor system with 5 HP rating and 80 gallon tank located in the laundry on site.

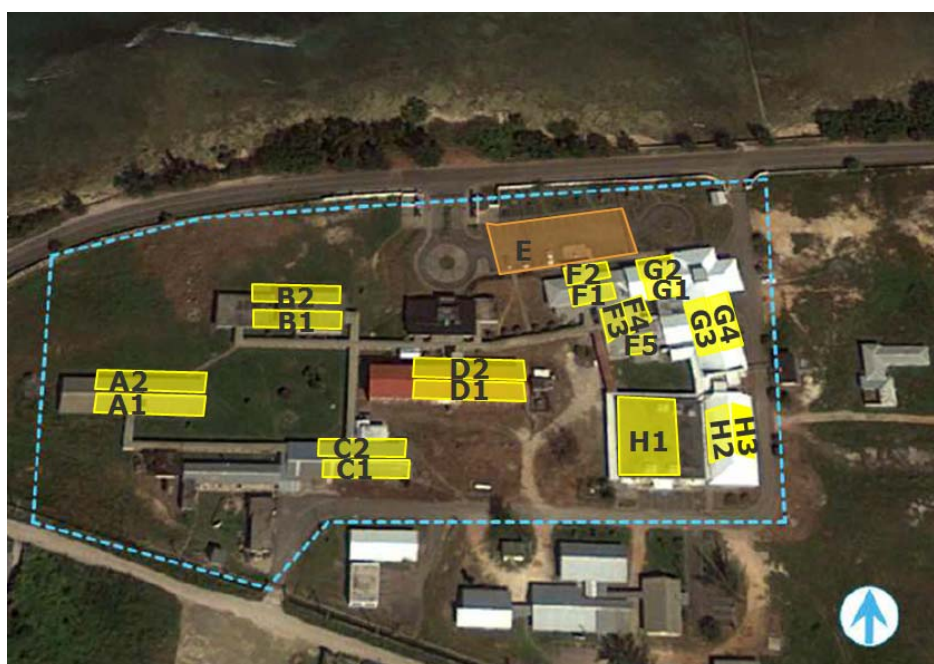
The following map shows the roof areas considered in the solar analysis and the table shows the results of the solar feasibility study conducted for the site.

Map of Potential Solar Array Opportunities on Site

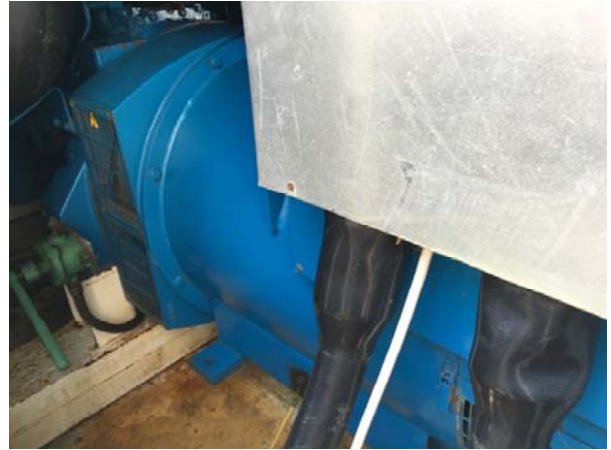
There is one backup generator on site that covers the full load for the hospital and is run every week as part of the maintenance schedule.

**Backup generator on site**

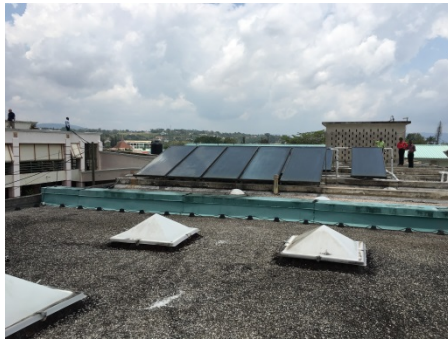
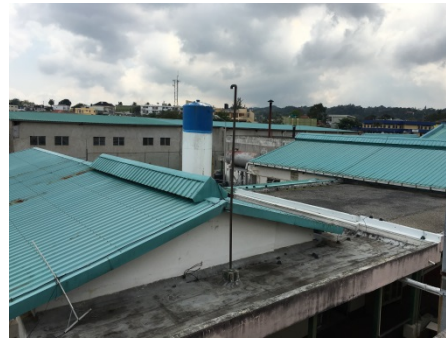
**Rooftop Examples: Mix of metal and asphalt**

Rooftops are mostly a combination of concrete construction with asphalt and metal roofing panels. Some of the flat roofs had membranes installed to limit leakage. The temperatures measured on each roof type varied greatly, with the asphalt reaching 128°F, and the metal roofs at 140°F. (The ambient temperature was recorded at 88°F). Maintenance staff report that many roofs require some ongoing maintenance as leaking membranes are a regular occurrence. If a roof replacement is imminent, this is may be an opportunity to improve insulation and install daylighting at a low incremental cost.
