# Investment Grade Audits of Schools and Hospitals in Jamaica

Jamaica Ministry of Science, Energy and Technology

Date: September 14, 2016

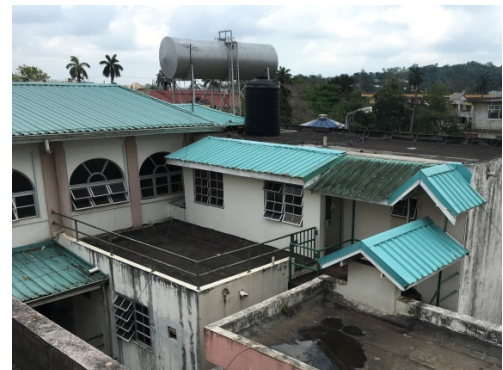
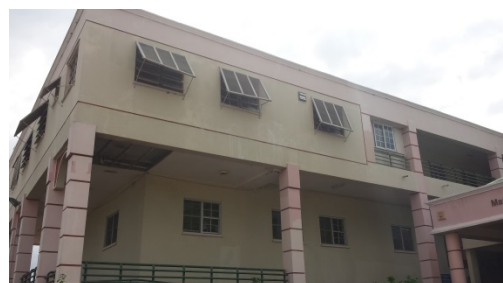
Air sealing the building envelope is one of the most critical features of an energy efficient building. The escape of freshly cooled air via open windows or doors results in a room that remains hot even while the air conditioner is running under full load, burning energy, and decreasing the equipment's useful life. Detected leaky areas need to be sealed in order to mitigate infiltration as well as potential leakage of the cool, conditioned air supply in places where there is an AC system installed.

**Typical Windows**

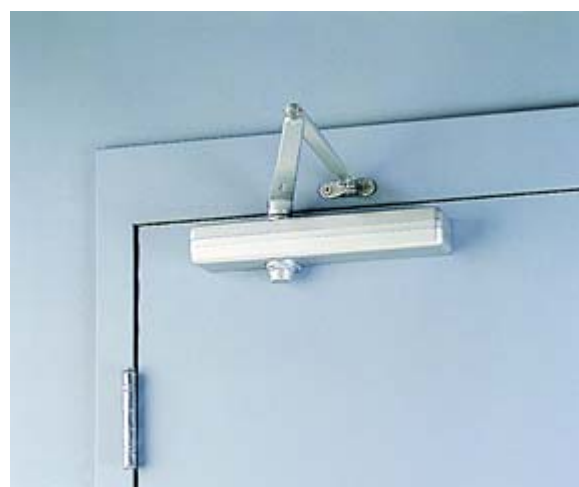
Doors were found to be open or improperly sealed, limiting the effectiveness of the cooling systems. The most cost effective strategy to automatically close the door is using a surface-mounted regular arm door closer attached behind the door frame where a spring mechanism is used to close the door. This ensures pressurization and limits infiltration, reducing the cooling power requirement.

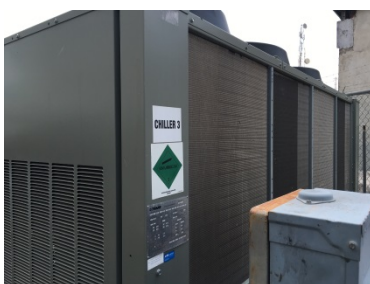
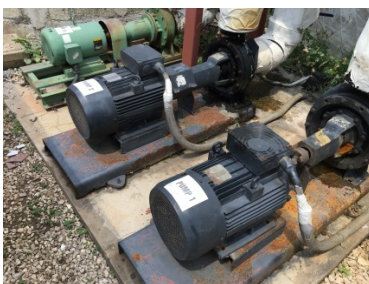
There are three Trane air-cooled scroll packaged chillers (80 ton) on site, although one was out of commission at the time of the site visit. The chillers were supplying chilled water at 44F and returning at 49F. There are three constant volume, 5 HP chilled water supply pumps (one per chiller). There are 13 air handling units (AHUs) throughout the facility that are scheduled to be replaced. The typical AHU has a 7.5HP CV fan.

The return temperature stays consistent at about 5 degrees above the supply temperature. This 5 degree delta T is low compared to most chilled water plant designs with 10 degree delta T, and there are actions that can be taken to address it on the system side to improve performance. Improving low delta-t syndrome can save considerable energy, by limiting the amount of time that more compressors than necessary on this chiller have to be running simultaneously to maintain load. Low delta-t syndrome can be caused by dirty or improperly sized coils, or by malfunctioning control valves.

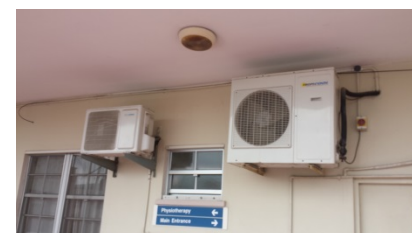
### Mini-Split AC Units

There are approximately 69 mini-split AC installed in wards, offices, and treatment rooms. There are a variety of manufacturers and unit capacities. Most of the units use basic remote-control systems with no temporal programming capabilities. Many of the condensing units have not been installed with manufacturer recommended spacing, limiting their effectiveness.

These systems require a significant amount of committed time for maintenance staff, and a substantial number of the units were out of service. It was repeatedly observed that staff were requesting repairs to their cooling systems throughout the walkthrough.

It is recommended that a high-efficiency inverter system should replace the older split systems as they are approaching their end of useful life. Maintenance cost of the higher efficiency units should be similar to a Direct Expansion (DX) unitary system where consistent preventive maintenance to change filters and clean coil are recommended.

It is recommended that the contractor measure current condensing unit spacing and increase spacing to one inch greater than manufacturers minimum clearance requirements in order to ensure condensing units are meeting design requirements. In the event that the air conditioning system is being replaced, ensure new condensing units are installed per the manufacturer's specifications.

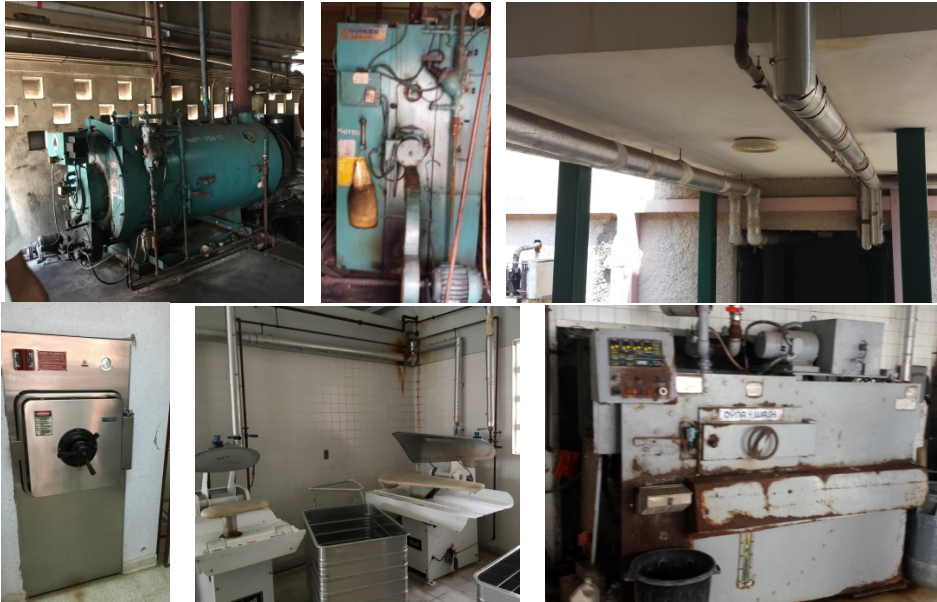
**Steam System**  
2 x Boilers  
3 x Autoclaves  
2 x Washer-Extractors  
Steam Irons

A central steam plant is in place with two boilers, with its distribution network supporting the laundry and sterilization facilities. Surgical and delivery facilities require large amounts of sterile equipment, and use steam autoclaves fed by the facilities' boiler system. The live steam injected into the pressure chamber is held for a period of time to ensure sterilization, with fifteen to twenty loads sterilized per day.

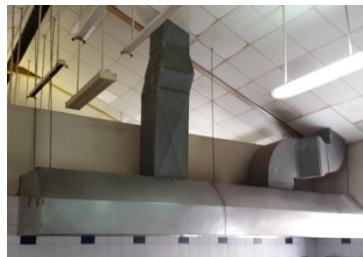
**Four Kitchen Exhaust Fans (CV)**

There are four hood exhaust fans (ranging from 2.5-5 HP CV) in the kitchen operated continuously from 7am – 8pm daily. No make-up air is provided to the kitchen spaces.

Installing a demand control controlled ventilation system to operate the exhaust fan is recommended. This system would include the VFD to control the exhaust fan motor, a digital controller, temperature probe, and smoke probe in the cooking hood to control the exhaust fan. Existing exhaust fan motor may need to be replaced with inverter duty motor.

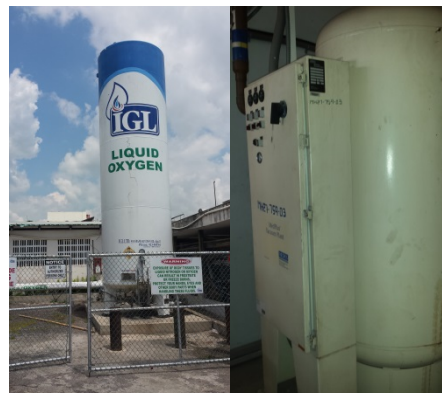
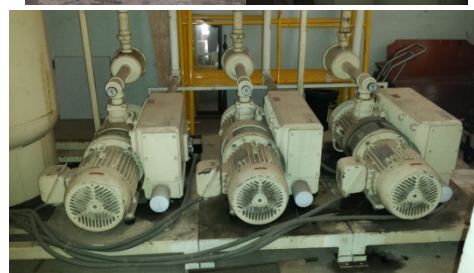
**Compressed Gasses and Vacuum Systems**

The hospital employs multiple high-energy process systems for medical uses. Medical equipment requires reliable compressor and vacuum systems for highly sensitive applications. The compressor system was noted to activate approximately every minute during the site visit, indicating a potential leak in the system.

Compressed Air leaks cause a fluctuating air pressure which stresses both the system and tools, increased run frequency and time of compressor package, increased maintenance, and decreased service life. It is recommended to perform a Leak Detection investigation and repair leaks.

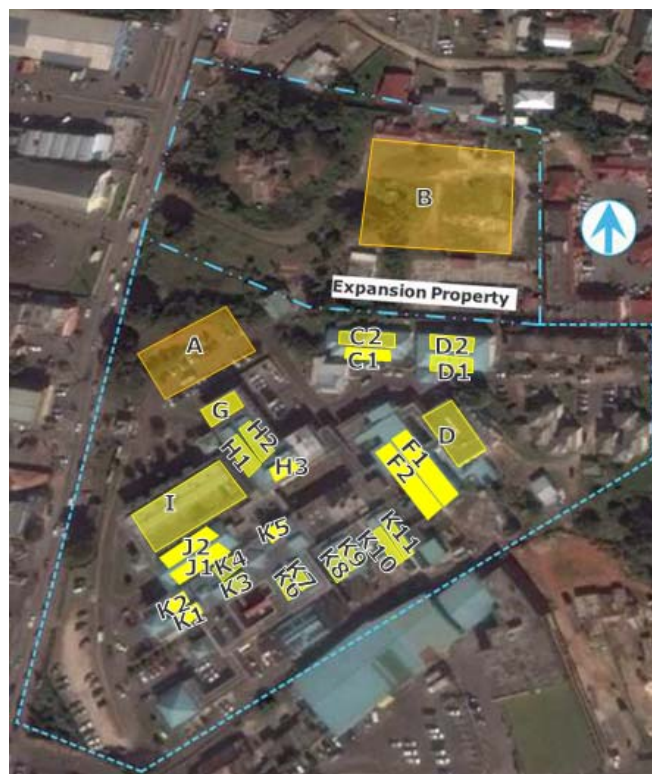
The following map shows the roof areas considered in the solar analysis and the table shows the results of the solar feasibility study conducted for the site.

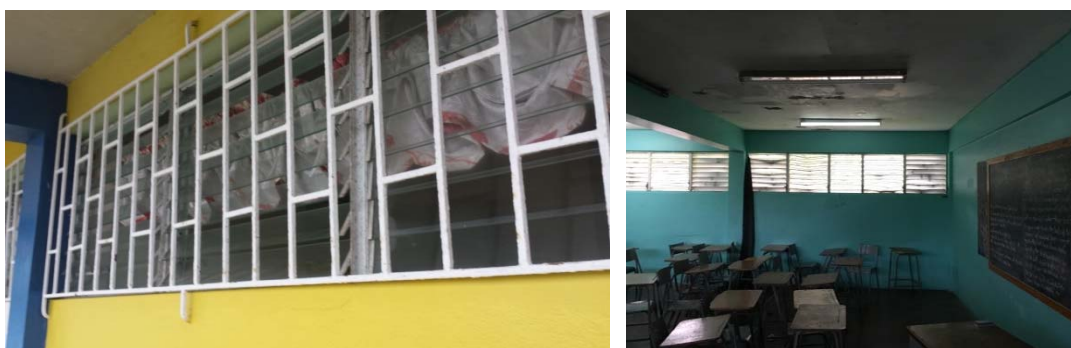
**Example Window Units**

The campus has exterior circulation, which allows for classrooms to incorporate operable windows, as displayed below. Curtains are used to limit direct sunlight.

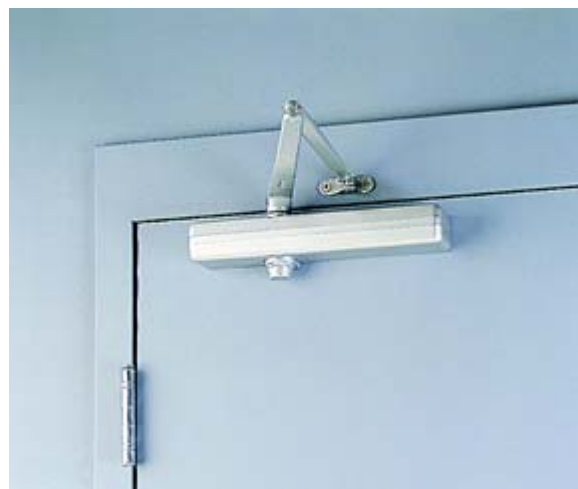
Improperly sealed doors often are a significant source for leakage of conditioned air, causing excess energy use. A 0.125-inch gap around a typical entryway door is the equivalent of drilling a 5.5-inch-diameter hole through an outside wall. A weather seal system includes weather stripping, which covers the sides and top of the door, and a sweep, which fills the space between the threshold and the door bottom. Foam, felt, plastic, or tubular silicone weather stripping products are designed for this purpose.

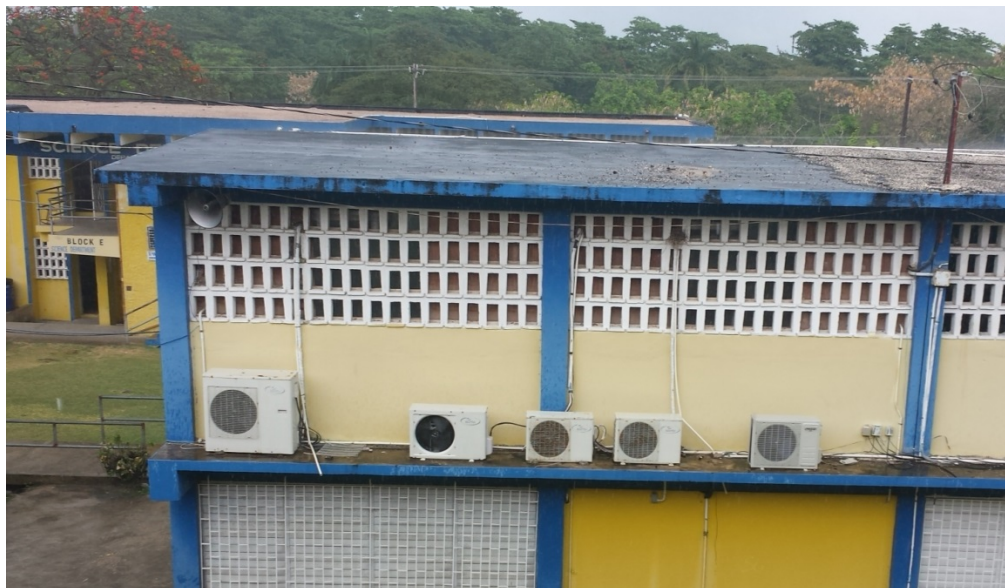
Condensing Unit Layout

The school was designed to have open air ventilation, however modern educational computers and equipment requires air conditioning to avoid overheating. Mini-split AC units have been installed (approximately 24) in classrooms, offices, and in all computer rooms. There are a variety of manufacturers and unit capacities ranging from 2-5 kW rated input. All of the systems used basic remote-control systems with no programming capabilities.

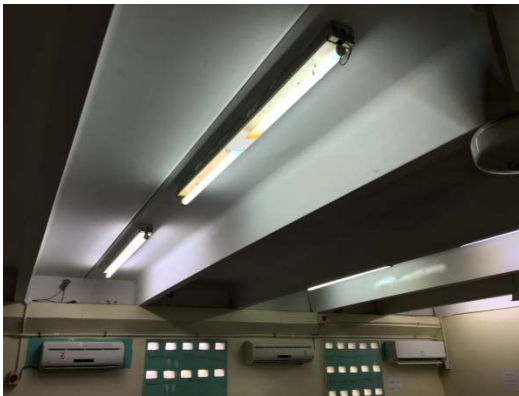
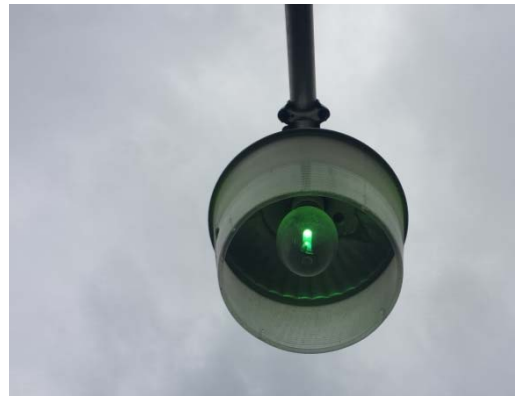
Typical interior and exterior lighting

The typical interior lighting configuration in Marcus Garvey is a manual-switch controlled set of T12 linear fluorescent fixtures. High occupancy areas and computer rooms have begun to switch to linear LED lamps, with about 50% completed. In classrooms, it was observed that often the lamps were often left off due to sufficient natural lighting.

Exterior lighting is primarily provided by metal-halide bulbs; however, there is a limited number of high-wattage CFLs.

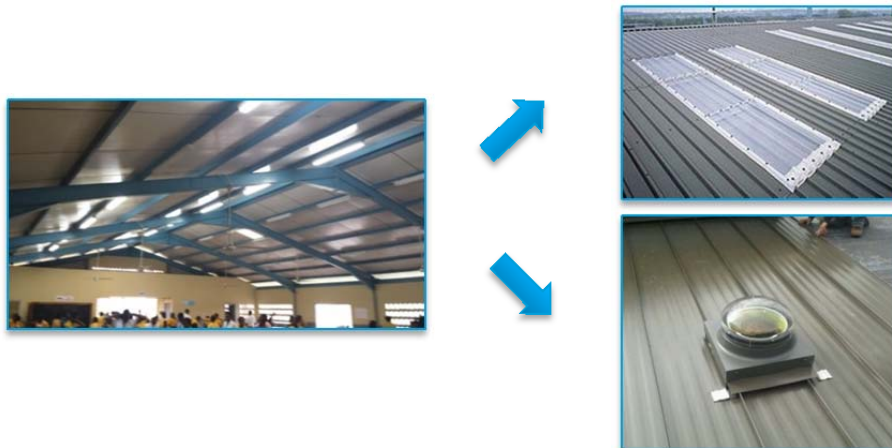
Solar tube daylighting systems use a rooftop dome capture system and a diffuser on the internal ceiling to distribute a dispersed light. These units require limited structural changes to the roof, and the smaller shape of the rooftop system limits the debris buildup that is common on translucent paneling.

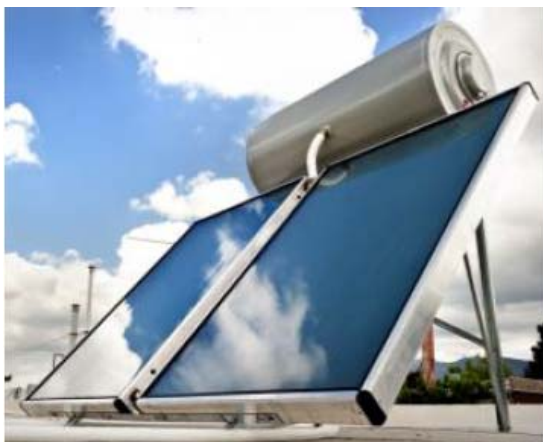
Glazed Flat Plate Collector with Storage

. A typical solar water heating system consists of solar collectors, piping, and insulated water storage tanks. Heat is generated from incoming solar radiation energy transferred to water or glycol circulating through the panel and back to a storage tank. The heated fluid is either directly used, or a heat exchanger is used with potable water. The fluid can either be actively pumped, or use gravity and a density/pressure differential in a passive flow.

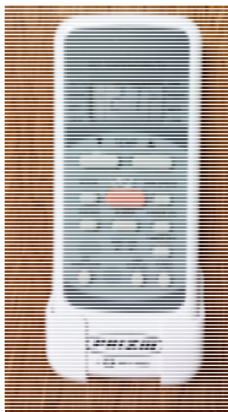
**Typical Split-System  
Remote Control**

Referenced in previous sections, programmable thermostats and lighting controls allow the facility managers to more accurately manage energy use throughout the facility, and to be more informed on any activity deviations. Energy savings will vary based on behavior and cannot be quantified at this time.

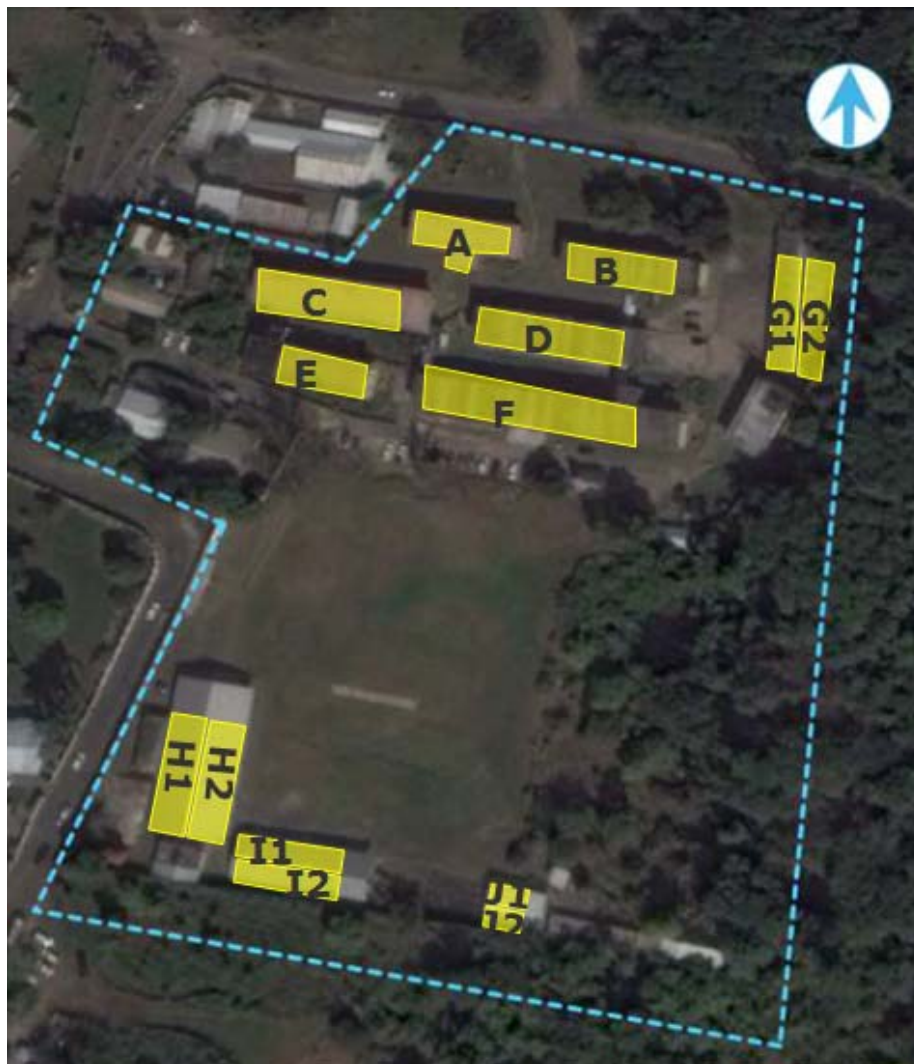
**Map of Potential Solar Array Opportunities on Site**

The following map shows the roof areas considered in the solar analysis and the table shows the results of the solar feasibility study conducted for the site.

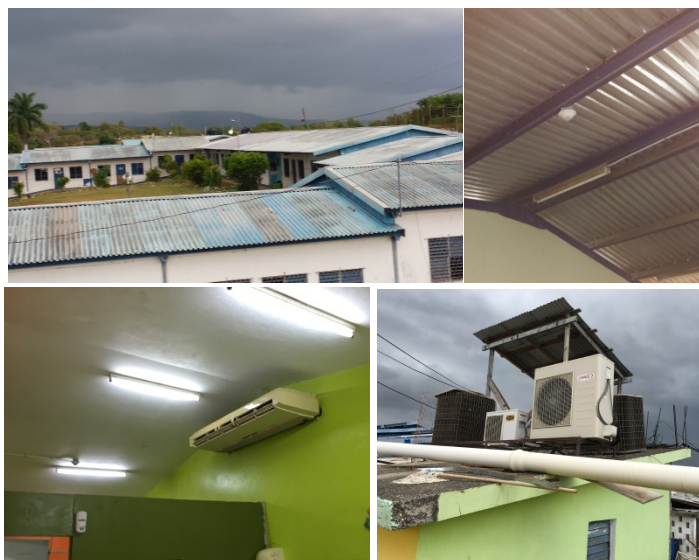
**Example Roofs**

Exterior and interior walls are typically uninsulated concrete, and building roofs were either bare corrugated metal or included a ceiling when the room was conditioned. A limited number of buildings included a poured-in-place concrete ceiling.

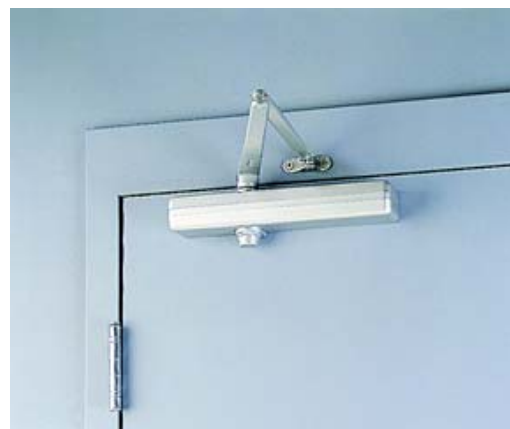
Improperly sealed doors often are a significant source for leakage of conditioned air, causing excess energy use. A 0.125-inch gap around a typical entryway door is the equivalent of drilling a 5.5-inch-diameter hole through an outside wall. A weather seal system includes weather stripping, which covers the sides and top of the door, and a sweep, which fills the space between the threshold and the door bottom. Foam, felt, plastic, or tubular silicone weather stripping products are designed for this purpose.

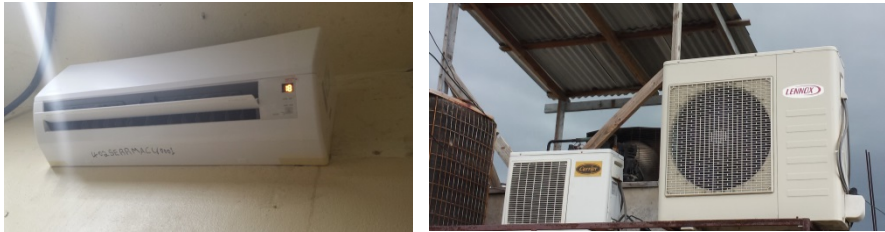
Rooms that require conditioning, such as classrooms, offices, and in all computer rooms, use mini-split AC units. There are a variety of manufacturers and unit capacities ranging from 2 kW–4 kW rated input, and approximately 54 units in total. All of the systems used basic remote-control systems with no temporal programming capabilities.

**Split System Typical Layout**

### 2. Replace split systems with high efficiency, inverter-driven units

It is recommended that a high-efficiency inverter system should replace the existing split systems as they are approaching their end of useful life. Maintenance cost of the VRF system should be similar to a direct-expansion unitary system where consistent preventive maintenance to change filters and clean coil are recommended.

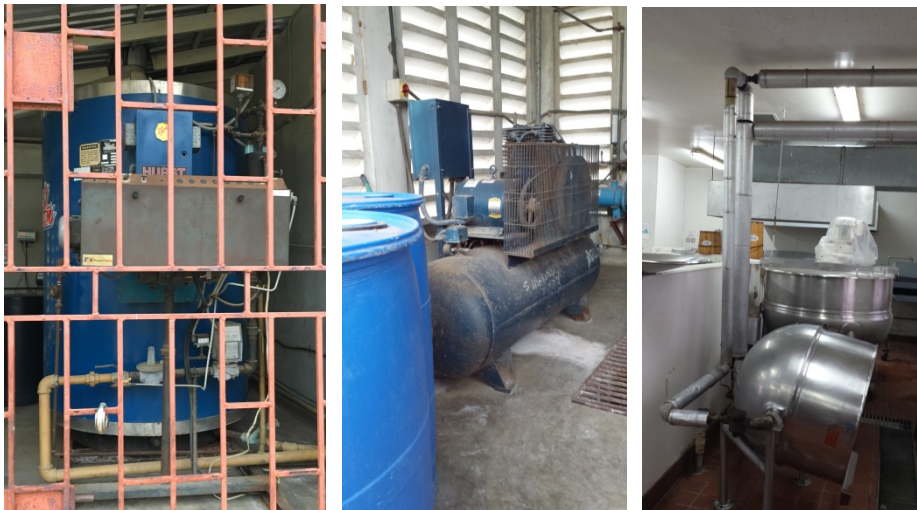
A large steam boiler system (23,350 W) is set up for the agro-processing operations.

**Steam System**

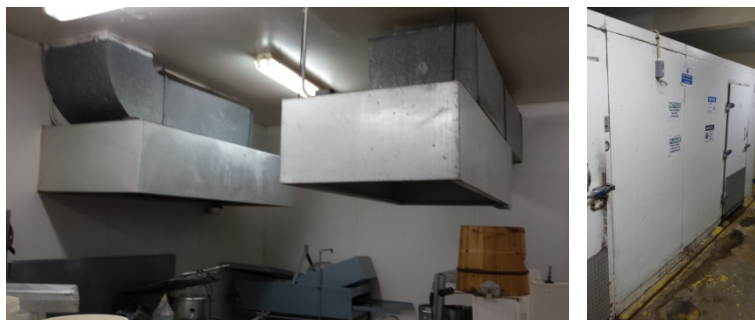
A set of walk-in storage refrigerator and freezer are used for processing materials and products. There are 2 additional walk-in refrigerators and 1 freezer in the agricultural center. There are medium-sized exhaust hoods in the kitchen/packaging classroom that are used.

**Kitchen Environmental Equipment**

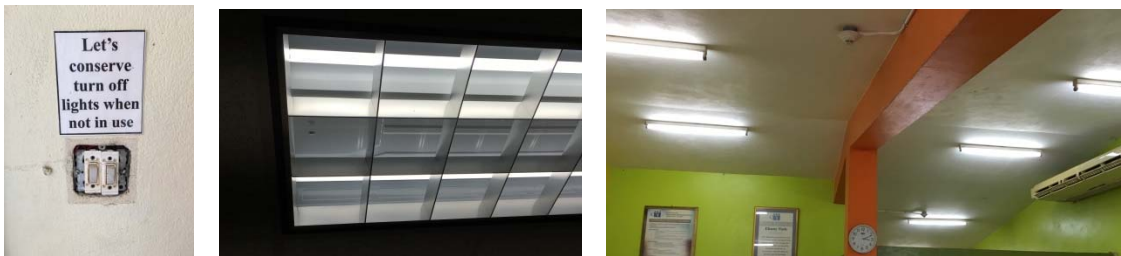
The typical interior lighting configuration in Ebony Park Academy is a manual-switch controlled set of T12 and T8 linear fluorescent fixtures. In classrooms, it was observed that often the lamps were often left off due to sufficient natural lighting. A lighting retrofit has been completed in the main administration building to switch to linear LED lamps.

Exterior lighting is primarily provided by fluorescent bulbs down exterior walkways, however there are a limited number of high-wattage CFLs.

Typical interior and exterior lighting

Alternatively, simply installing LED tubes with a ballast bypass into the existing fixture can be more cost-effective with a simple wiring change. T12 fixtures already have a non-shunted rapid start lamp holder, and T8 fixtures need a replacement lamp holder for use with the LED tube.

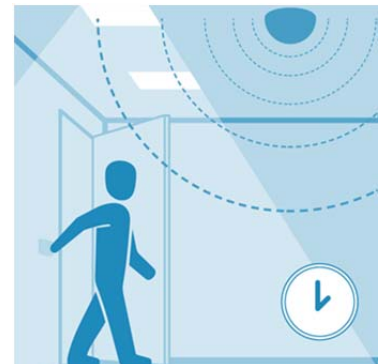
Due to the prevalence of natural light, if LEDs are installed, daylighting photocells can be tied into the lighting controls. These controls measure the ambient light levels to appropriately match the artificial lighting with the natural light present in the space. This "daylight harvesting" technique provides energy savings, allows for the automatic control of lights, and has the additional benefit of providing appropriate task lighting for the students.

Utilizing an integrated room control (IRC) system combines these technologies and meets ASHRAE 90.1 requirements of lighting by combining receptacle control, occupancy sensing, space control, lighting control, and automatic shutoff.

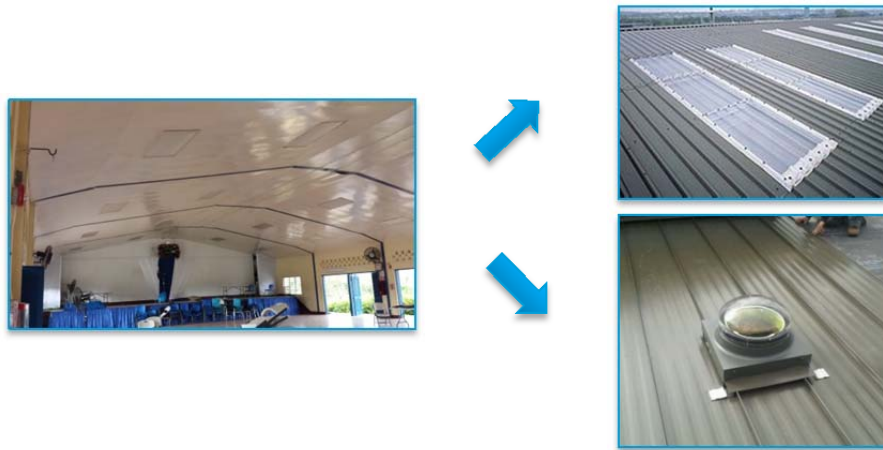
Translucent paneling has been used elsewhere on the campus, and can provide a soft natural light to substitute for artificial lighting. Panels can be made of various colors depending on the lighting levels needed for the space.

#### Example of Skylights and Solatubes

Solar tube daylighting systems use a rooftop dome capture system and a diffuser on the internal ceiling to distribute a dispersed light. These units require limited structural changes to the roof, and the smaller shape of the rooftop system limits the debris buildup that is common on translucent paneling.

While most of the facilities have concrete roofs and are often used for night classes, the large cafeteria has a large corrugated metal roof, and is used primarily during daylight hours. This is a prime location for installation of a natural daylighting system. The two preferred options available are the installation of translucent roof paneling or solar tube daylighting.

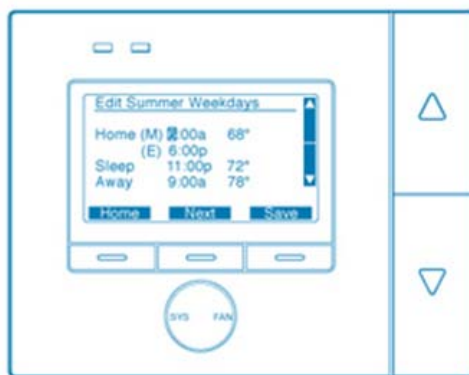
**Typical Programmable Panel**

It is recommend that programmable setback thermostats or equipment timers be installed where possible to better manage the classrooms according to scheduling, and restrict access to facility personnel to avoid overuse. None of the currently installed units appeared to have anything by temperature controls and restricted run timers. Behavioral changes are effective at energy savings, but automatic controls present a more reliable option.

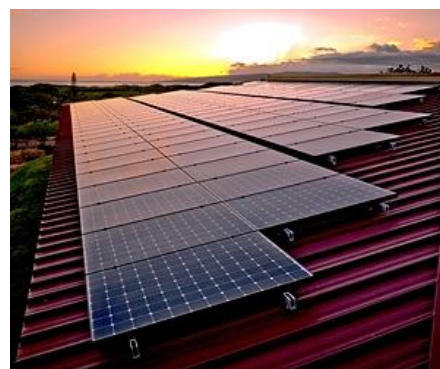
A solar analysis was performed to illustrate the potential solar opportunity at the site. The following assumptions were made regarding roof areas:

- 80% of flat roof area was assumed to be solar ready (20% unavailable for mechanical equipment, structural, and miscellaneous equipment on roof)
- 75% of pitched roof area was assumed to be solar ready (25% unavailable for mechanical equipment, structural, and miscellaneous equipment on roof)

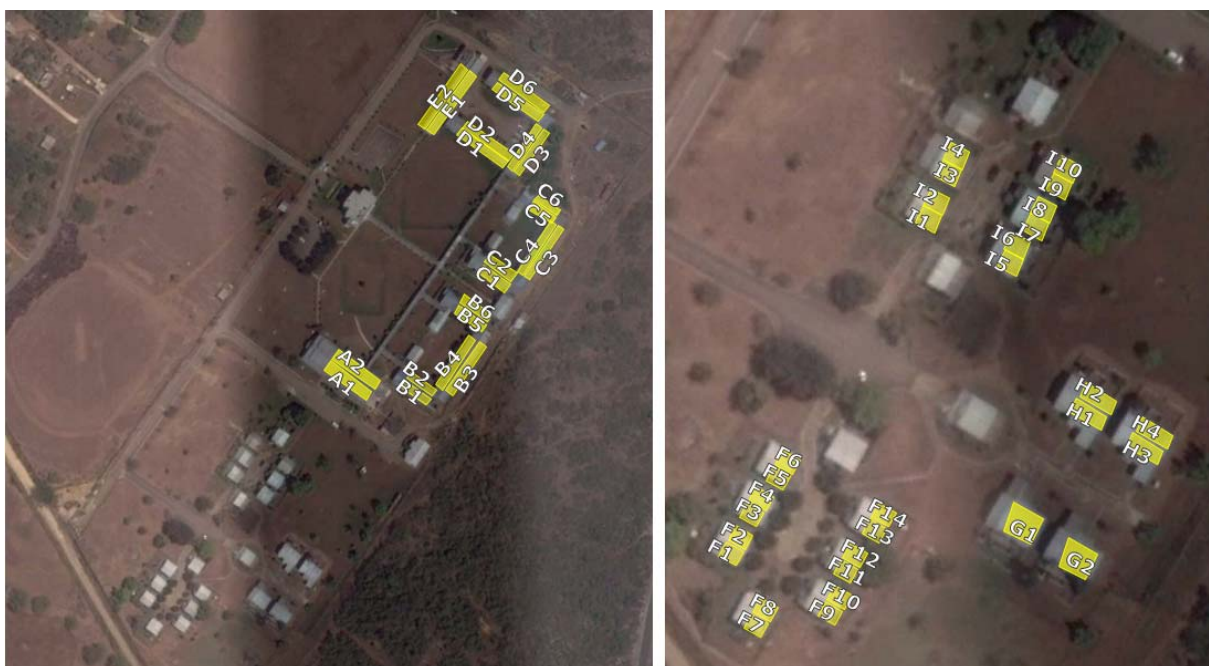
The following map shows the roof areas considered in the solar analysis and the table shows the results of the solar feasibility study conducted for the site.

Table 75. Renewable Solar PV Potential

Area	Azimuth	Collector Area (square meters)	Collector Area (square feet)	KWdc	Capital Cost (USD)	Annual Energy Generation (kWh)	Annual Cost Savings
A1	225	285	3,068	42.8	\$128,400	69,921	\$17,480
A2	45	285	3,068	42.8	\$128,400	60,692	\$15,173
B1	225	112	1,206	16.9	\$50,700	27,609	\$6,902
B2	45	112	1,206	16.9	\$50,700	23,965	\$5,991
B3	135	226	2,433	33.9	\$101,700	55,757	\$13,939
B4	315	226	2,433	33.9	\$101,700	47,668	\$11,917
C1	225	143	1,539	21.4	\$64,200	34,961	\$8,740
C2	45	143	1,539	21.4	\$64,200	30,346	\$7,587
C3	135	167	1,798	25.1	\$75,300	41,284	\$10,321
C4	315	167	1,798	25.1	\$75,300	35,294	\$8,824
C5	225	139	1,496	20.9	\$62,700	34,144	\$8,536
C6	45	139	1,496	20.9	\$62,700	29,637	\$7,409
D1	225	230	2,476	34.5	\$103,500	56,362	\$14,091
D2	45	230	2,476	34.5	\$103,500	48,922	\$12,231
D3	135	163	1,755	24.4	\$73,200	40,132	\$10,033
D4	315	163	1,755	24.4	\$73,200	34,310	\$8,578
D5	225	230	2,476	34.5	\$103,500	56,362	\$14,091
