Environmental and Social Analysis

Urban Upgrading and Revitalization Program

IVAN LAUGHLIN
HUMAN SETTLEMENT CONSULTANT AND PRACTITIONER
LAND SURVEYOR

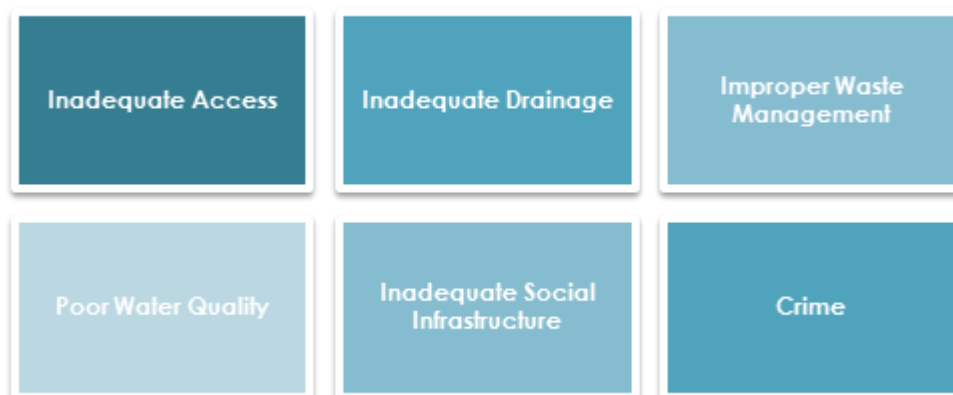
Figure 19. Main Environmental and Social Issues

The main environmental and social issues identified, are listed in the **Figure 19** below:

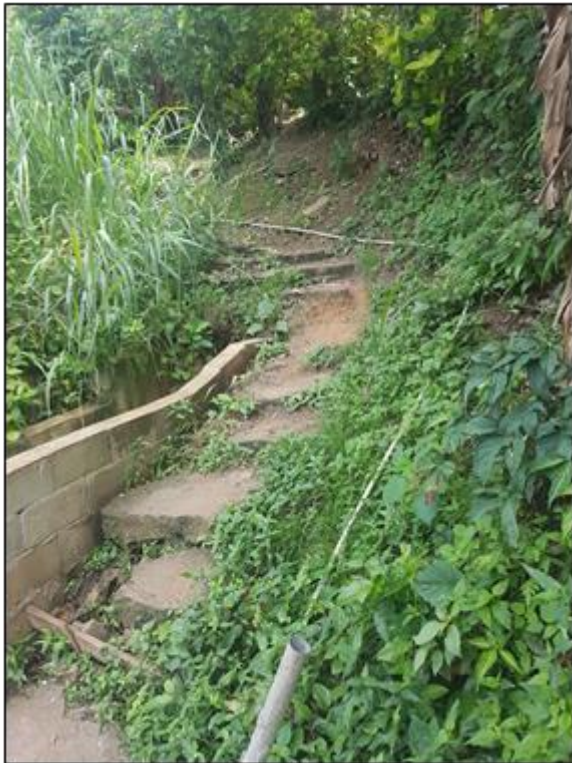
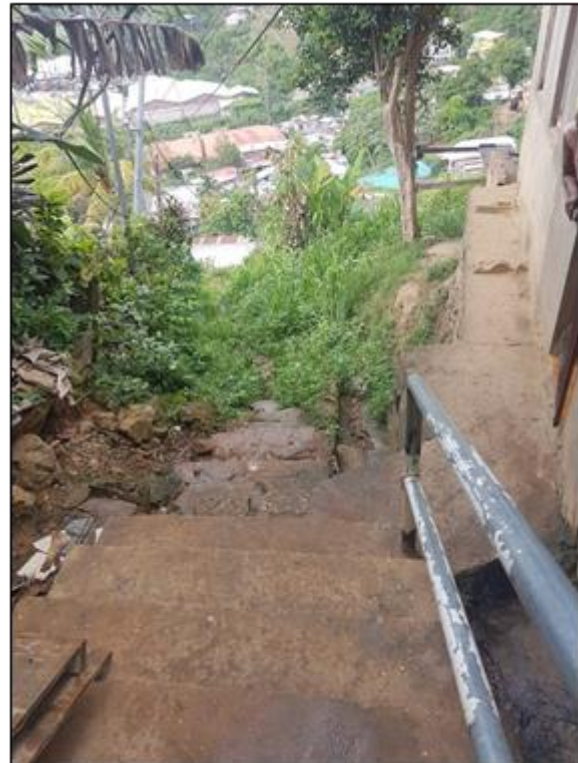
Due to the steep topography, vehicular access is limited. As a result, the residents currently access their homes using narrow pathways and self-constructed concrete steps. As can be seen in **Figure 20**, the concrete steps are degraded and overgrown with vegetation. **Figure 21** shows concrete steps with a handrail only to the right.

Figure 20. Concrete Steps, Factory Road

Figure 21. Concrete Steps, Factory Road

- **Injury** – Due to the poor condition of some of the steps and pathways, getting to and from houses may be difficult. The use of broken steps or steps without handrails may result in injury (**Figures 20 and 21**).
- **Mobility of Residents** – As previously stated, vehicular access is limited as a result of the steep topography. Thus, this may restrict those residents who may be less mobile, i.e. the injured, disabled or elderly.
- **Access of Services** – Water trucks and garbage trucks are unable to enter the Settlement. Moreover, in the event of an emergency, fire trucks and police vehicles would not be able to enter the upper regions of the community.

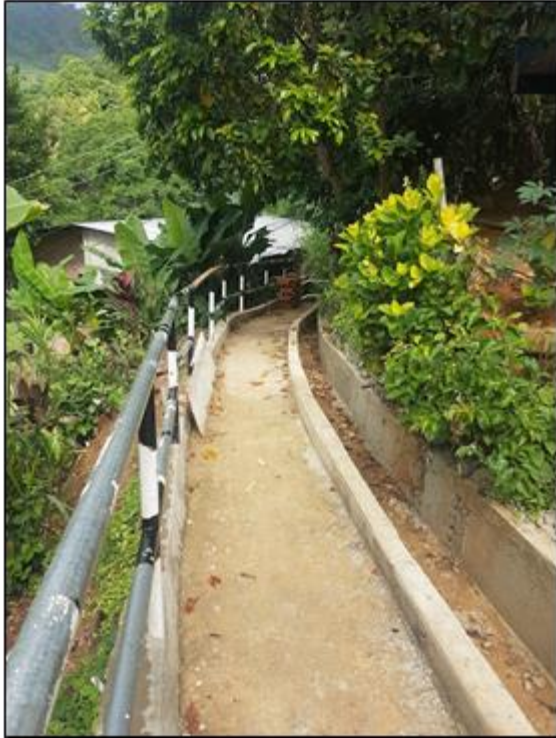
Some of the pathways observed were also constructed in concrete and were accompanied by handrails (see **Figures 22** and **23**). The pathway in **Figure 22** was recently improved, as part of an infrastructural upgrading project. The pathway in **Figure 23** was designed to facilitate traction when walking.

Figure 22. Recently Upgraded Pathway with Handrail, Factory Road

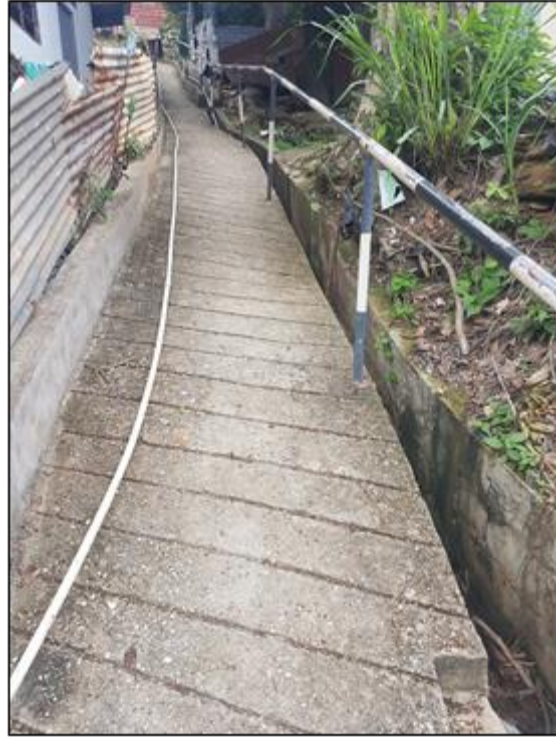
Figure 23. Pathway with Traction and Handrail, Factory Road

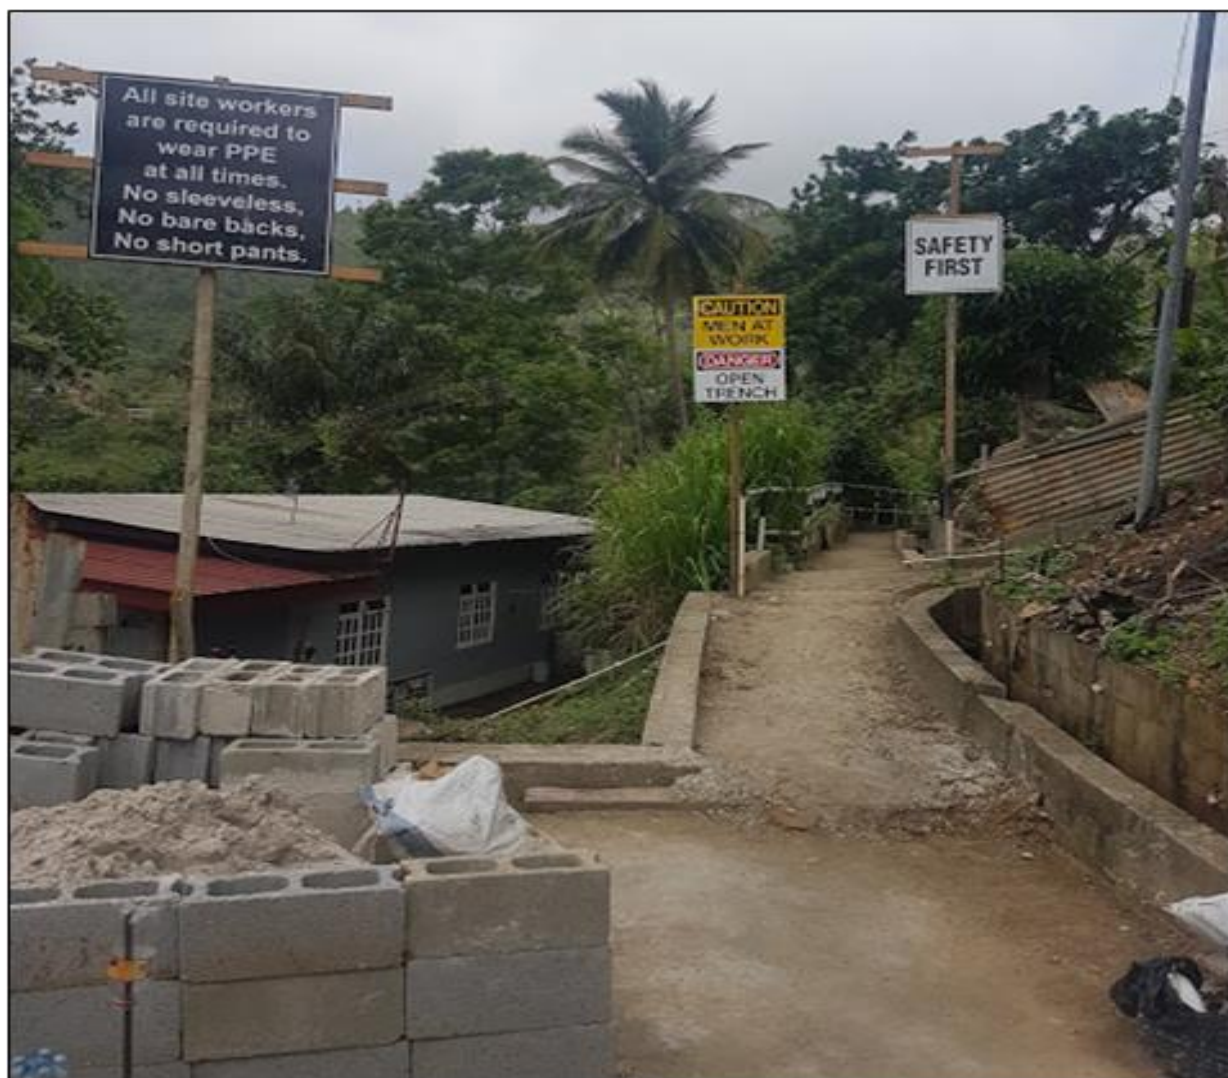
Figure 24. Construction Signs, Factory Road, Diego Martin

Signage indicative of the ongoing construction work was apparent throughout the Settlement (see **Figure 24**). I met with Mr. Romelle Pierre - representative of the LSA, and Mr. Darill de Silva - Community Leader of Factory Road, on site. They explained that the infrastructural work was being facilitated by the LSA in conjunction with the community. The project includes the establishment and improvement of access ways and box drains. All labour is generated by the community and the building materials are provided by the LSA. This collaboration indicates the willingness of the residents to improve their living conditions. Moreover, the construction signage prepared by the Community Leader, indicates the responsible way the project is being done.

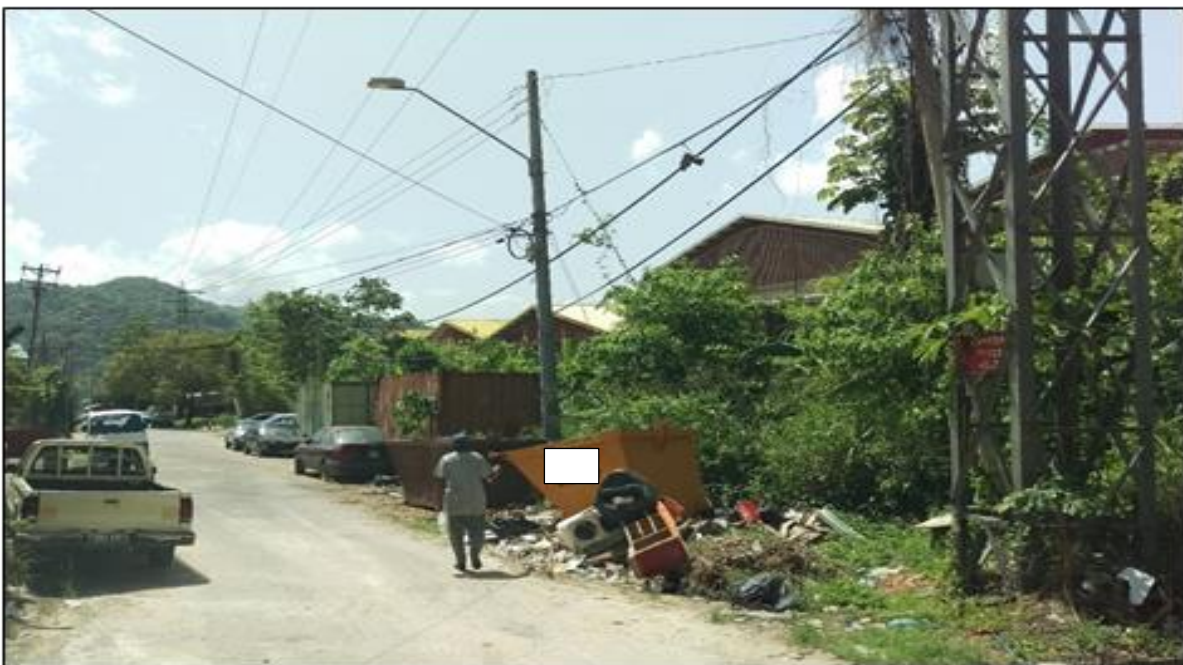
Figure 25. Garbage Skip, Factory Road

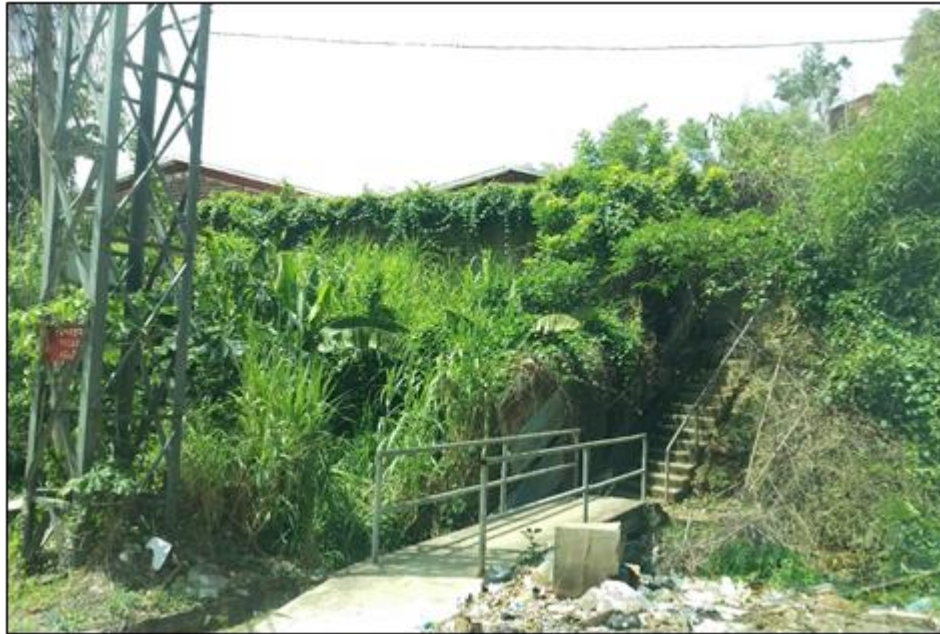
As can be seen in **Figure 26**, there is garbage at the bottom of the concrete steps. These steps are used as a pedestrian entrance to the Settlement. Improper waste management can lead to the proliferation of pests and diseases in the Settlement which can negatively impact the health of residents. Pests include rats which spread *Leptospirosis* and mosquitoes which spread the *Dengue Fever*. Moreover, the presence of haphazardly placed garbage significantly decreases the aesthetics of the area.

Figure 26. Improper Garbage Disposal, Factory Road

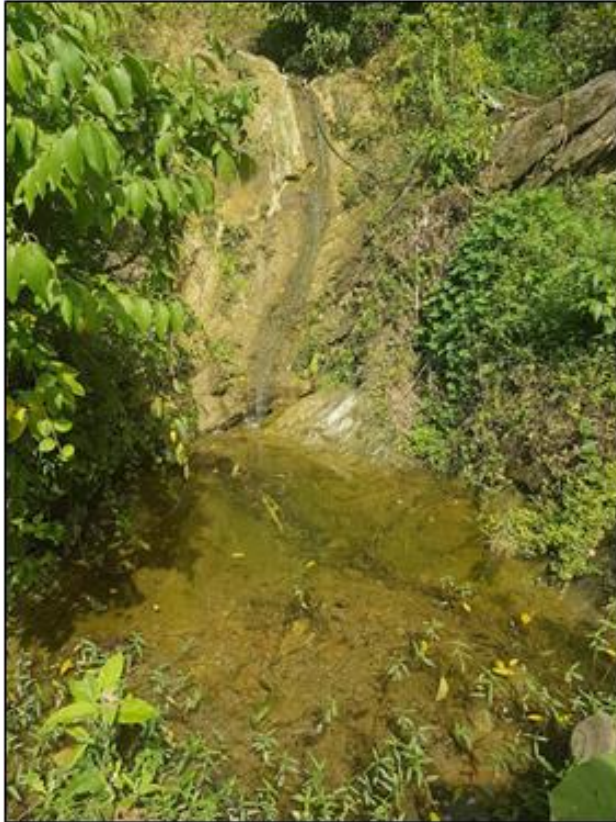
The Settlement currently receives its water supply from a small spring on the hillside which can only be accessed via foot. A stream emanates from this spring and flows through the community and down to the Industrial Estate (see **Figure 27**). Investigations revealed that residents have established water connections from the spring to their homes using PVC pipes.

Nonetheless, residents indicated that the spring water is no longer safe for human consumption. Improper waste management practices coupled with the expansion of agricultural activities on the hillside may have compromised the water quality in the Settlement. Pesticides and herbicides are used by some residents for their crops. Thus, the water is largely utilized for the washing of clothes, household cleaning and crop irrigation. Many residents have started purchasing bottled water for drinking.

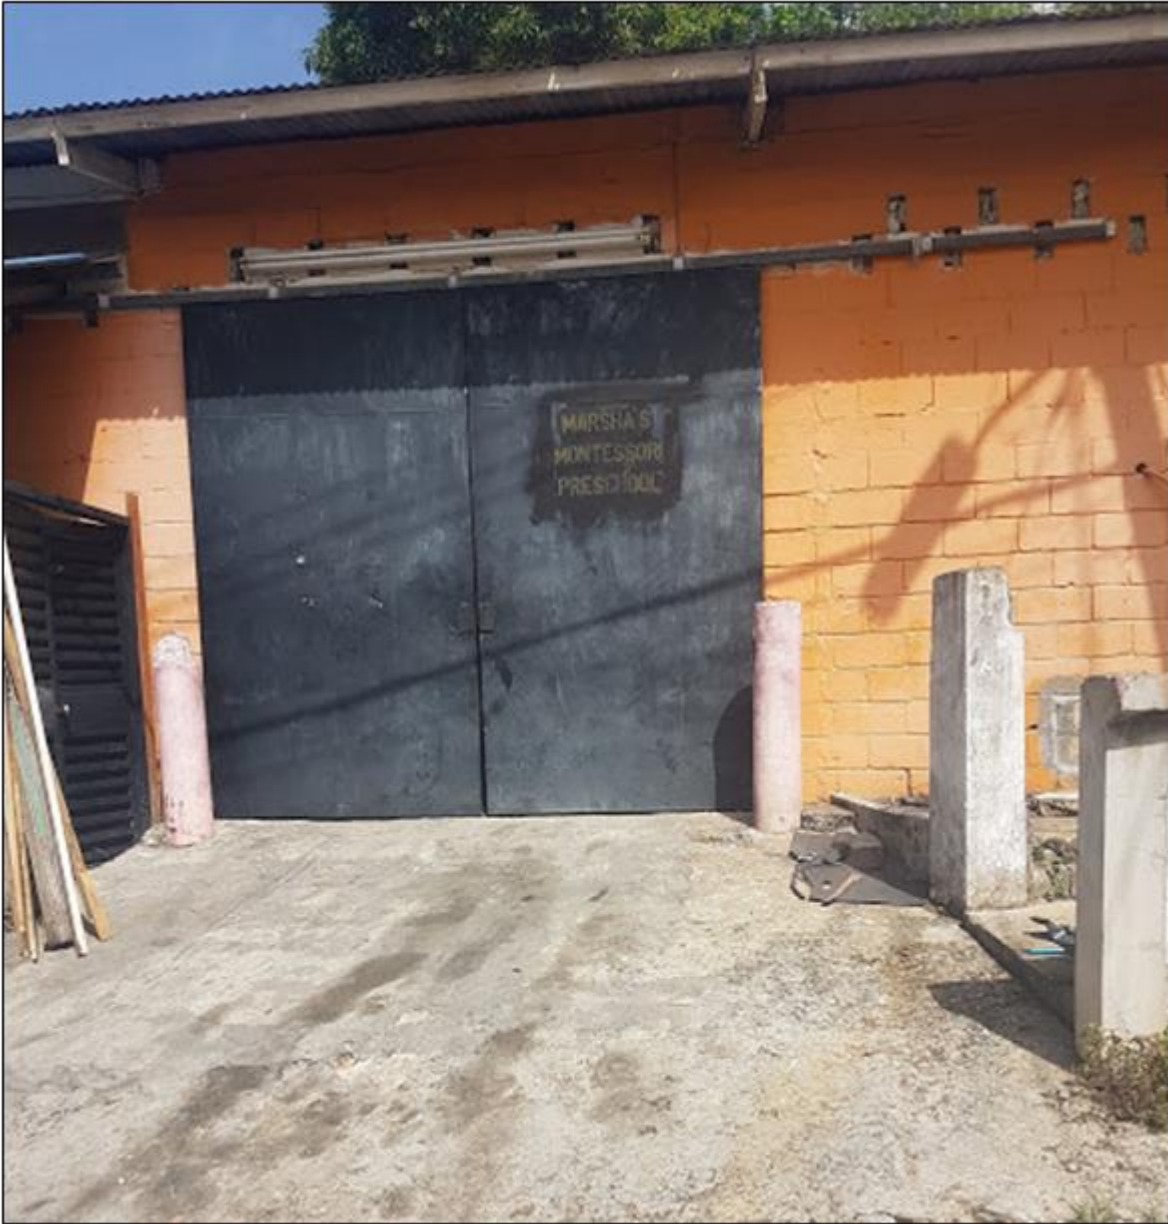
Figure 28. Marsha's Montessori Pre-school, Factory Road

Marsha's Montessori Pre-school was the only educational institution observed in the Settlement (see **Figure 28**). The School was closed at the time of the site visits and so no contact was made with the teacher (s). Mr. de Silva informed us that the School was established to accommodate working parents with young children. Facilities of this Pre-school should be inspected by the relevant authorities to ensure it is a suitable environment for young children.

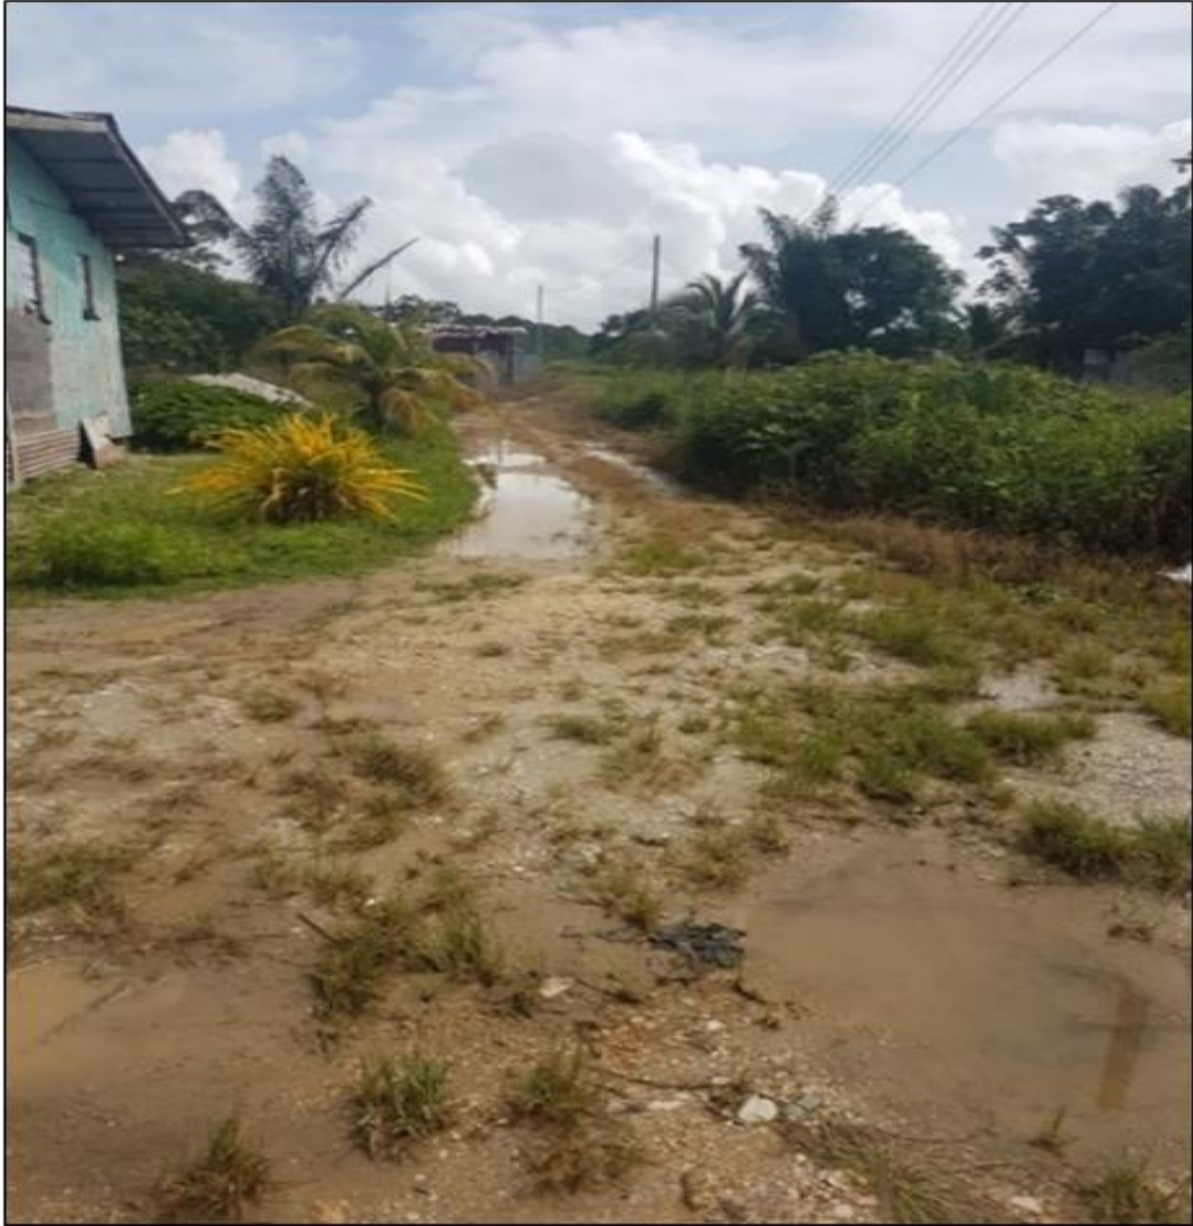
Figure 43. Hammet Trace, Sahadeen Trace

The existing road network in the Sahadeen Settlement is a combination of earthen and paved roads. Residents expressed that many of the roads were cleared and financed by the community.

In the dry season, the earthen roads may contribute to a decline in air quality as a result of the dust generated from vehicular movement. This may impact on the health of those residents who may suffer with respiratory problems. Moreover, during periods of intense rainfall, earthen roads may become muddy. This can restrict the mobility of vehicles or affect travellers on foot. This is especially crucial in emergency situations.

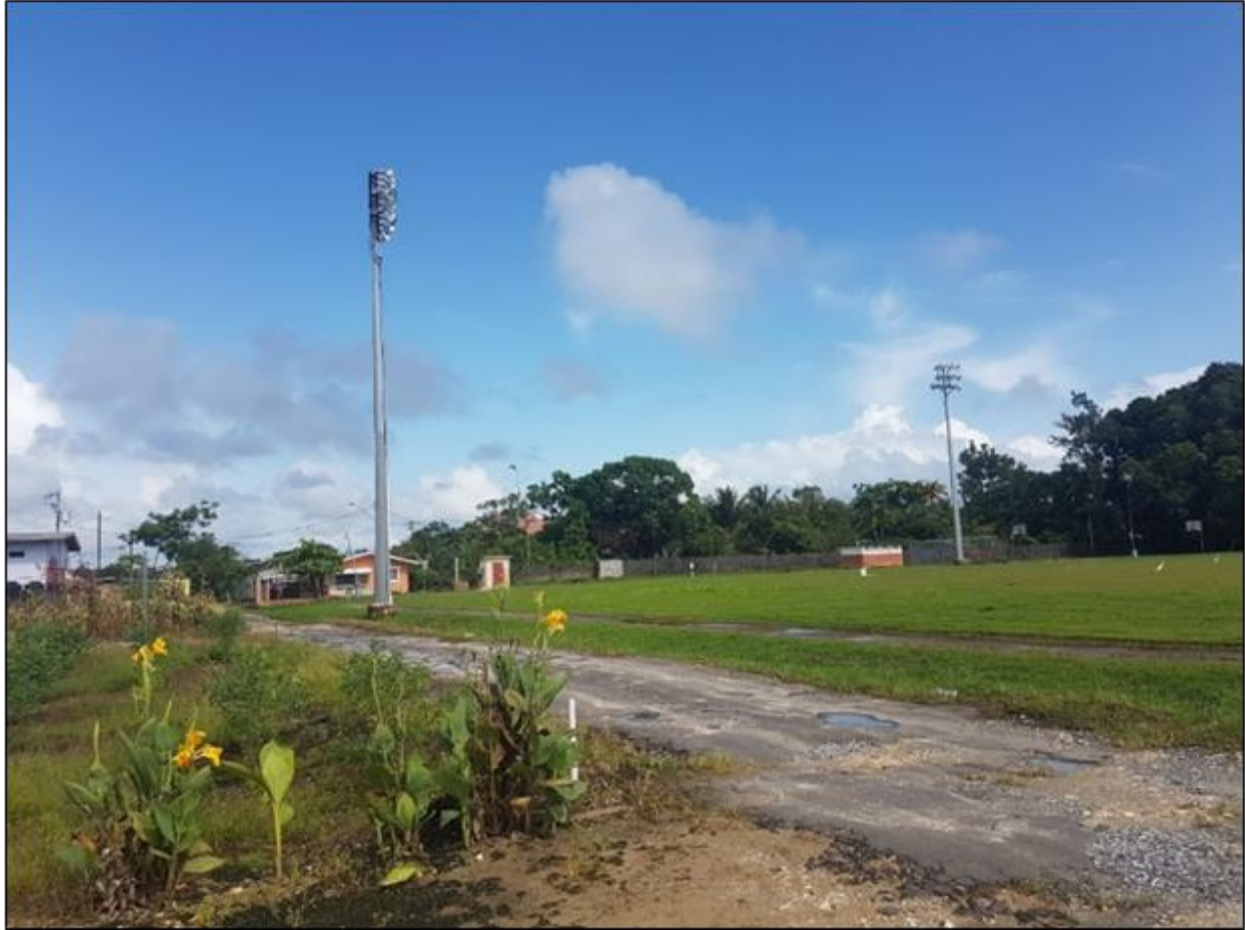
Figure 44. Partly Paved Road, Recreation Ground, Sahadeen Trace

Development Issues	Recommendations
Inadequate Access	Roads should be paved by the Regional Corporation. This should be guided through a collaboration between the LSA and the Regional Corporation.
Inadequate Drainage	Inadequate and poorly maintained drains have led to flooding during periods of heavy rainfall. Drains should be established and regularly cleaned by the Regional Corporation.
Improper Waste Management	Methods of proper garbage collection should be guided by the EMA or Regional Corporation.
Inadequate Social Infrastructure	A portion of land in the Settlement should be designated for agricultural purposes. This will keep the Cemetery free from unauthorized land usages.

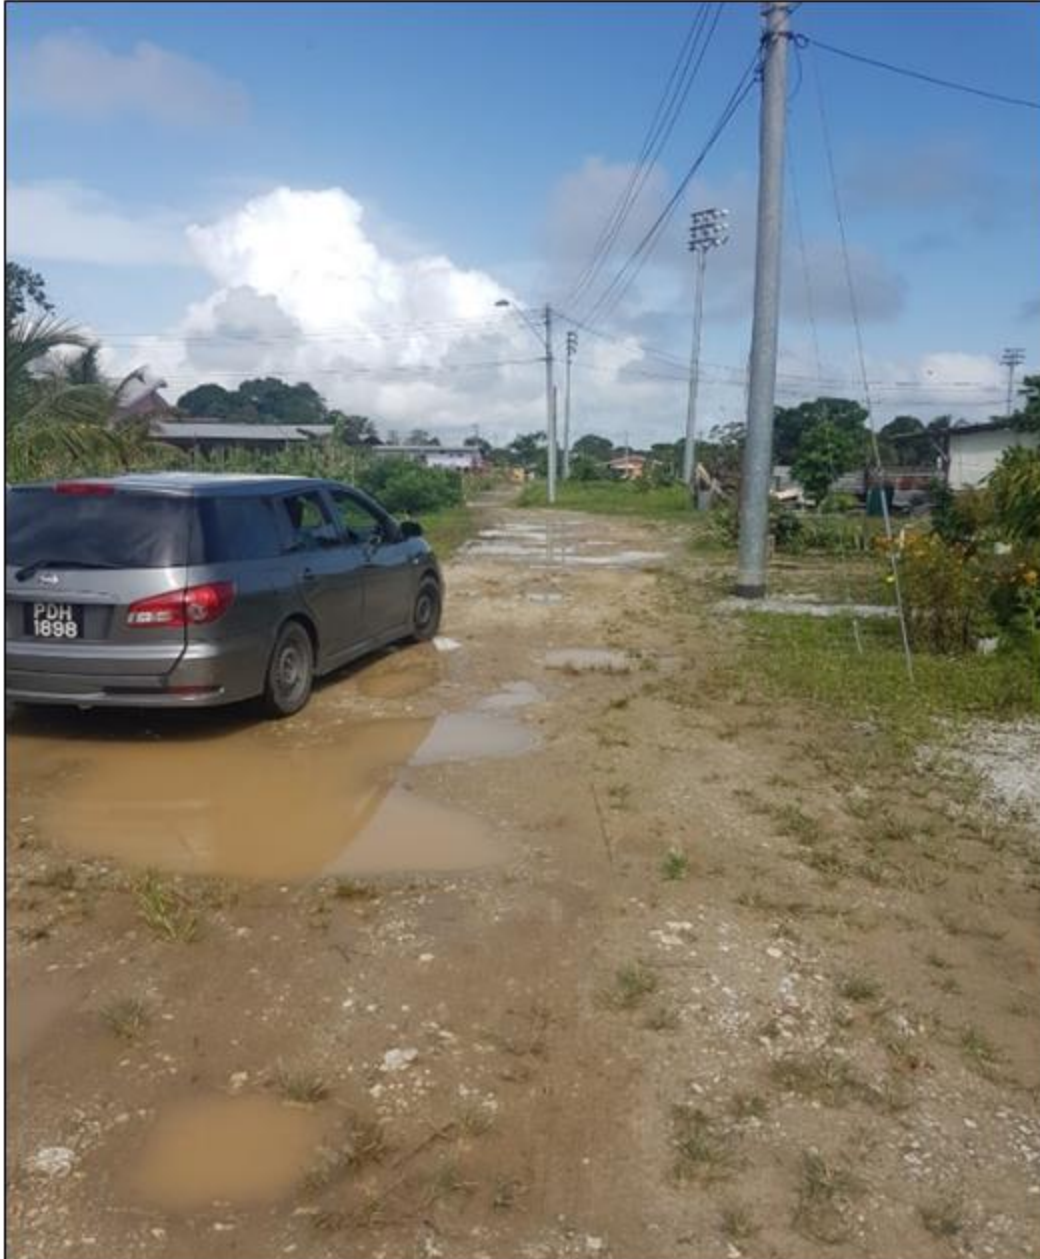
Residents stated that flooding occurred in the Settlement in 2018 as a result of intense rainfall and inadequate drainage. Moreover, inadequate drainage can impact crops and, in some cases, jeopardize the livelihood of those who use the crops to sustain their households. Crops that are located in poorly drained areas tend to form shallow rooting systems and are unable to obtain sufficient moisture for their growth. It also contributes to crop diseases which lessen the impact of crop fertiliser. The **Figure 45** below shows the puddles of water on an earthen road with no drainage.

Figure 45. Puddles on Earthen Road, Sahadeen Trace

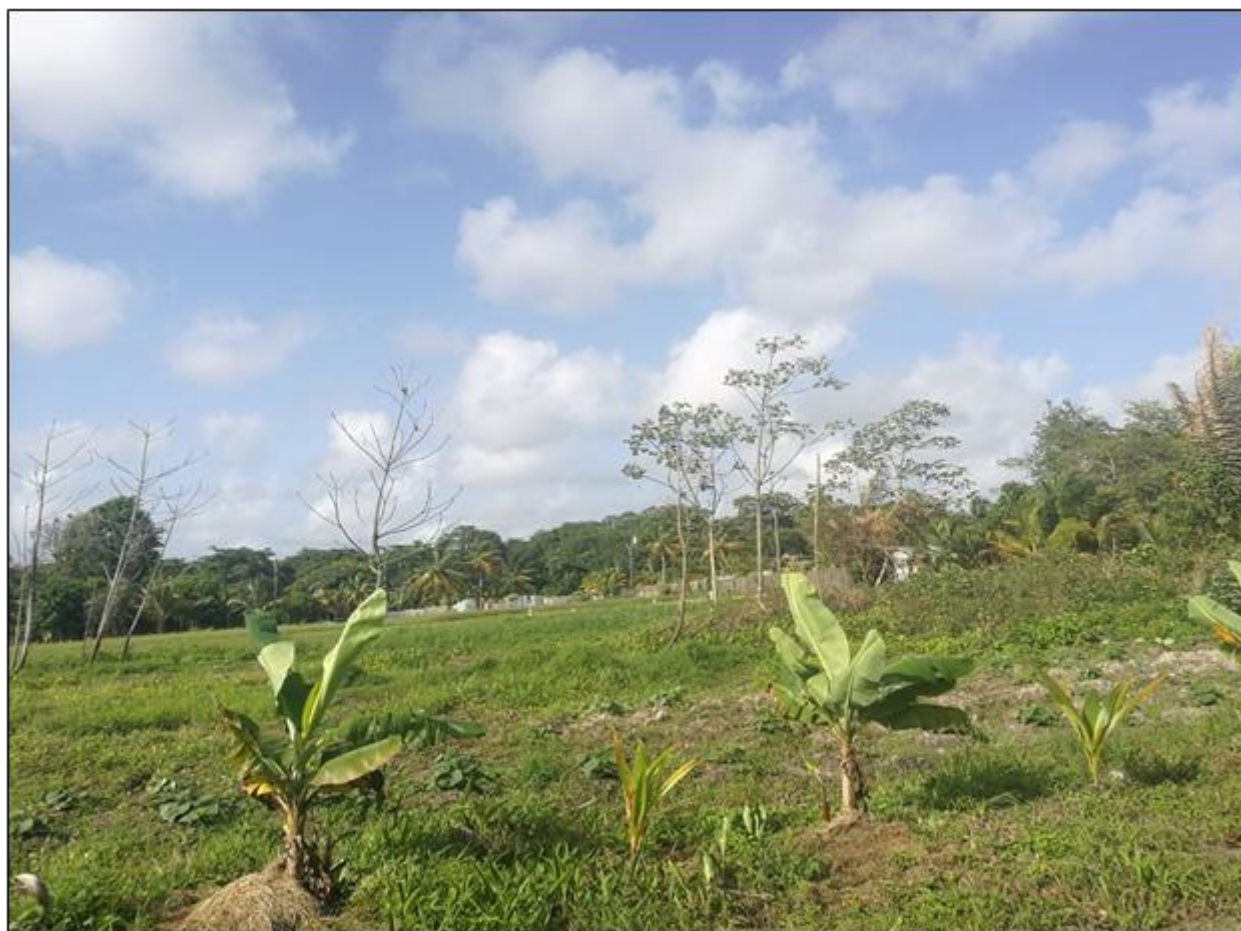
As can be seen in **Figure 46**, there is the Cemetery in the Settlement. The portion of land to the east of the Cemetery is supposedly an extension of the burial ground. Residents stated that this extension of land is also utilized for small-scale agriculture. The crops grown include bananas and vegetable crops.

Figure 46. Agriculture on Cemetery Land, Sahadeen Trace

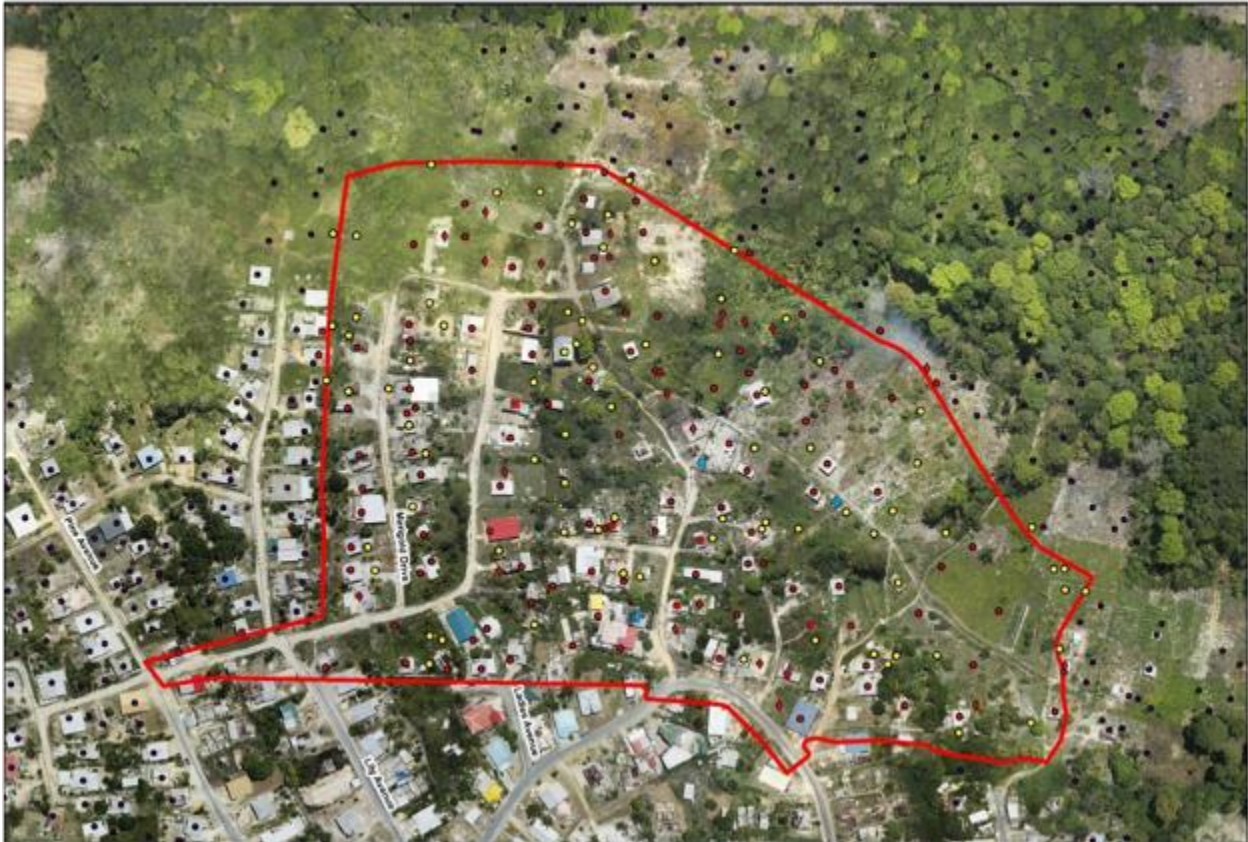
Figure 48. Bois Bande – Settlement C, Sangre Grande

Layout Plans were previously designed for the LSA for three (3) Bois Bande Settlements, namely, Settlements A, B and C (see **Figure 47**). Settlement C falls within the previous Layout Design. As seen in **Figure 48**, the extent of Bois Bande - Settlement C is outlined in red.

Thus far, observations indicate that the additional unauthorized development taking place to the north of Settlement C falls beyond the approved site. It is important to note that the section of land to the north of Settlement C falls within the route of the proposed Roadway to Manzanilla.

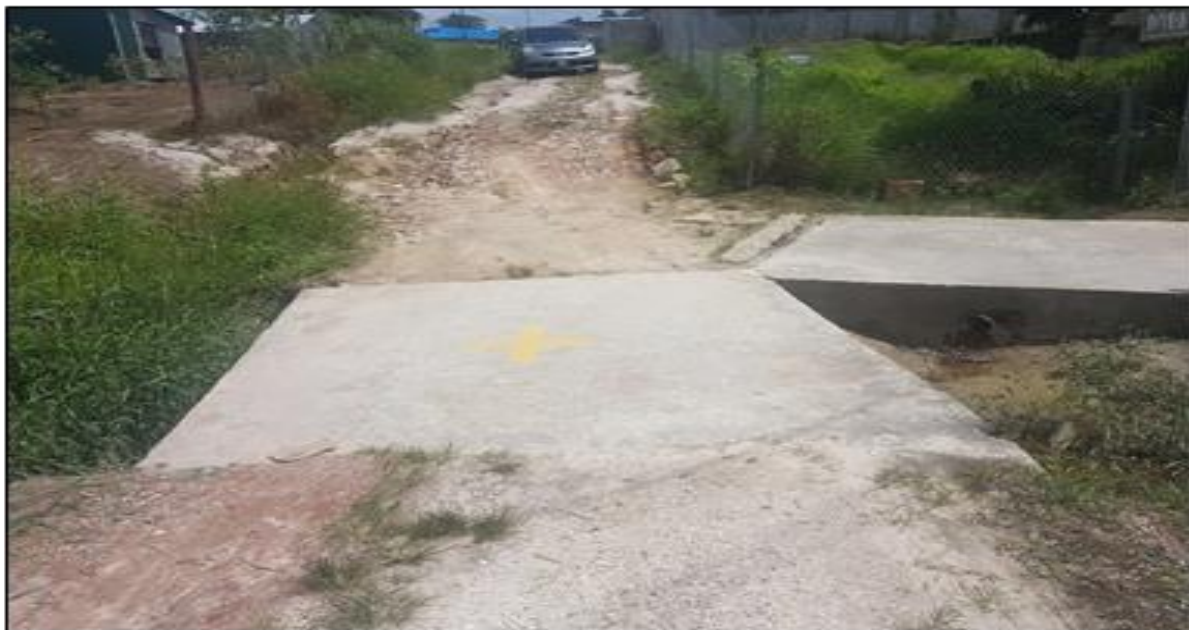
Figure 64. Road at Bois Bande – Settlement C

The existing road network in Bois Bande - Settlement C is a combination of earthen and paved roads. Residents expressed that some of the roads were hand cleared and financed by the community. **Figure 64** shows a road that is partly paved to accommodate outfall drains and **Figure 65** shows a paved road at Rose Avenue with a poorly maintained box drain. The Settlement therefore has an incomplete and poorly maintained road system. This results in faster deterioration of roads which contributes to potholes. Additionally, when vehicles drive on the earthen section of the road it causes dust to rise which reduces air quality and increases respiratory problems amongst residents.

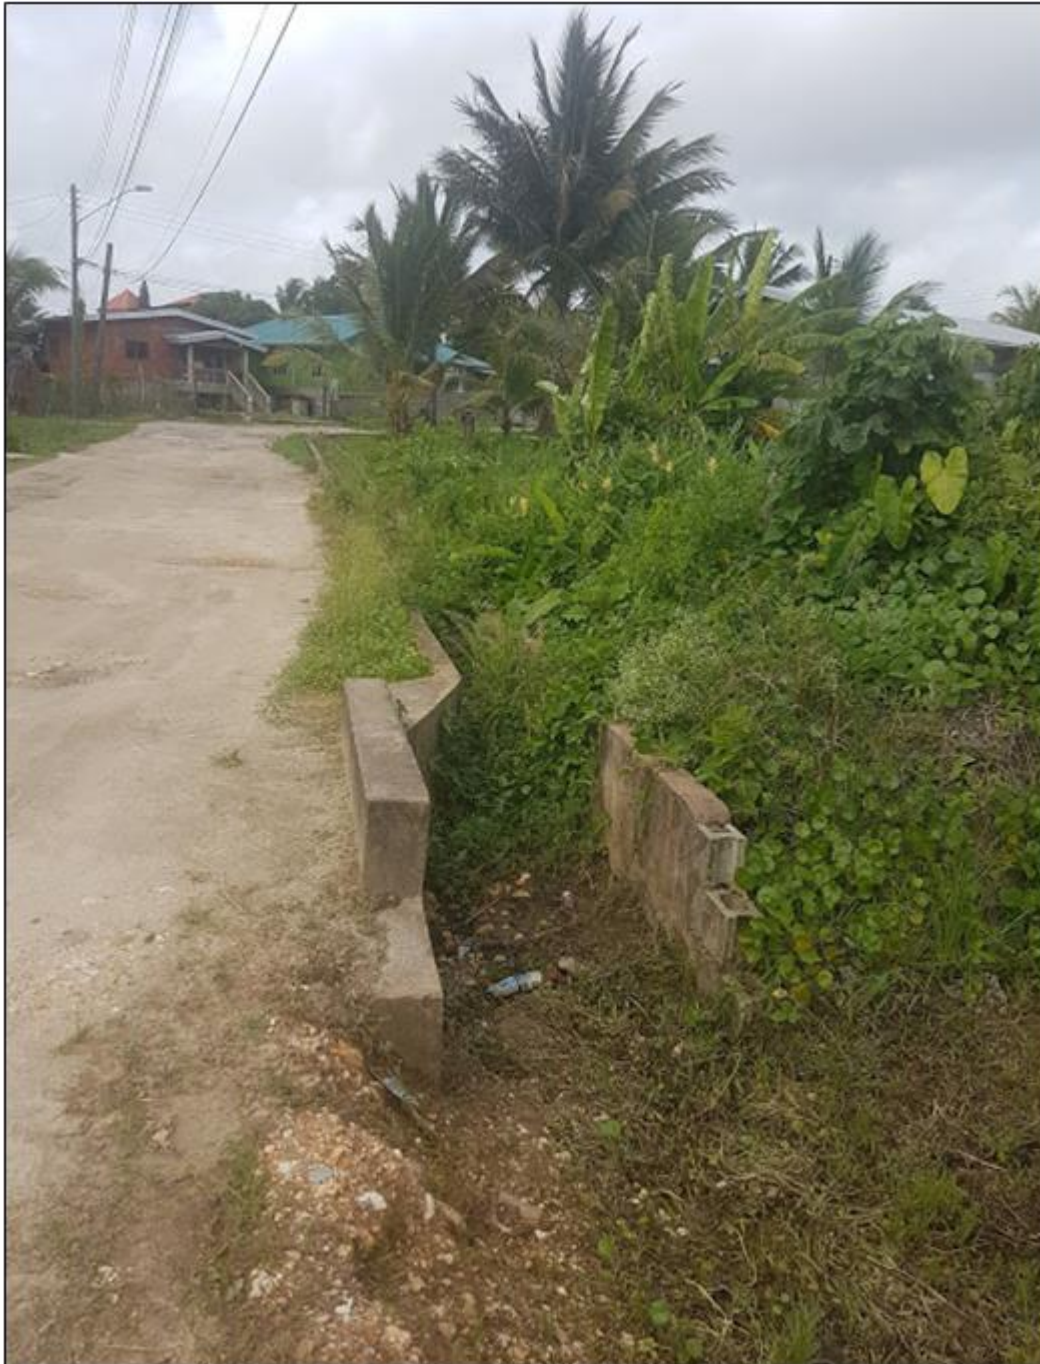
Figure 65. Partly Paved Road, Rose Avenue, Bois Bande – Settlement C

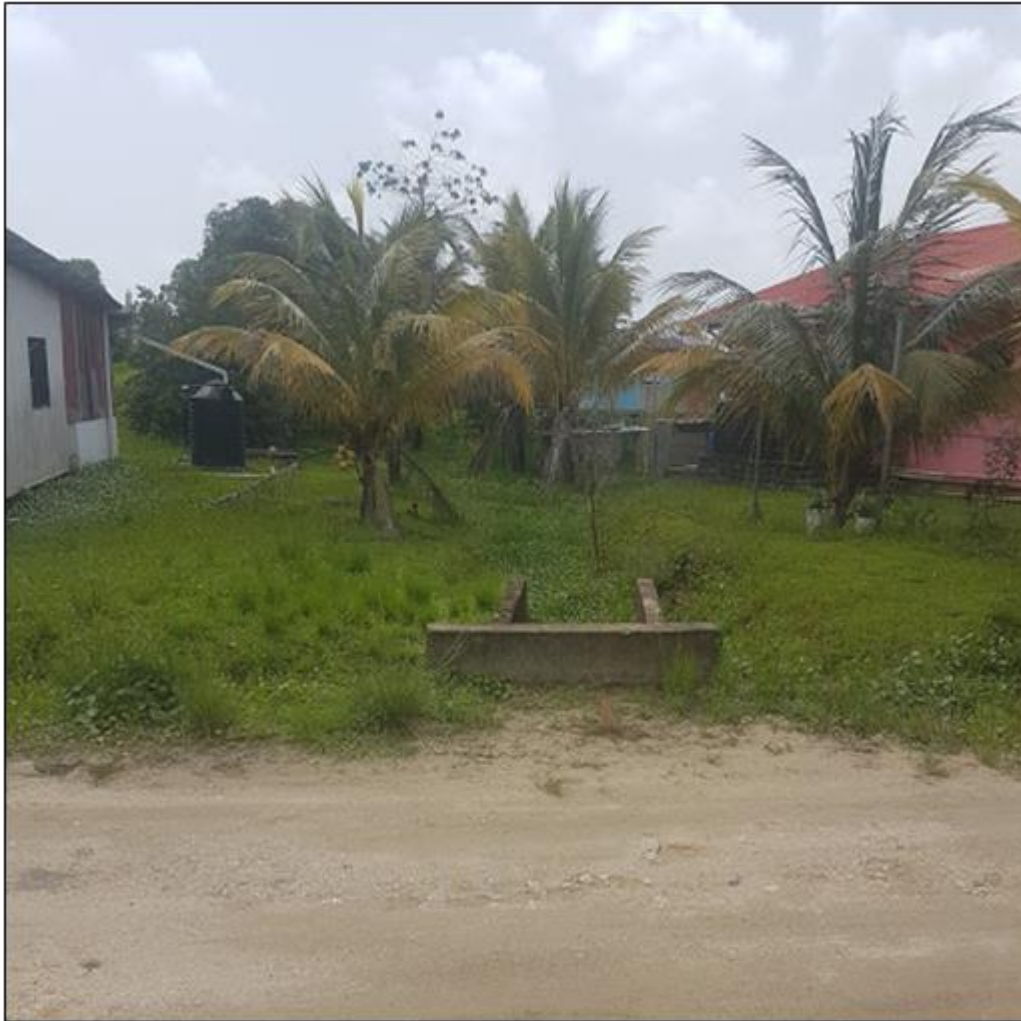
Due to inadequate drainage infrastructure and maintenance, flooding occurs after heavy rainfall. **Figure 66** shows an existing drain on Rose Avenue where the drainage channel appears to be under vegetation. This can hamper the flow of water through the channels. It therefore contributes to stagnant water from improper outfall which has the potential to foster pests. Consequently, potential health problems, such as gastrointestinal disorders and the *Dengue Fever*, may arise as a result of the presence of flies and mosquitoes.

Figure 66. Drain under vegetation, Rose Avenue, Bois Bande – Settlement C

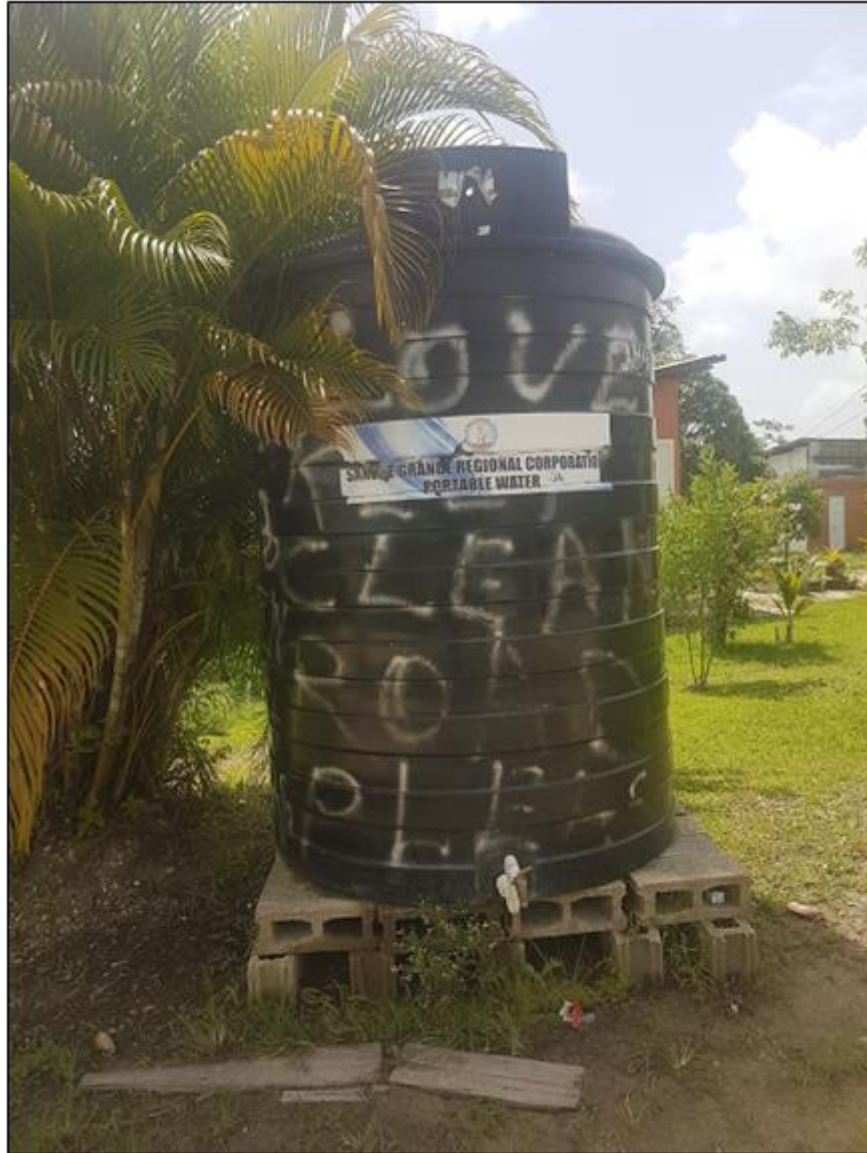
It was observed that some roads in the Settlement did not have pipe-borne water. For instance, at Marigold Drive, residents explained that during the dry season, the Sangre Grande Regional Corporation supplies them with truck-borne water. This water is stored in a communal tank. During the raining season, however, residents collect and utilize rainwater. As seen in **Figure 55** only 29% of residents had pipes within their dwellings whilst the majority used other means for obtaining water in addition to the community tank seen in **Figure 67**. While this water is usable for any needs of the residents, it may not be enough to support the entire Settlement.

Figure 67. Communal Water Tank, Marigold Drive, Bois Bande – Settlement C
