Assessment of the Effects and impacts  
Caused by **Hurricane Irma**

# The Bahamas

2017

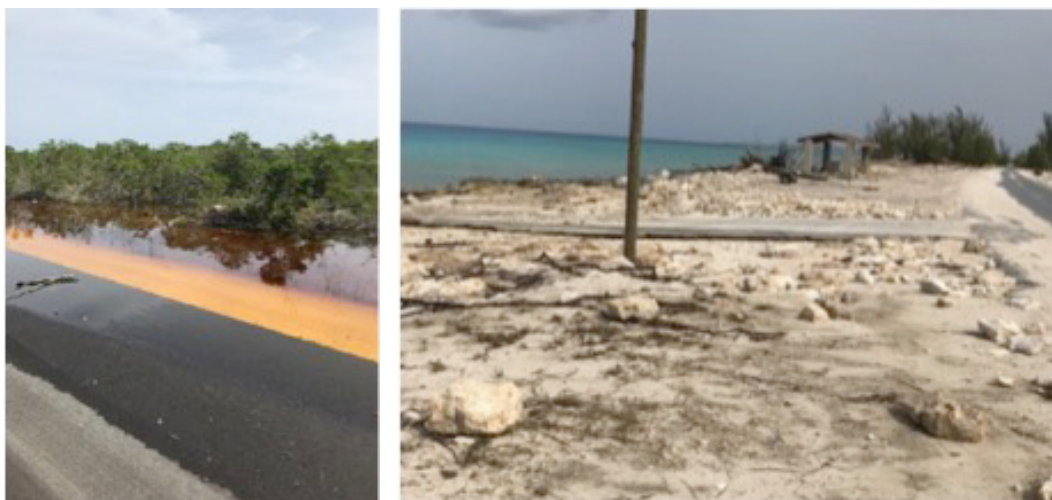
- A. Lack of a consistent design and construction standards and methods
- B. Insufficient technical supervision during construction to ensure a correct outcome
- C. Inefficient and low quality structural components and construction deficiencies
- D. Use of inappropriate materials given the local hazards and environment, causing the structure to deteriorate and become unable to withstand the effects of natural events
- E. Absence of proper draining channels and systems to conduct rainfall adequately

**Image 1** - Pavement structure and draining problems, in Acklins and Great Inagua Islands.

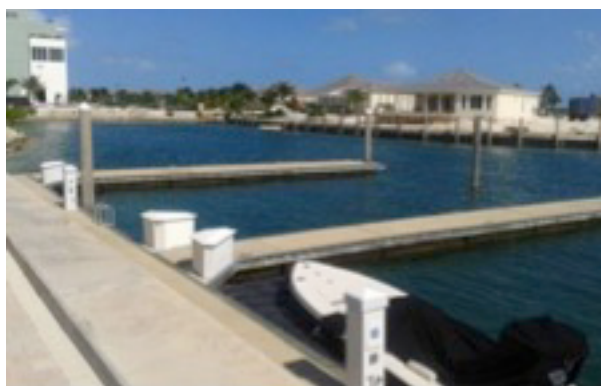
**Image 3** - Resort World Marina (Bimini).

General marina activities are an aspect of significant importance for the economy of Bahamas, and tourism represents over 60 per cent of the Bahamian GDP. The islands assessed in this report have a significant group of commercial, fishing, and sporting ports that are critical to support the operation of collateral sectors. Image 3 shows a private marina on Bimini.

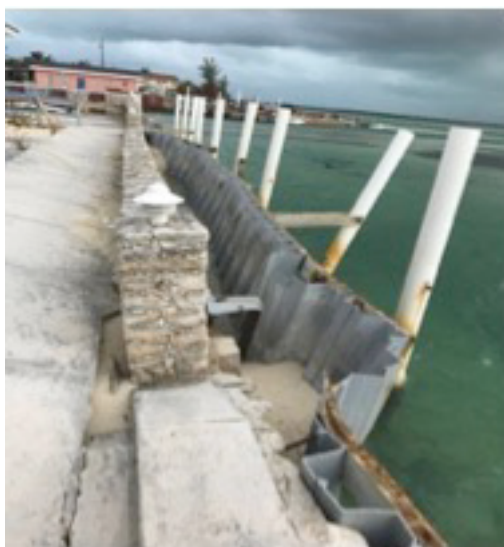
In general, port structures suffered minor damage to pillars and to decks made of concrete slabs for the small fishing docks. Also, as per the assessment team's inspection and interview with one of the private dock managers, the continuous and cyclical sea surge and tide impact caused severe damage in the infrastructure of the Resort World Marina in Bimini. The effects were the result of various aspects: 1) Potential noncompliance with structural criteria (Image 4); 2) Light floating structures that barely support the effects of these type of natural events 3) Construction materials that when damaged can subsequently create an environmental problem (Image 5). These facilities are critical to other important sectors, and should be designed and constructed considering rigorous codes and standards in order to support natural events of this nature, more in accordance with the resilient design observed in Great Inagua dock facilities (Image 6).

**Image 4** - Damage on private dock facility at Bimini

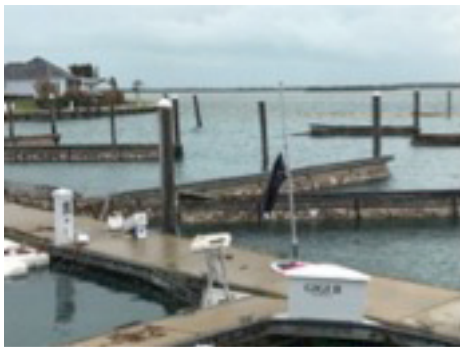
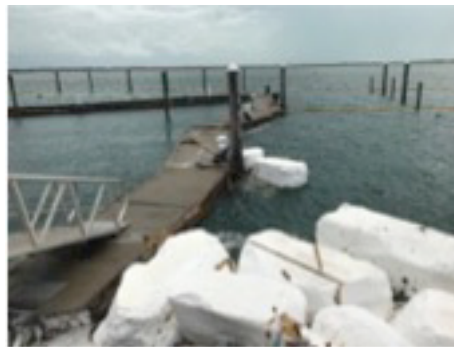
**Image 5** - Damage at Resort World Private Marina (Bimini)

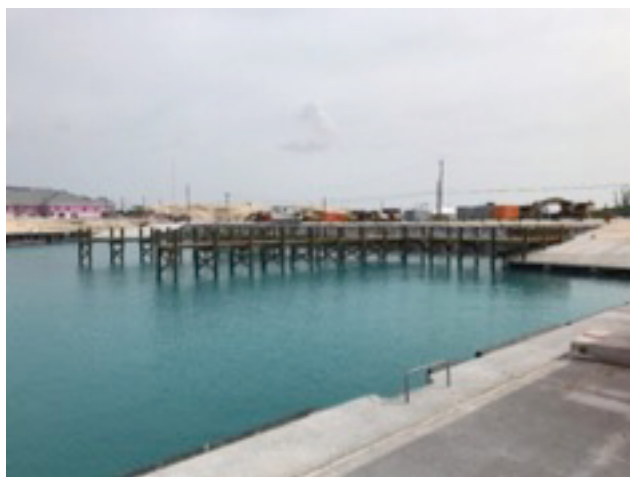
**Source:** Assessment team**Image 6** - Dock in Great Inagua

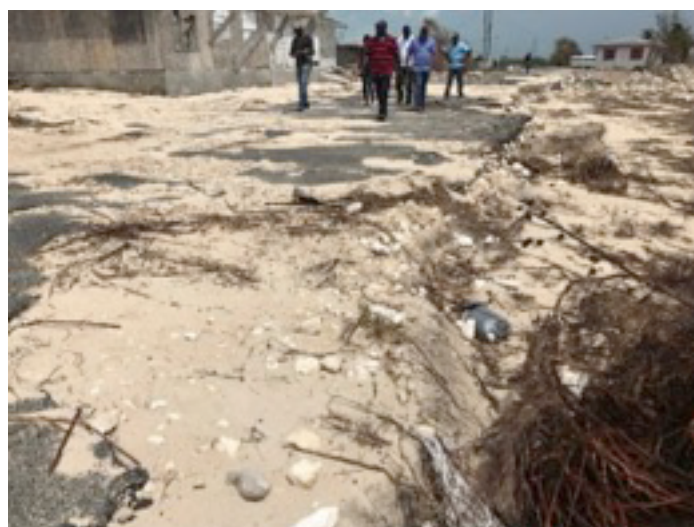
The road network is mainly paved, so most hurricane damage consisted of pot-holes formed by erosion due to heavy water flow as observed in Salina Point area (see Image 7). The absence of proper drain channels, sidewalk gutters, ditches, gutters and counterdrains generate excess water flow to damage the pavement structure at laterals. This allows water to run without restraint, causing it to reach and residences.

**Image 7** - Damage in Roads at Salina Point, Acklins Island

It is important to evaluate areas for the potential for building storm water-retention ponds in strategic areas. Such ponds can regulate the delivery of rainfall to rivers, minimizing the risks of possible floods from excess water. Ideally, a storm water retention pond is designed so that the land vents at least 10 per cent less water flow than if in a normal undeveloped condition. This allows the region to start minimizing the impact of rain entering the river network throughout the country.

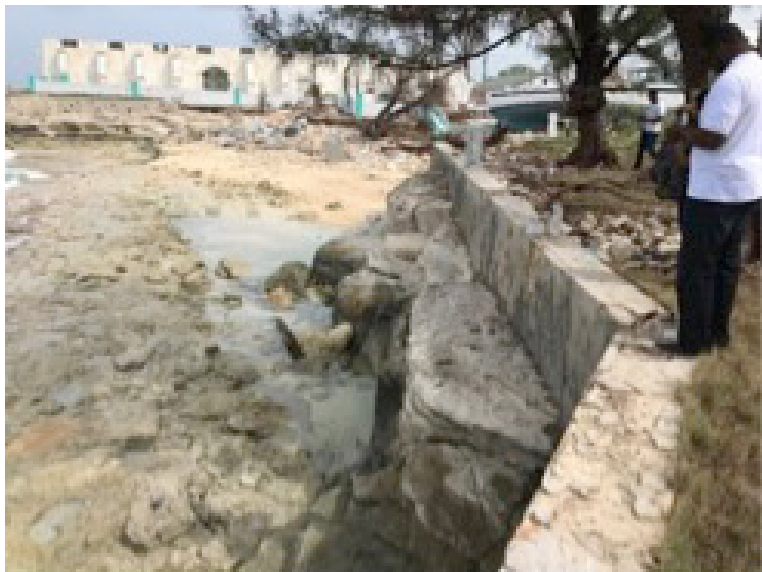
wall and damage in the structure was observed in addition, other seawall areas were not executed according to the basic design and construction practices for a protection structure of this importance. This was seen as the implementation of temporary solutions to create defensive seawalls, often informally done by accumulating large natural rocks and laying them onto the existing beach material, as well as using non-resilient construction solutions, low quality materials, and the inadequate site construction supervision and inspection (Image 8). This creates an area of weakness in the shoreline by exposing the population to a non-resistant solution.

Image 8 - Seawall Damage Inspected in Great Inagua

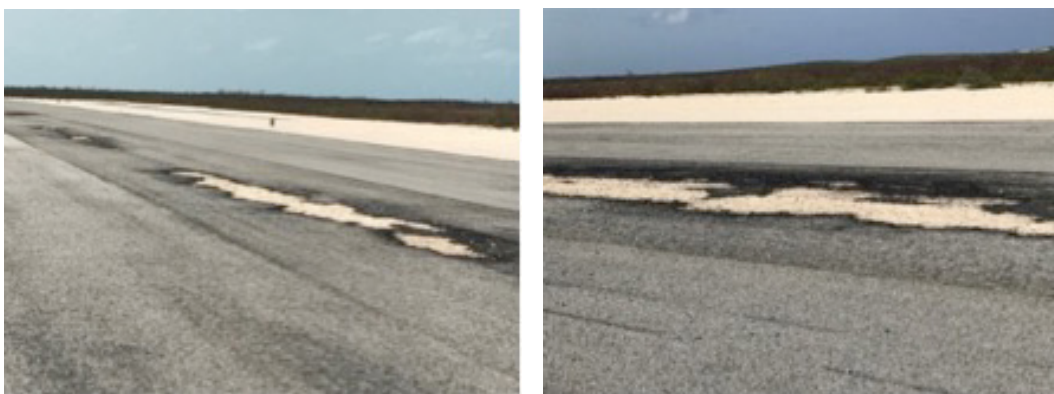
**Image 9** - Damage in the Ragged Island Airport Runway

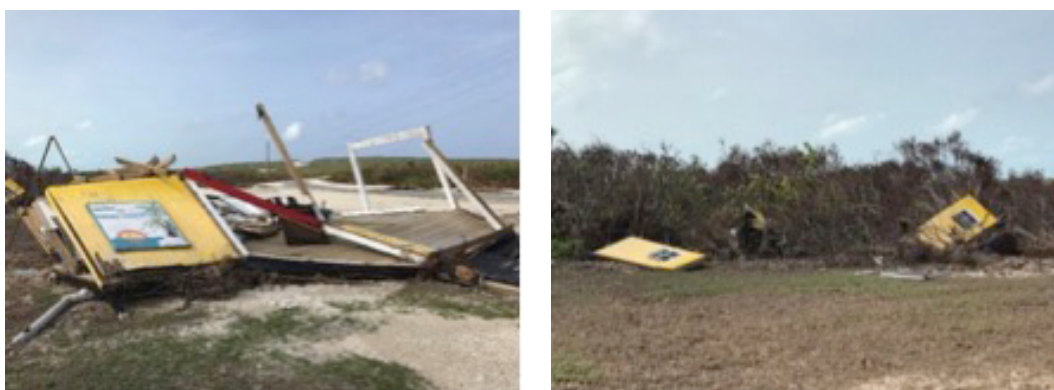
**Source:** Assessment team**Image 11** - Collapse of Ragged Island airport terminal

Other examples of robust and resilient design failures and successes were assessed in Ragged Island. There, the storm surge completely devastated the airport terminal. This situation contrasts with the robust design of the US Coast Guard Aviation Facility in Great Inagua (Image 18). By using resilient designs and adequate construction materials the probability of damage of these important and strategic assets can be considerably reduced.

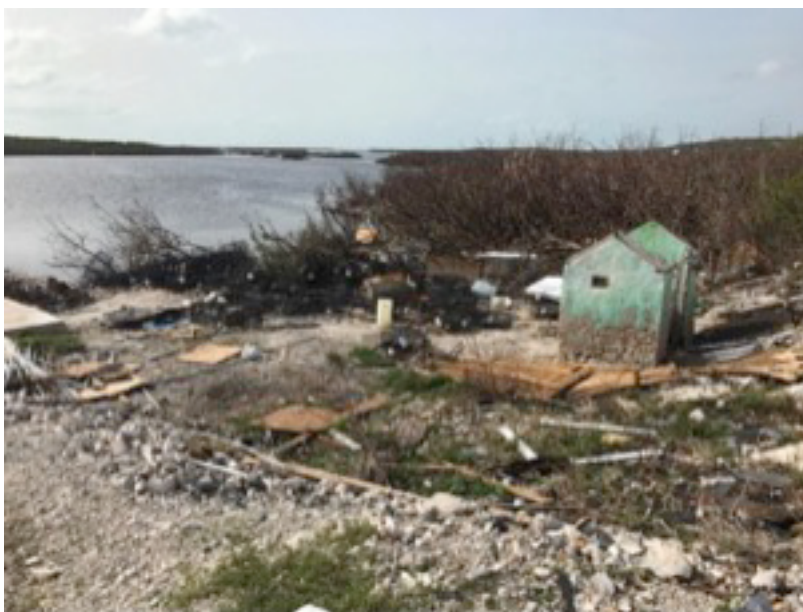
**Image 12** - Ragged Island Fishing Dock Damage

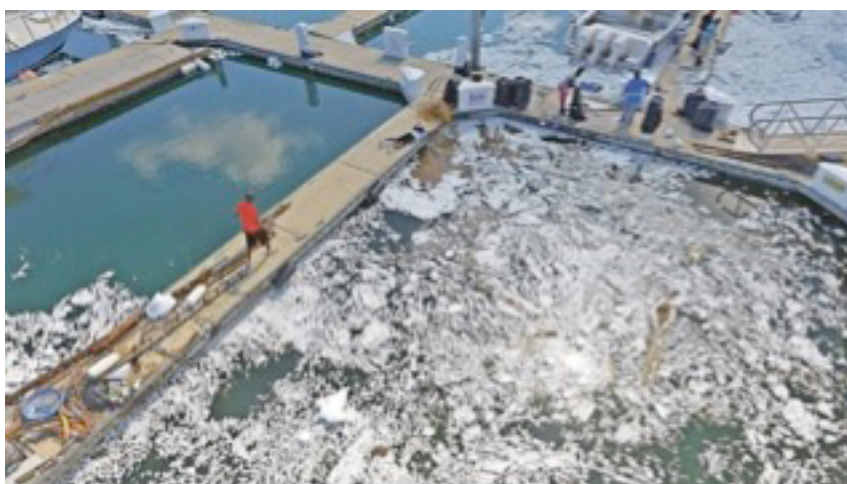
On Bimini the Resort the World Marina was damaged. This affected the beaches and the surrounding environment due to the degradation and subsequent spreading of materials such as polystyrene foam in the surrounding waters (Image 13). Special considerations and evaluations of the reconstruction process should be taken to mitigate the risk of this situation in potential future events.

**Image 13** - Styrofoam floating in the ocean in Bimini in September

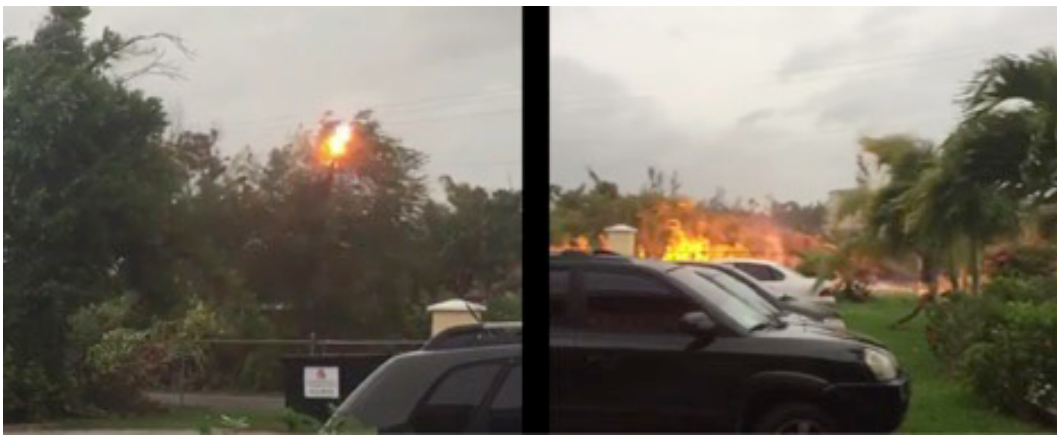
**Image 14** - Brush fire caused by contact between vegetation and power lines

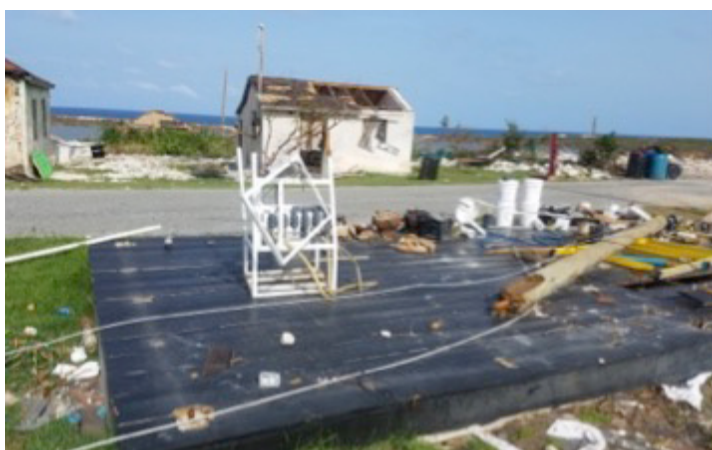
**Image 15** - Damage in RO water plant- Ragged Island

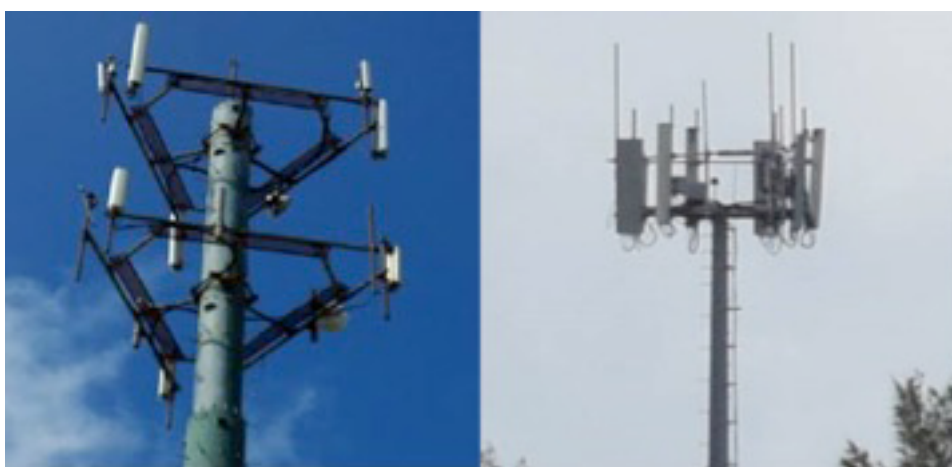
**Image 16-** Antennas connected to a tower at one point vs. antennas connected at two points using a bracing bar

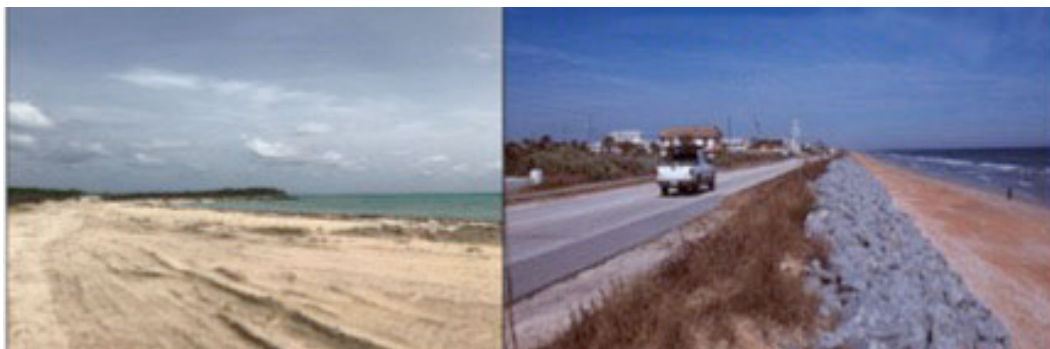
**Image 18-** Road elevation

As seen in the field visits to the affected areas, roads, especially those close to the shoreline, evidenced an excessive exposure and vulnerability to natural the lash of Hurricane Irma. This is particularly the case on the road from Spring Point Airport to Salina Point. The current situation of the road triggers a risk factor to an important infrastructure asset that interconnects Salina Point with the rest of Acklins Islands. Resilient design such as an elevation is required in these critical points in order to mitigate the impacts of hurricanes and similar natural hazards (Image 18).

The Bahamas

Florida Highway A1A, Flagler Beach

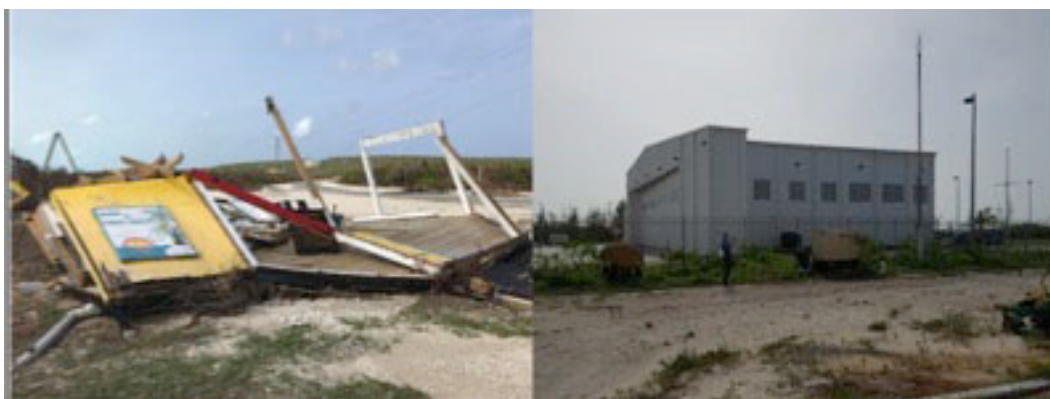
Ragged Island Airport Terminal

Guard Aviation Facility in Great Inagua
