Assessment of the Effects and Impacts of Hurricane Matthew

The Bahamas

**Assessment of the
Effects and Impacts of
Hurricane Matthew
The Bahamas**

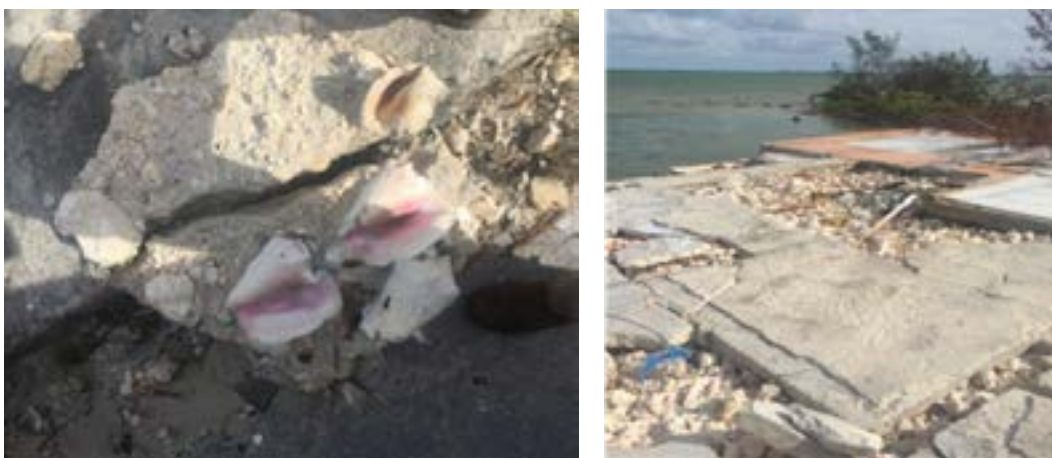
Figure 3- Conch shells used as an aggregate in concrete slab destroyed by storm surge in Lowe Sound

Another ill-advised practice observed was the use of conch shells in concrete mixes and as the main filler material for concrete slabs (Figure 3). These shells are abundant and inexpensive, making them popular for use in filling and preparing concrete, instead of a more appropriate aggregate. However, when economy demands, conch shells are used, and their use is adequate so long as this complies with respective codes of practice.

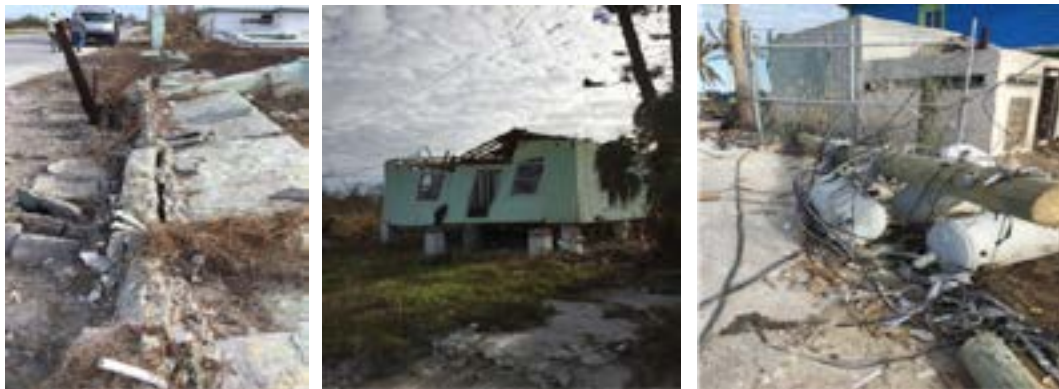
Figure 4- Photos showing front walls, buildings and other major damage caused by storm winds and surge flooding in West End

Strong winds damaged power lines and transformers, interrupting the electrical service for at least several weeks in most parts of the island, and resulting in interruption in the water supply for most of the dwellings effected.

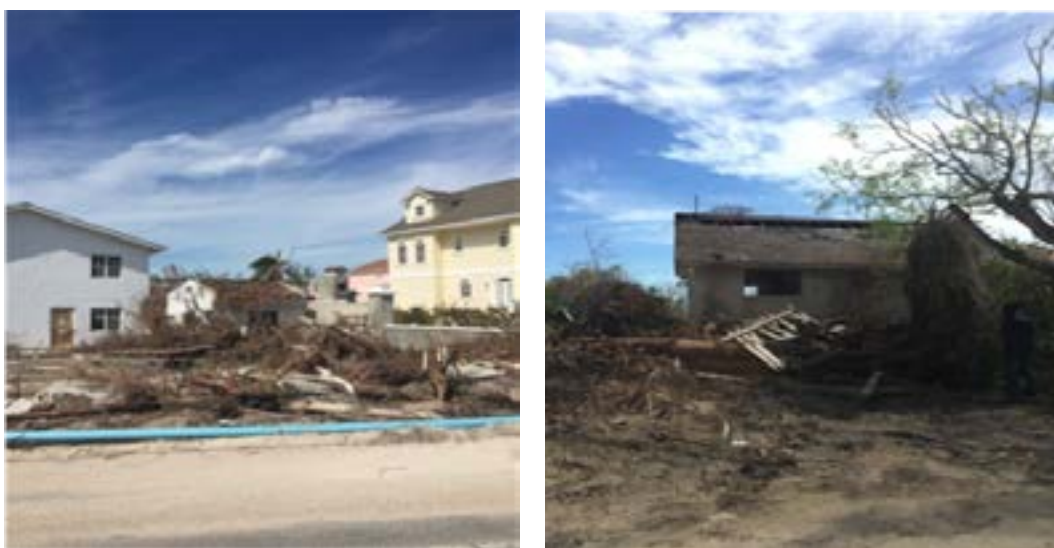
Figure 5- Fallen trees and accumulations of organic debris

Poorly engineered structures, particularly homes, were the most extensively damaged. As on the other islands, the houses most frequently destroyed or severely damaged were older homes. The team observed that some homes had inadequate pier foundations or a complete lack of pier reinforcement, causing severe structural damages.

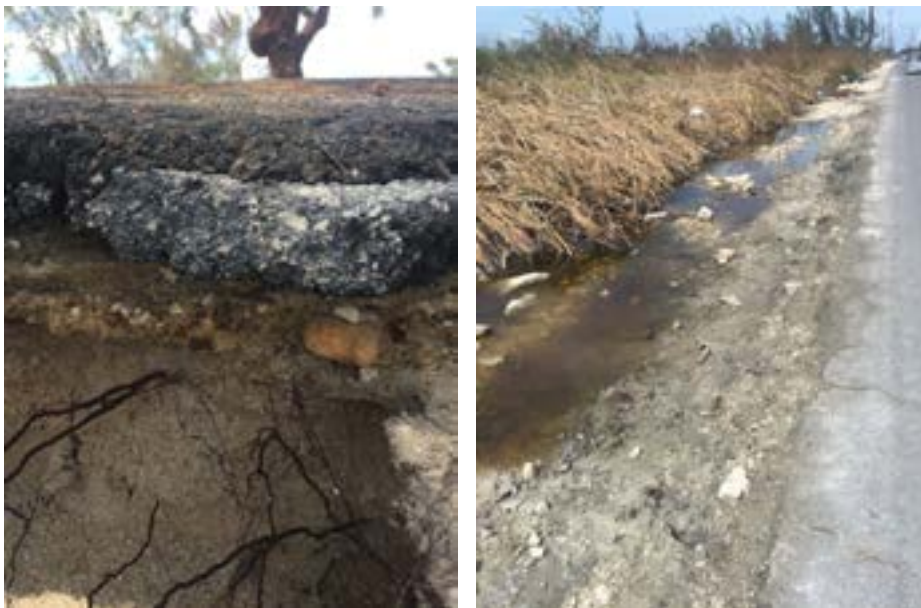
Figure 6- Pavement structure and draining problems, South Beach San Andreas

- A. Lack of technical supervision during construction to ensure a correct outcome
- B. Inefficient and low quality of structural components and construction deficiencies.
- C. Use of inappropriate materials given the local hazards, so the structure deteriorates readily.
- D. Absence of updated modelling information applied to current design and construction such as sea walls.
- E. Absence of proper draining channels to conduct rainfall adequately.
- F. Absence of proper draining channels to conduct rainfall adequately

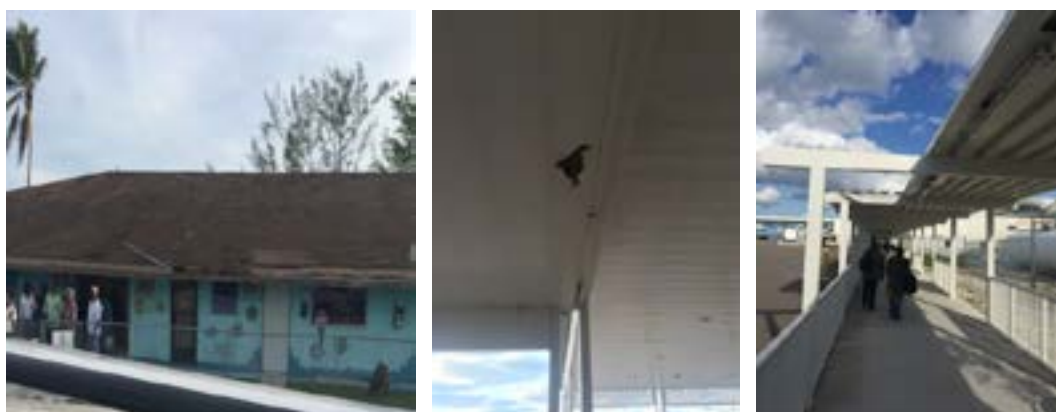
Figure 7- Affected airports in Berry Islands and New Providence.

All four of these airports have paved runways, but none suffered any damage as a direct consequence of Hurricane Matthew. Mostly, the terminal and administration offices suffered minor damage to the roof cover and ceilings throughout the whole structure (Figure 7). The roofs are shingled; the ceilings have suspended light supports in internal offices and an alternate ceiling system for the outdoors.

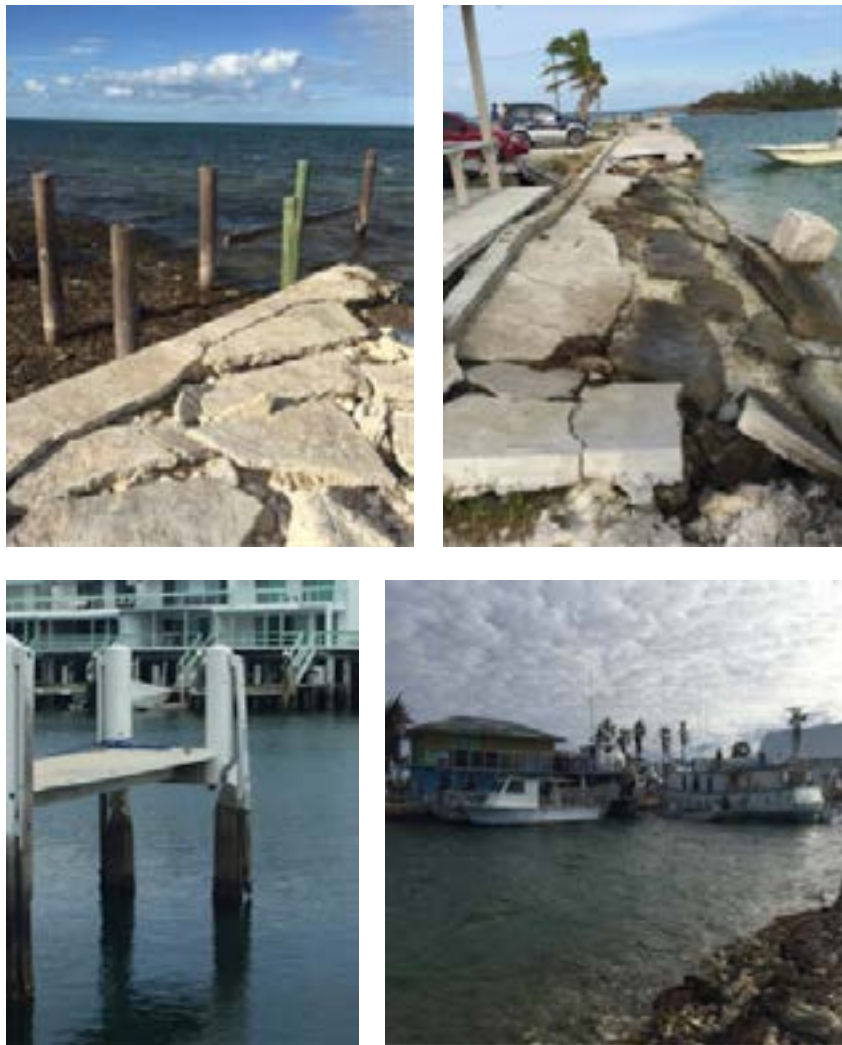
Figure 8- Affected docks in West End and Berry Islands

Port structures that suffered the most hurricane damage were generally small and used mostly by local fishery activity, which is of great importance to the economic sector. These ports, docks and harbour structures present a simple construction process and design, as seen in Figure 8.

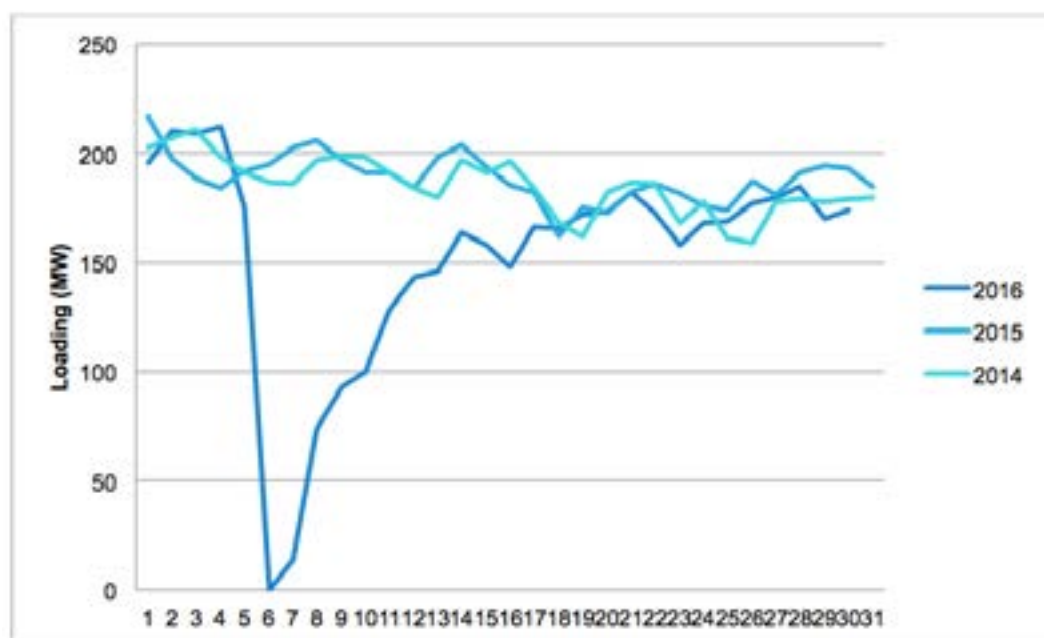
Figure 10- Daily peak load readings for New Providence in October

Losses in the power sector represent sales of electricity that did not occur because of damage to the network. Information from BPL indicates that electricity usage in New Providence dropped to near zero on 6 October. Usage recovered to about 75 per cent of the previous peak load one week after the storm, and reached full recovery by the time BPL announced completion of its restoration work on 28 October, as can be seen in Figure 10. Though energy use was lower at the end of October than at the beginning, this is consistent with the seasonal profile of electricity use in past years

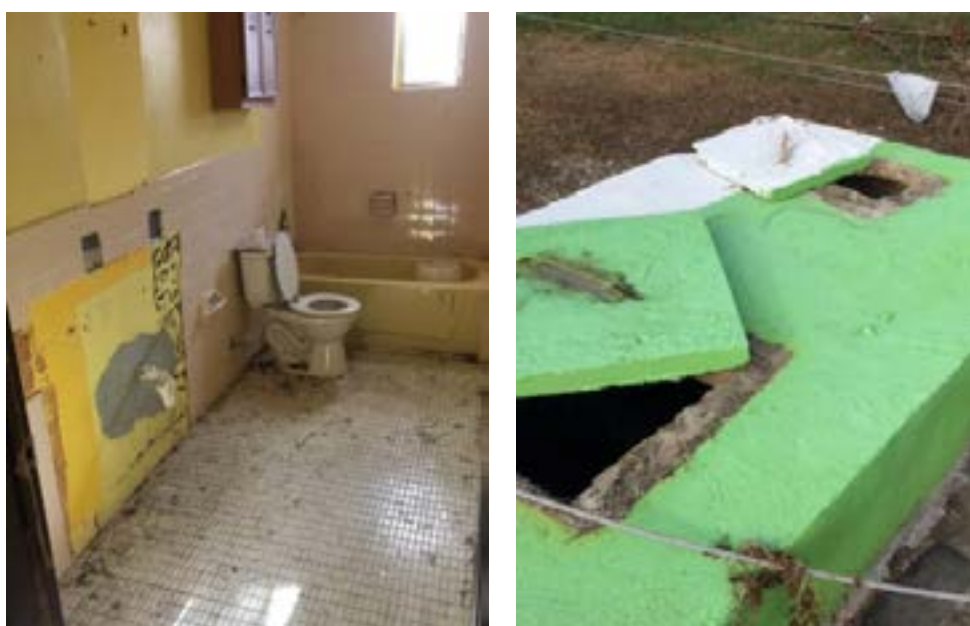
Figure 12- Bathroom and septic tank system affected by flooding in the West End settlement

In Grand Bahama, sewer systems did not show much damage. Damage to septic tanks was observed, including missing covers, in several affected houses (Figure 12). As in New Providence, some distribution lines were destroyed or showed leaks or were damaged by roots when trees were torn from the ground.

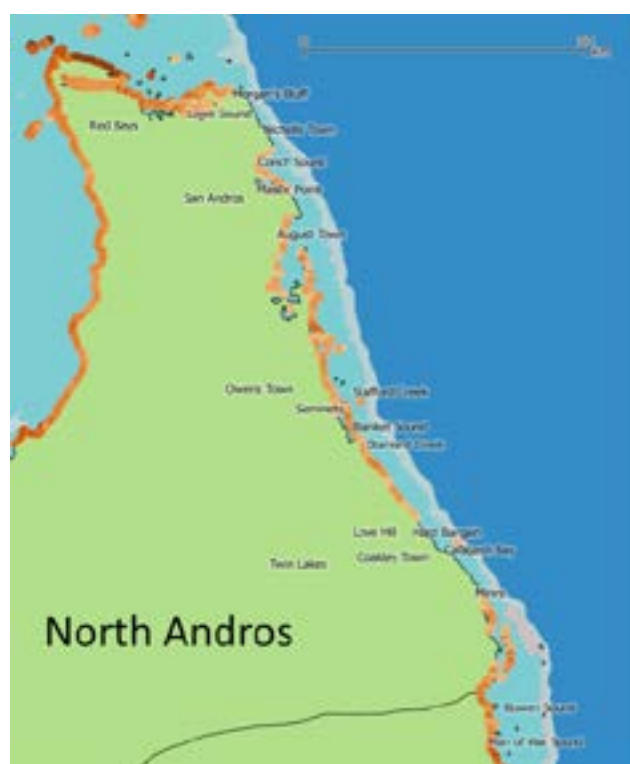
Figure 15- Coastal vulnerability index (CVI) in North Andros

One output of the project is a Coastal Vulnerability Index (CVI). This model uses factors such as wave height and bathymetric and coastal profiles to forecast relative exposure to risk of areas along the shoreline. The model is a tool for understanding what areas are at elevated risk. These areas can be further evaluated to determine if their infrastructure and population is unduly vulnerable. Figure 15 illustrates the CVI in populated areas of Andros. Expanded use of this tool would help identify communities in The Bahamas in need of relocation or additional coastal protection.

The CVI tool cannot be considered in isolation. For example, while the model indicates that the north shore of Andros is particularly at risk, it labels portions of the town of Lowe Sound as in relatively sheltered points along the shoreline. However, Lowe Sound is where Hurricane Matthew caused the greatest damage to Andros buildings and infrastructure. This kind of model could not account for the particular disposition of this specific hurricane, and thus the way in which the angle of wind interacted with the contours of the coastline. Apparently, as the direction of the wind changed, water that had been driven to pile up at one end of the sound quickly shifted to a different location. This water appears to have interacted with the contours of the shallow coastal waters in a way that magnified the height of the water as it encroached upon the town.

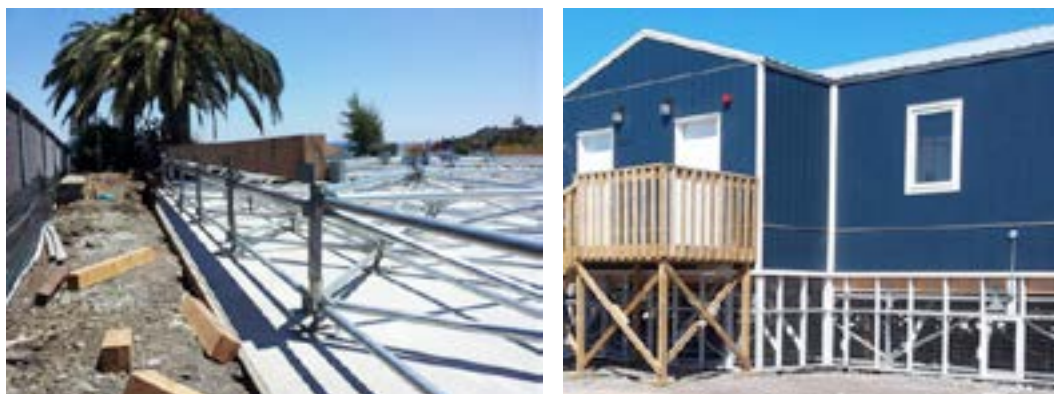
Figure 17- Multipoint foundations

- Cost competitive with alternative foundations
- Typical assembly with hand tools in a few days
- No need for excavation, piers, piles, concrete
- Pre-engineered for each building plan
- Durable galvanized steel and aluminium
- Securely anchored against wind forces
- Uniformly supports and stiffens the building
- Easily modified for future additions
- Used in both new and retrofit applications
- Minimal site preparation and can be placed on native soil
- Gravel pad and timber pads not required in most circumstances
