TECHNICAL ANALYSIS  
FOR THE DESIGN AND CONSTRUCTION  
OF THE MOH AND CENTRAL SERVICES  
INFRASTRUCTURE

Fritz Tjong Ayong, MSc. Arch.

Paramaribo, June 2018

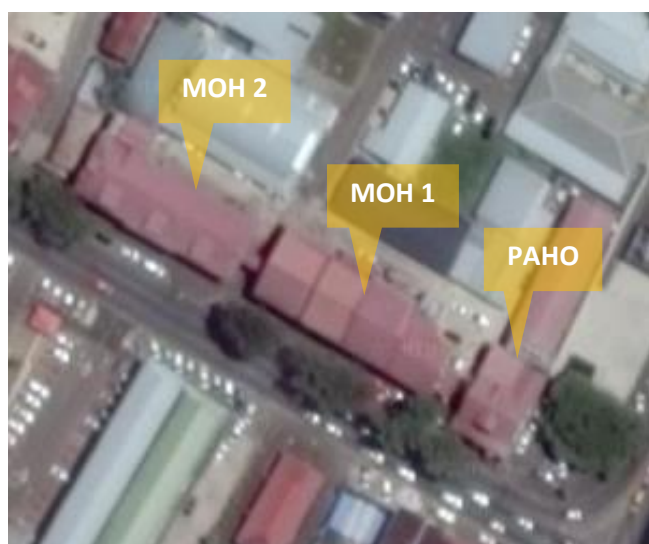
Figure 2: MOH Headquarters

The MoH HQ, located at the historic center of Paramaribo, consists of three historical buildings which are part of the List of Monuments of Suriname. The entirely wooden structures have serious maintenance problems and structural defeats, and it lacks anti-fire systems, accessibility measures, cooling system and technological infrastructure. The historic compound is comprised of two adjacent buildings, connected by a bridge on the first and third floors. The Pan-American Health Organization (PAHO) is located within the same compound. All the buildings are property of the Government of Suriname.

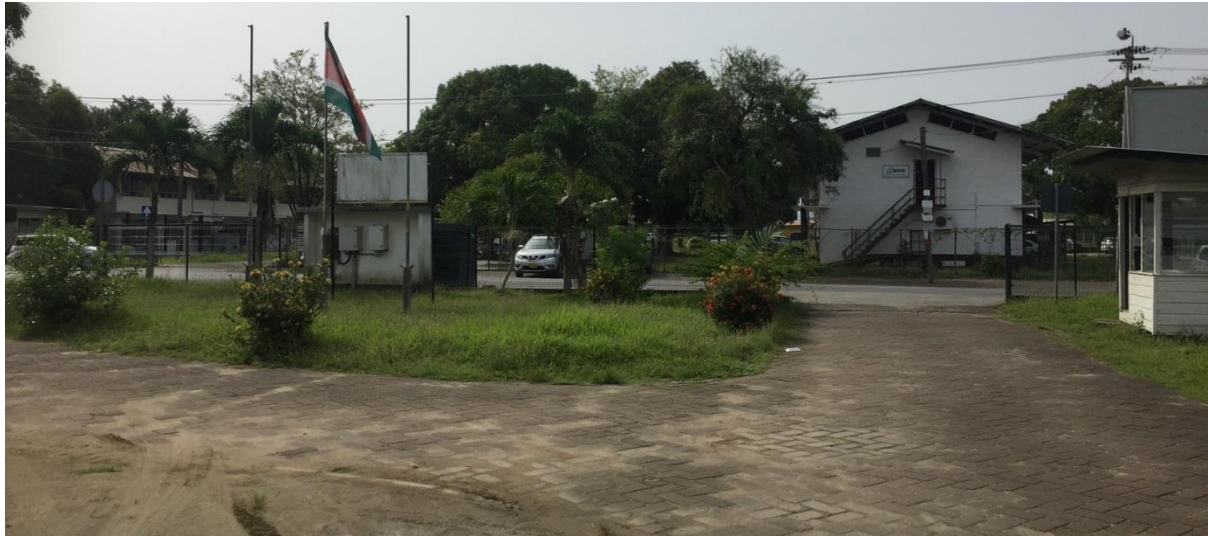
**Connection, mobility and parking:** The entries are not directly connected to each other and the buildings are to be reached through sandy car driveways. On lot # 1 the driveway forms a one-way turn, around the building A, with parking lots next to the building, connecting all the other buildings. On lot # 2 the drive way is around a not well-kept lawn, located between buildings B and C, with possibility to park next to the buildings. Besides that, secondary entrances are on the Gravenberch street which borders the compound on the southern side.

Figure 7: Entrance to lot #2

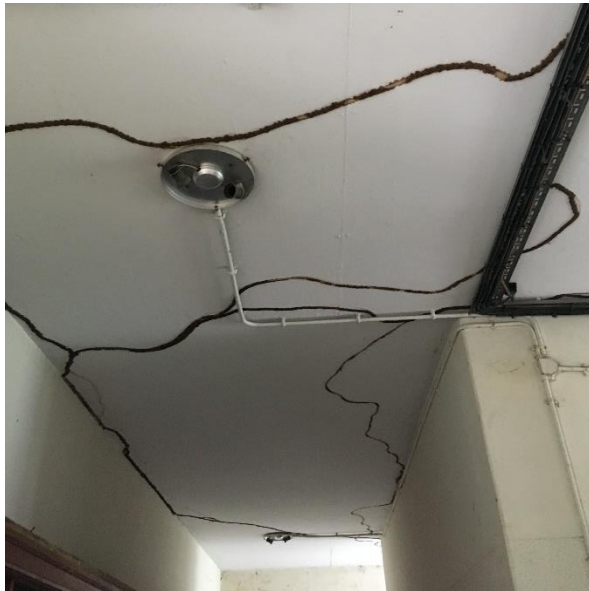
**Pest infestation:** Parts of the existing buildings were partially emptied when their functions were transferred to another location. The abandoned parts of the buildings became an ideal environment for pests. Particularly, termites and bats found shelter under the abandoned roof and the mango trees within the Health compound became their nourishment.

Figure 8: Building B - termites infestation

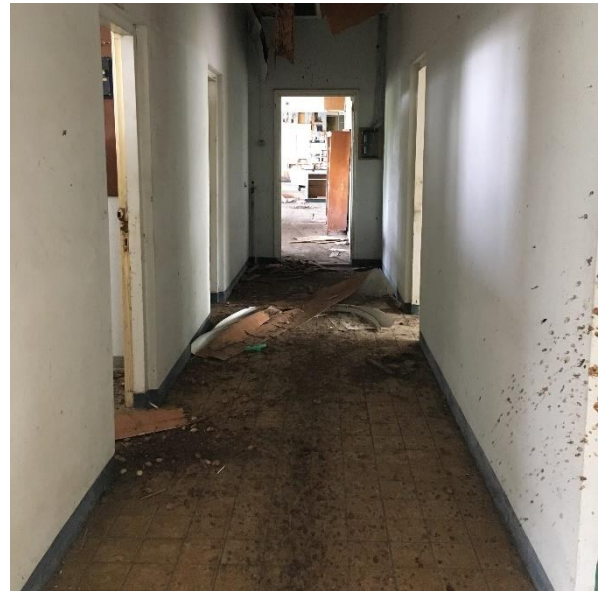
Figure 9: Building B - bats infestation

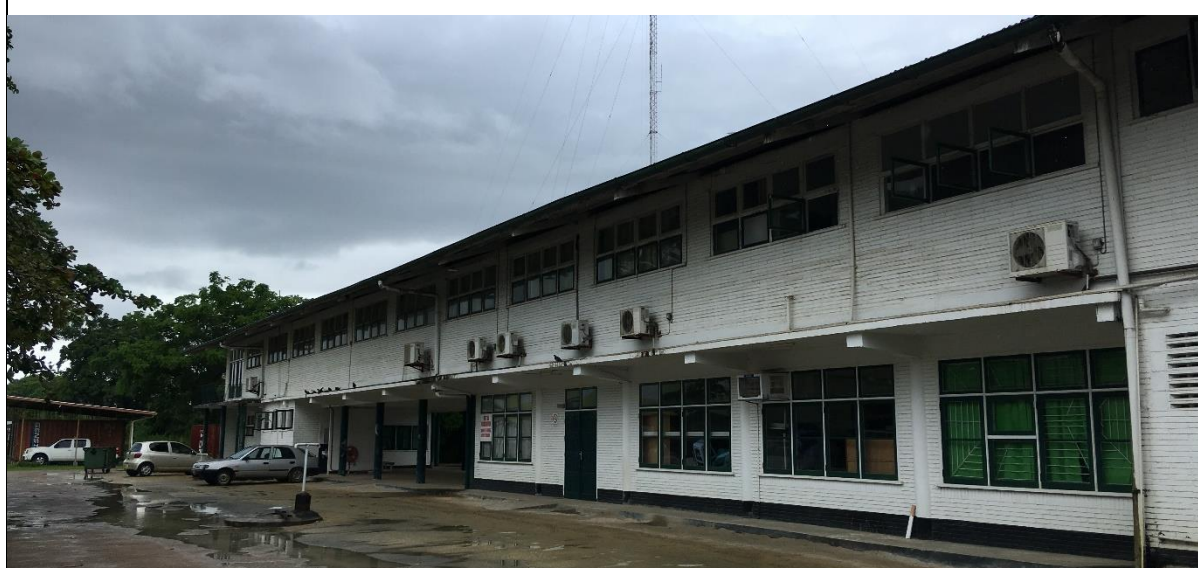
#### BUILDING A

ESTIMATED DIMENSION:	Ground floor: ±850 m²	Total area 1760 m²
	Second floor: ±910 m²	
FUNCTIONS:	Offices for the Bureau of Health	
DESCRIPTION:	The entire building is used for the offices of the Bureau of Health.	
EMPLOYEES:	100	
CONDITIONS:	Fair/poor, with no abandoned portions.

<b>USAGE:</b>	Generally underuse, with roughly 50-70% of available space used.		
<b>REMARKS:</b>	a. Outer walls, facades :	<ul style="list-style-type: none"> <li>• Construction in cement blocks</li> <li>• Paint peeling</li> <li>• No cracks in the walls</li> <li>• No sacking in the flooring</li> </ul>

b. Roofs and ceilings	<ul style="list-style-type: none"> <li>• Ceiling boards, rotten, pest infested</li> <li>• Rain pipes rusted</li> <li>• Galvanized roof rusted</li> <li>• Leaking roofs</li> </ul>

c. Windows and doors	<ul style="list-style-type: none"> <li>• Windows old and defective</li> <li>• Doors ok</li> </ul>	
	d. Stairs and banisters	<ul style="list-style-type: none"> <li>• Outside stair, concrete affected with concrete rot</li> <li>• Indoor stairs ok</li> </ul>

e. Electrical installations	<ul style="list-style-type: none"> <li>• Fuse boxes, most are obsoleted, some are new</li> <li>• Electric system, outdated</li> </ul>	
<b>SUB ANNEXES</b>	Old archive	±125 m <sup>2</sup>	NA
	Breast feeding programme	±95 m <sup>2</sup>	3 people
	Garage	±590 m <sup>2</sup>	8 people

<b>BUILDING A</b>		
<b>Subject :</b>	<b>Description</b>	<b>Score (%)</b>
Decoration	Paint, steps, rainwater drainage, gutters and pipes	50
Finishing	Walls, facades, windows, doors, floors, construction details.	45
Structure	Roof-bearing, floor construction.	45
Installation	Electricity, water, sewerage.	60
<b>Average</b>		<b>52.5</b>
<b>Comments</b>	Conditions varies from moderate to very bad. The building is in average in bad condition and would require a major renovation.

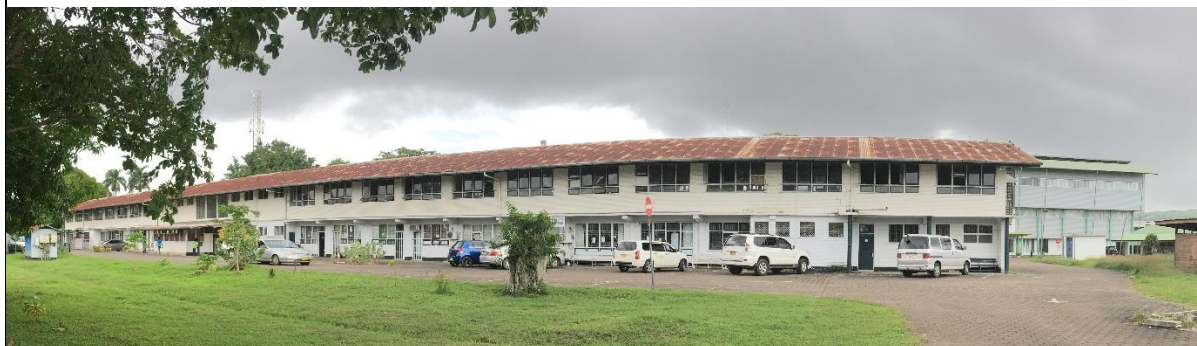
## BUILDING B

ESTIMATED DIMENSION:	Ground floor: ±850 m <sup>2</sup>	Total area 1760 m <sup>2</sup>
	Second floor: ±910 m <sup>2</sup>	
FUNCTIONS:	Vaccines storage and services on the groundfloor.	
DESCRIPTION:	Aproximately half of the ground floor of this is building is used by the vaccination department, for patients’ treatments (malaria, yellow fever) and for central stockroom for vaccines, medicines and tools. The second floor is entirely abandoned and infested by pests. The collapsing roof poses a hazard on the subjacent vaccine center and the presence of pests and their escrementes challanges the accomplishment of basic hygiene. Certainly the vaccine area is underdimensioned, getting easily crowded, at the point that people need to sit outside before being called for the services.	
EMPLOYEES:	19	
CONDITIONS:	Ground floor (Vaccines storage and services) fair conditions.  First floor, abandoned, extreme bad conditions (infested with termites and bats, covered in bats excrement, roof is collapsing).

USAGE:	75% of building (entire 1F and 50% GF): abandoned since 2008.	
REMARKS:	a. Outer walls, facades	<ul style="list-style-type: none"><li>• Construction in cement blocks</li><li>• Paint layer is peeling off</li><li>• No cracks in the walls</li><li>• No subsidence detected in the building</li></ul>

b. Roofs and ceilings	<ul style="list-style-type: none"><li>• The ceiling panels are partly rotten, loose and must be demolished</li><li>• The drain pipes are rusted/rotten</li><li>• The zinc plates are rusted/rotten</li><li>• Leaking roofs</li></ul>

c. Windows and doors	<ul style="list-style-type: none"> <li>• The window frames are outdated and affected</li> <li>• The interior doors are in good condition</li> </ul>	
	d. Stairs and balustrades	<ul style="list-style-type: none"> <li>• The outdoor stairs are in a bad condition, presenting signs of concrete rot</li> <li>• Indoor stairs are ok</li> </ul>	
	e. Electrical installations	<ul style="list-style-type: none"> <li>• Fuse boxes are mostly old and obsolete. Some switch and security cabinets are renewed/new.</li> <li>• Electric system and cabling is outdated.</li> </ul>	
<b>SUB ANNEXES</b>	Electric generators	N/A	N/A

BUILDING B		
Subject :	Description	Score (%)
Decoration	Paint, steps, rainwater drainage, gutters and pipes	40
Finishing	Walls, facades, windows, doors, floors, construction details.	50
Structure	Roof-bearing, floor construction.	40
Installation	Electricity, water, sewerage.	50
<b>Average</b>		<b>45</b>
<b>Comments</b>	Conditions varies from bad to very bad. The building is in average in bad condition and would require a major renovation with partial replacements.

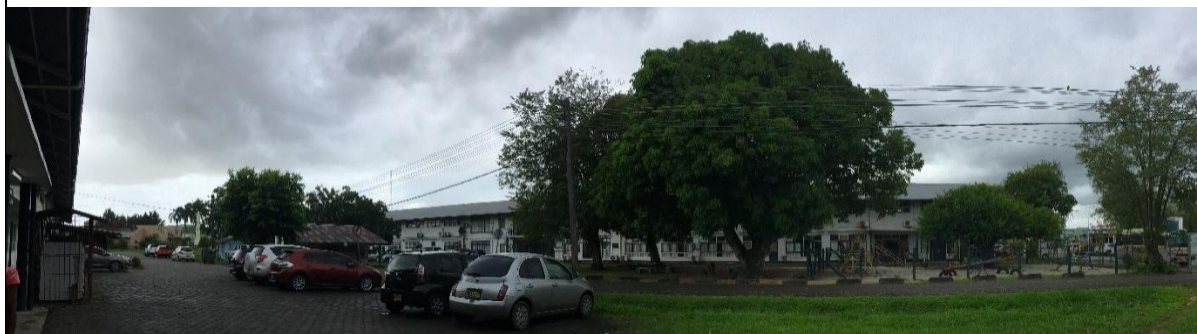
## BUILDING C

ESTIMATED DIMENSION:	Ground floor: ±850 m <sup>2</sup>	Total area 1760 m <sup>2</sup>
	Second floor: ±910 m <sup>2</sup>	
FUNCTIONS:	Health Inspection Department, Medical Education Bureau, Family Health Program, School for Midwives, Medical Commission	
DESCRIPTION:	On the ground floor there is the Health Inspection Department (HID) and the Medical Education Bureau (MEB). About 120 people work in this facility, among which about 50% work in the field. On the second floor there are the Family Health division and the School for Midwives.	
EMPLOYEES:	120 on ground floor, 30 on second floor.	
CONDITIONS:	Fair, with no abandoned areas.	
USAGE:	Some areas, like the HID, seem overcrowded while others appear to be underused. For example, in the area designated for the MEB, no one was seen during the visits. Same for the rest of the building.	
REMARKS:	a. Outer walls, facades	<ul style="list-style-type: none"><li>• Construction in cement blocks</li><li>• Paint peeling</li><li>• No cracks in the walls</li><li>• No sacking in the flooring</li></ul>

b. Roofs and ceilings	<ul style="list-style-type: none"><li>• Ceiling boards, rotten, pest infested</li><li>• Rain pipes rusted</li><li>• Galvanized roof rusted</li><li>• Leaking roofs</li></ul>

c. Windows and doors	<ul style="list-style-type: none"><li>• Windows old and broken</li><li>• Doors are ok</li></ul>

BUILDING C		
Subject :	Description	Score (%)
Decoration	Paint, steps, rainwater drainage, gutters and pipes	50
Finishing	Walls, facades, windows, doors, floors, construction details.	40
Structure	Roof-bearing, floor construction.	50
Installation	Electricity, water, sewerage.	60
<b>Average</b>		<b>52.5</b>
<b>Comments</b>	Conditions varies from moderate to very bad. The building is in average in bad condition and would require a major renovation.	
OLD ARCHIVE AND BREASTFEEDING CENTER		
<b>Comments</b>	Conditions are very bad. It is suggested to demolish them completely.	
GARAGE		
<b>Comments</b>	Conditions are overall good.

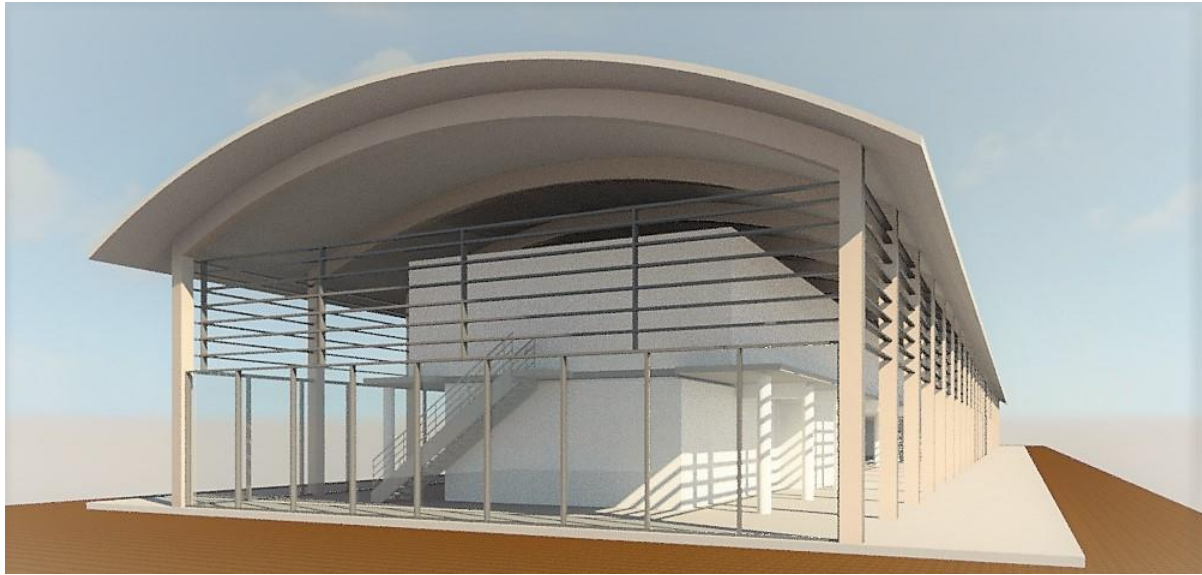
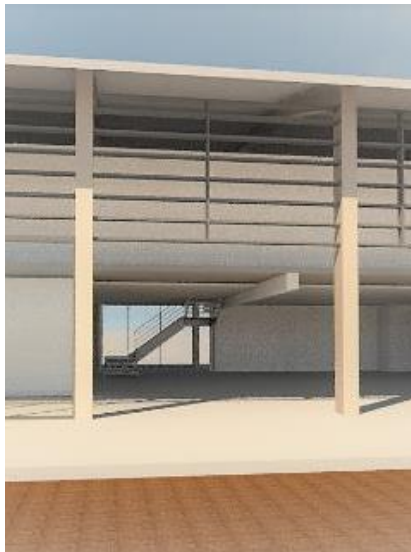
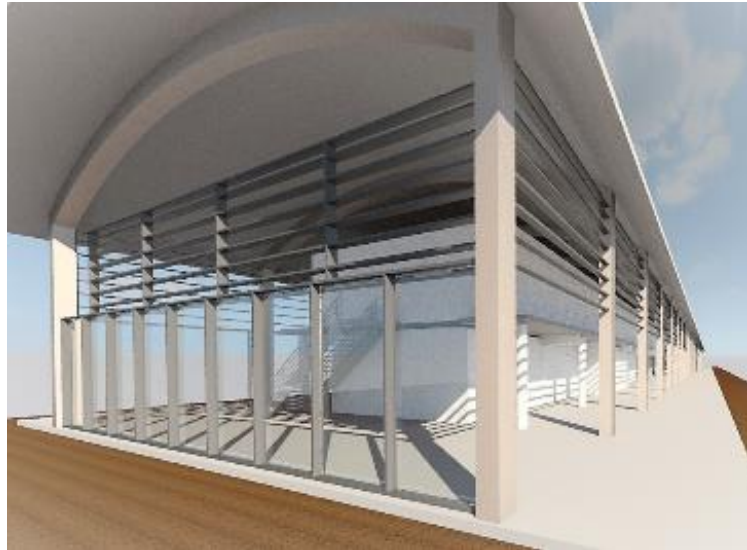
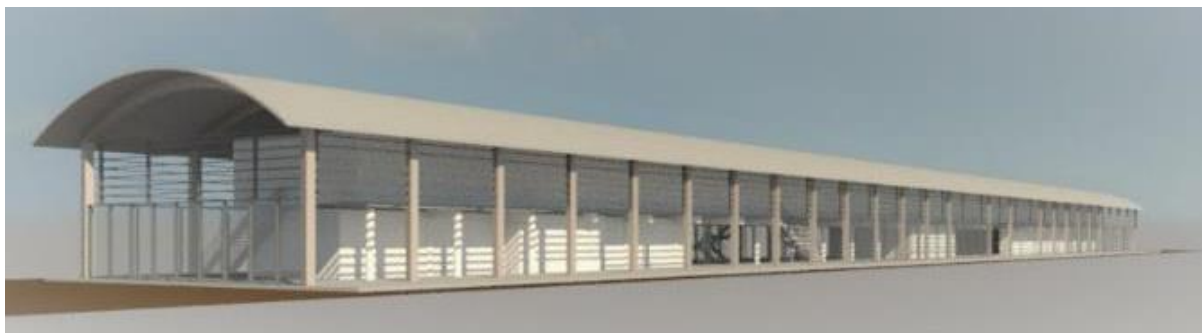
*Figure 10: Possible adaptation of the existing buildings*

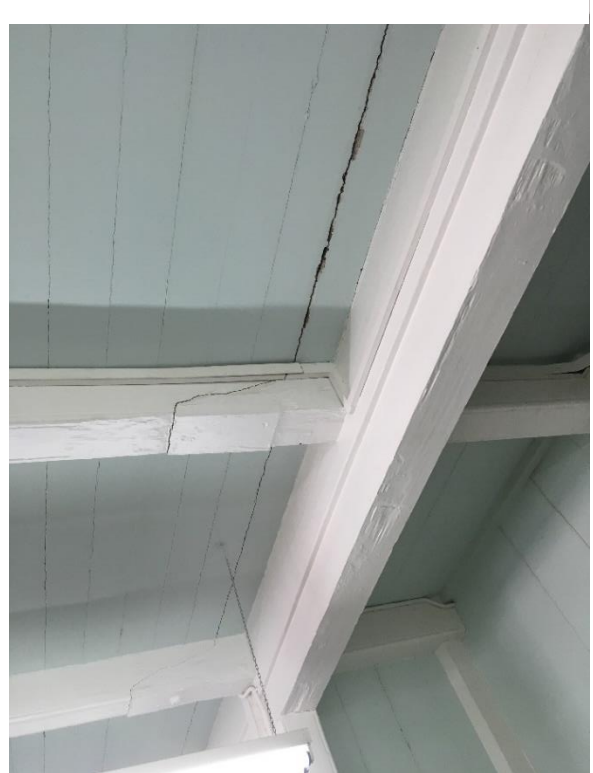
Figure 21: MoH Headquarters - structural defects

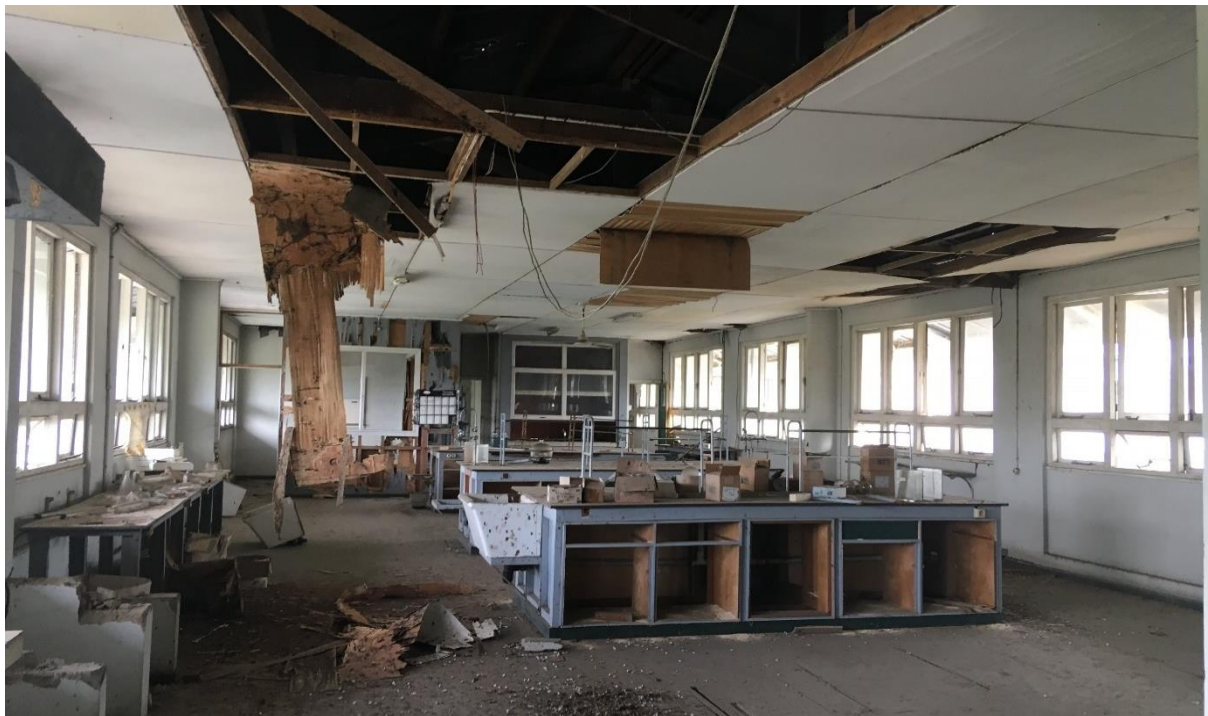
Figure 31: Building B - abandoned central laboratories

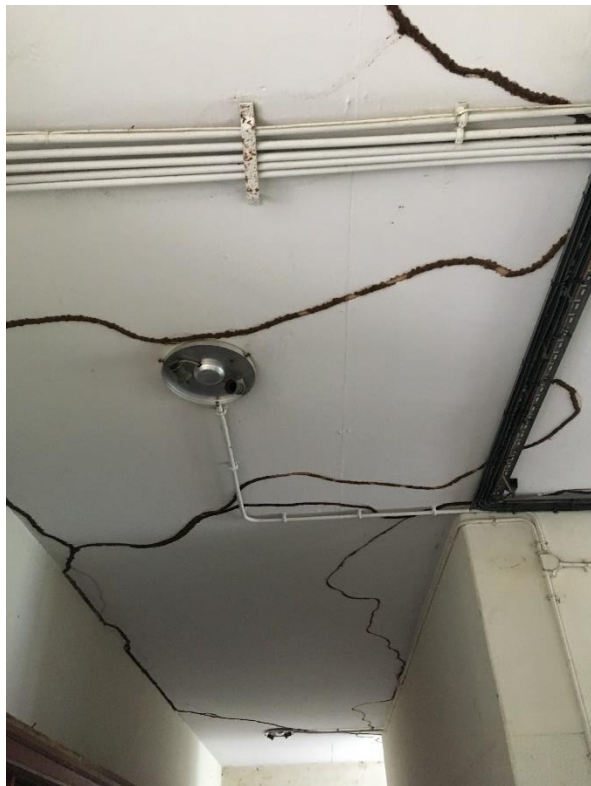
Figure 350: Building B - termites infestation

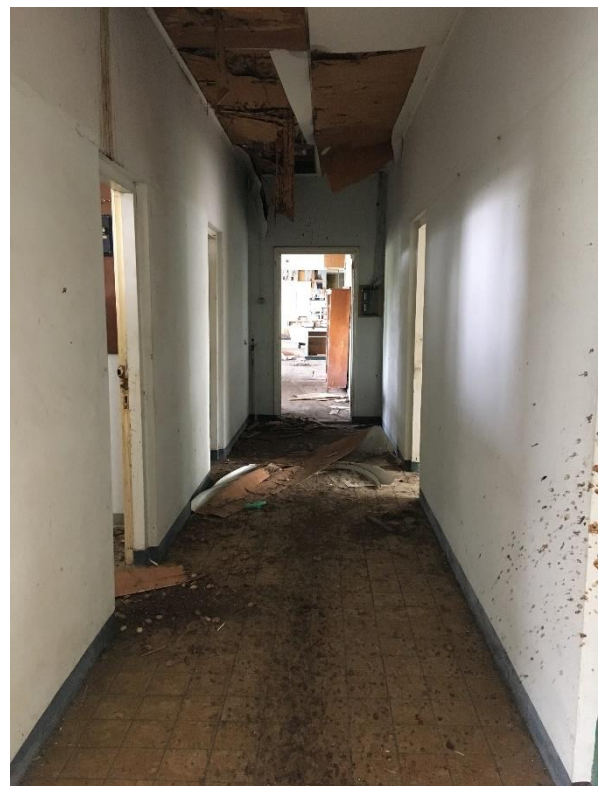
Figure 31: Building B - bats infestation

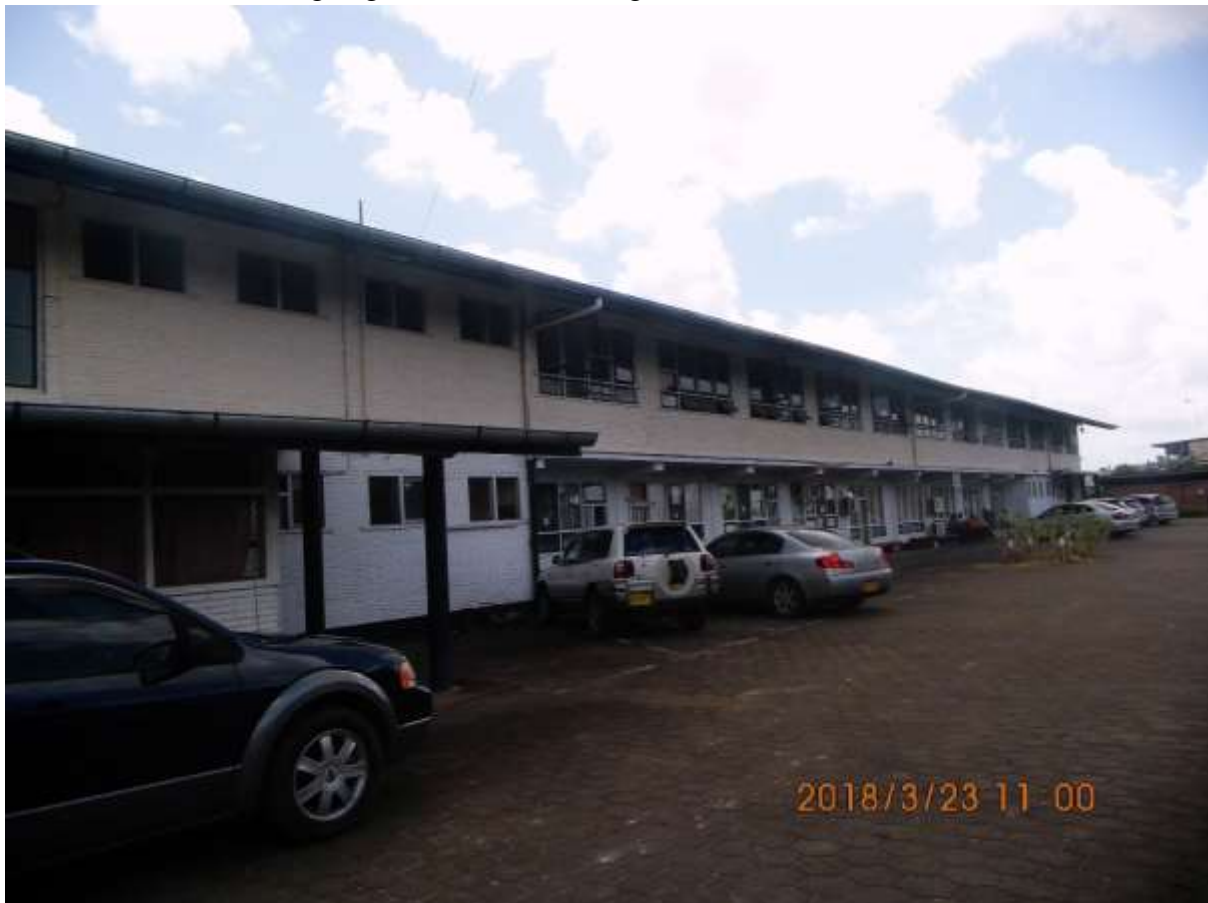
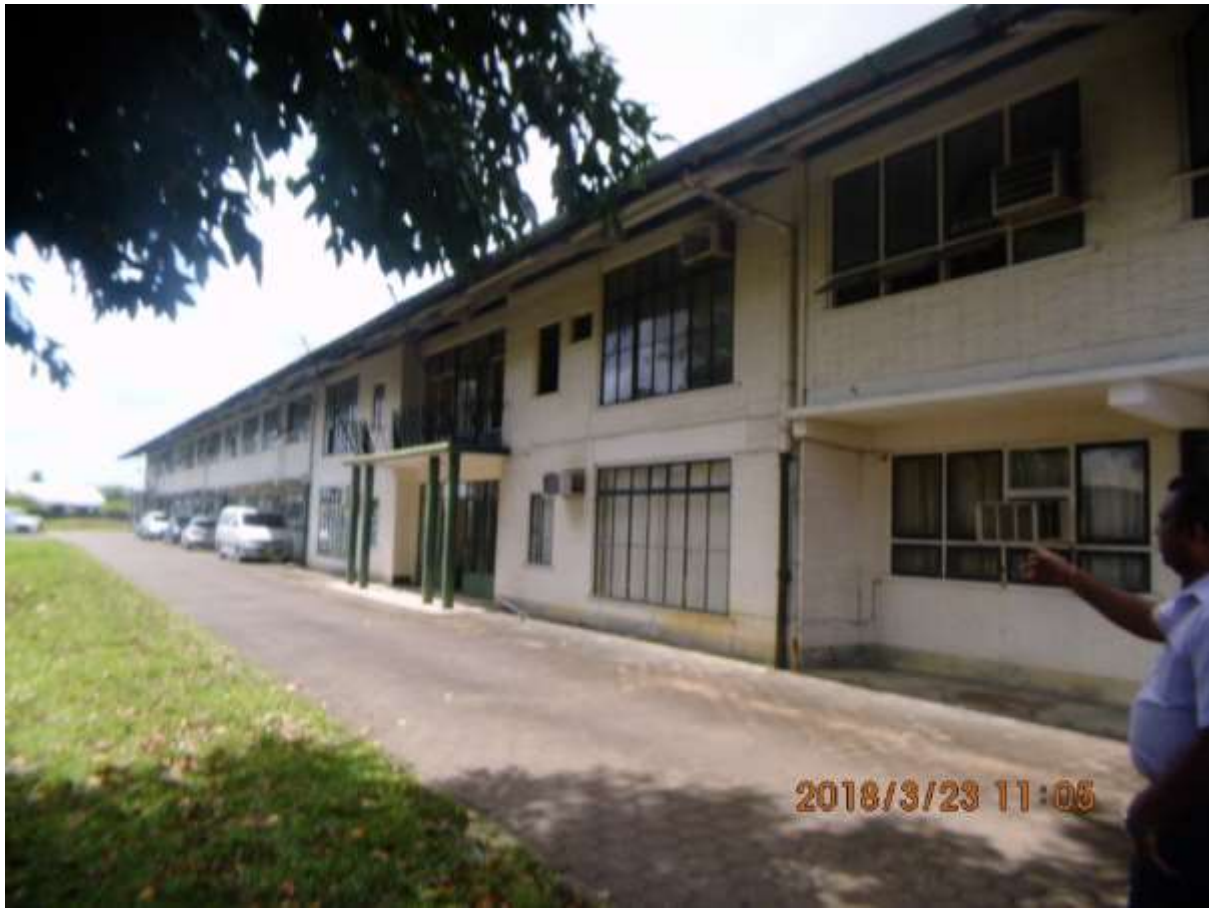
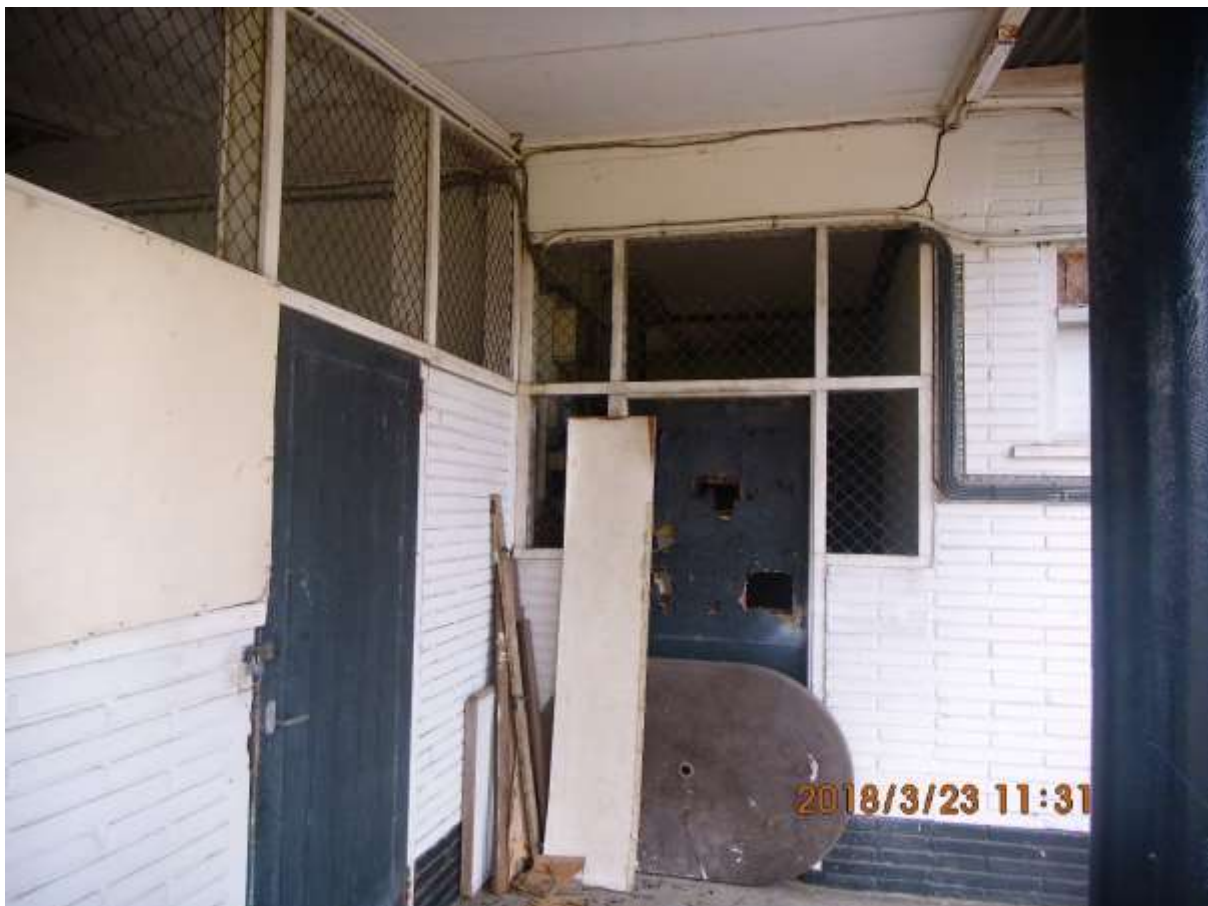
### A. Gevels/wanden

- Gevels: Bakstenen en 4" stenen
- Afbladdering van de verflaag op de gevels
- Geen scheuren in de muren
- Geen verzakkingen geconstateerd in het gebouw

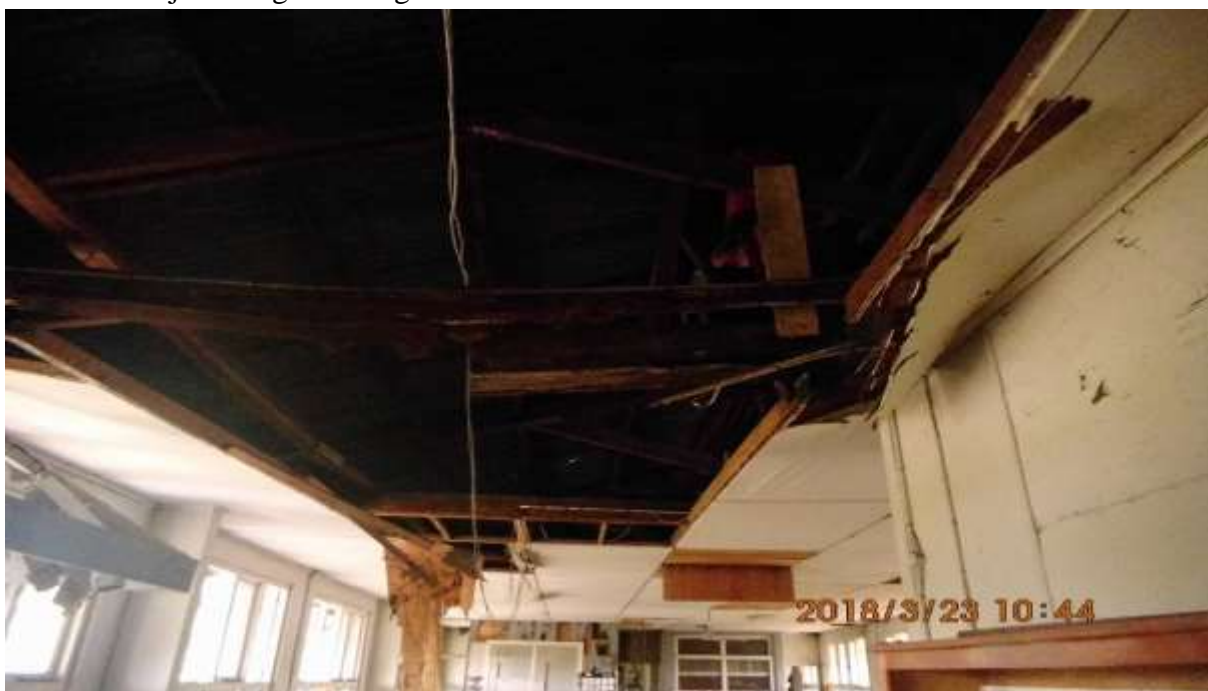
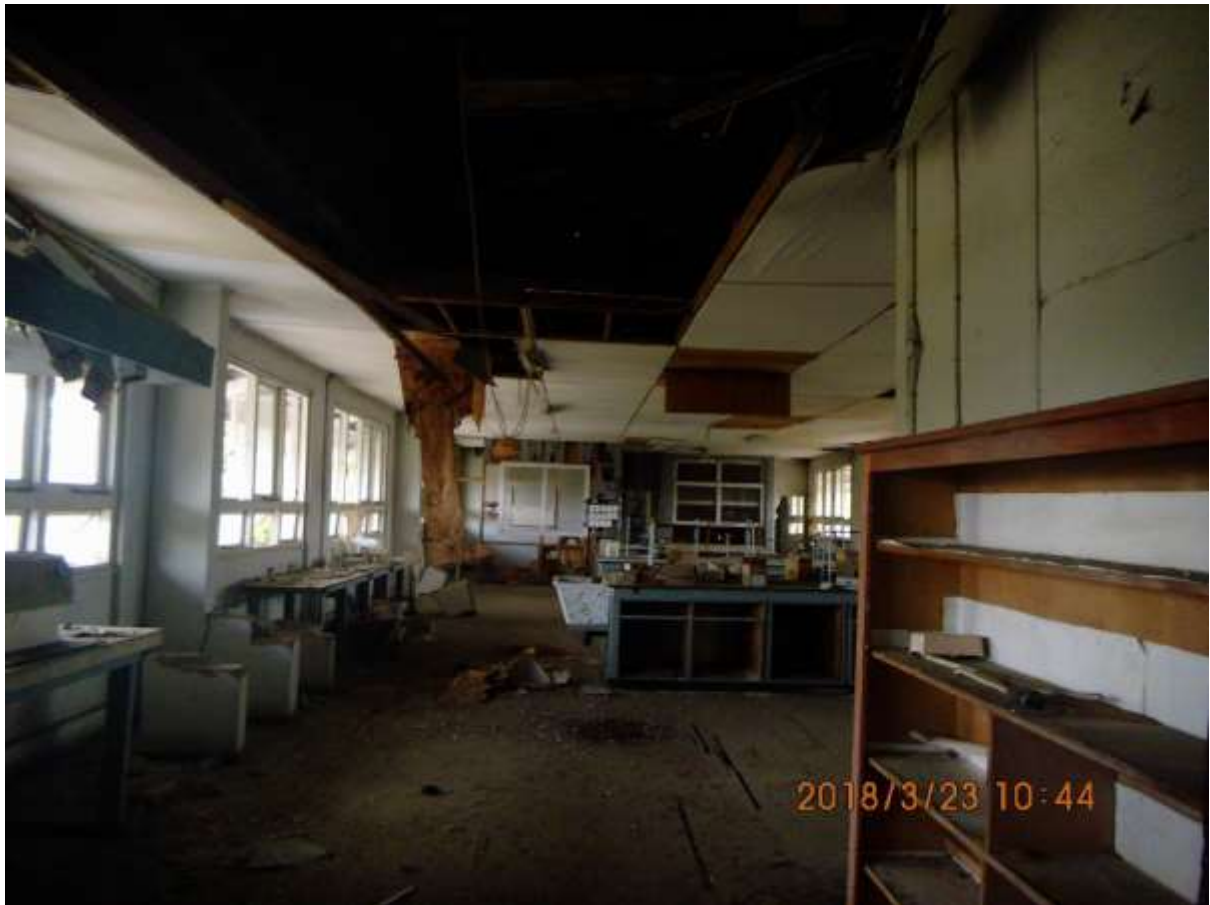
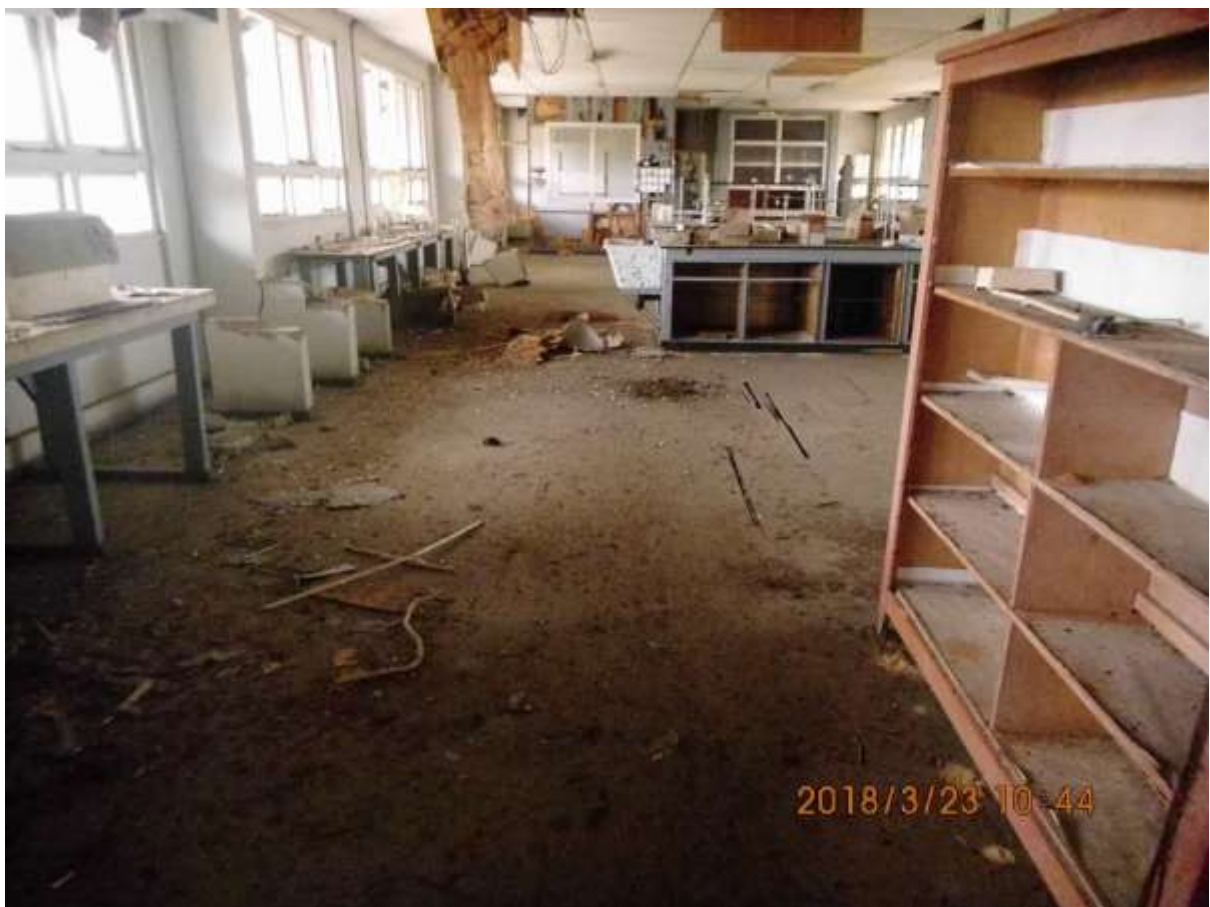
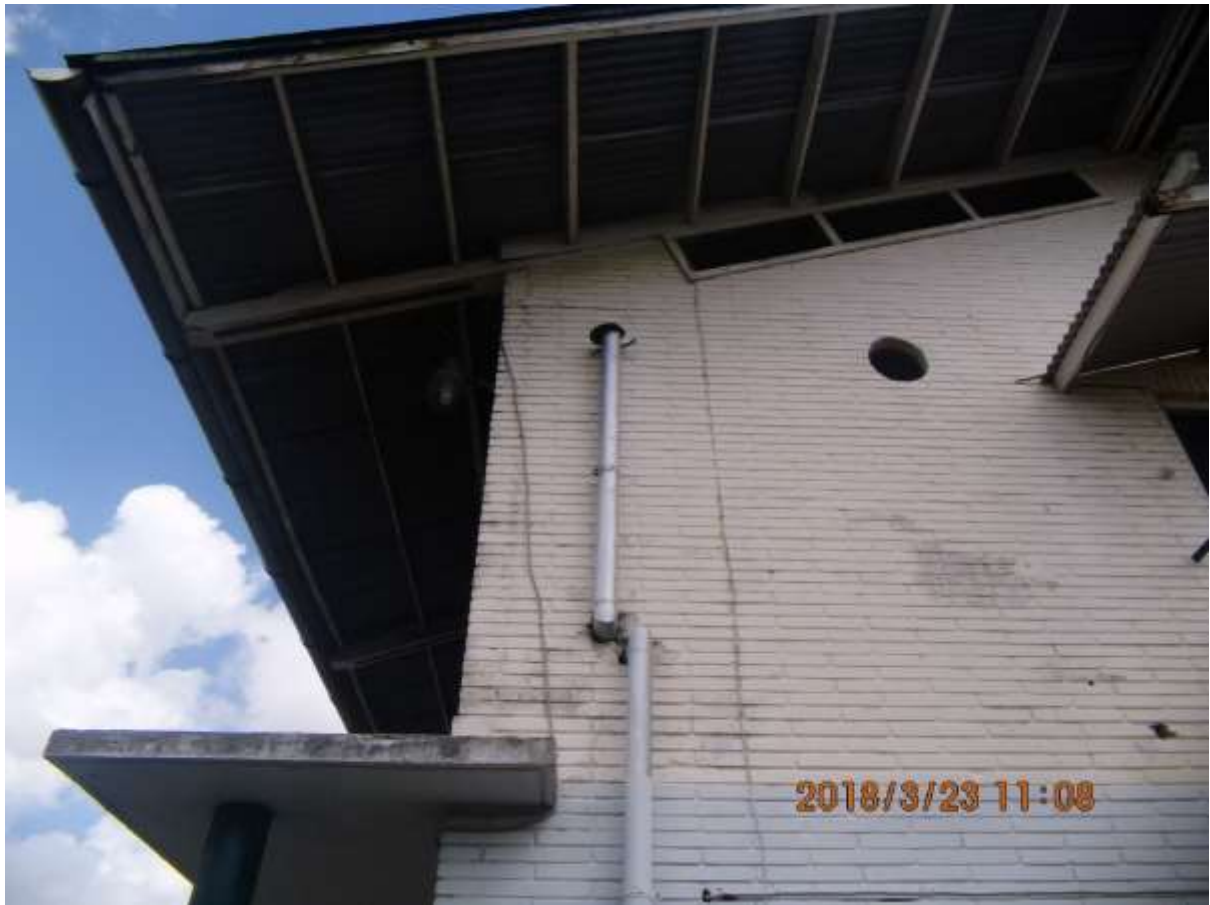
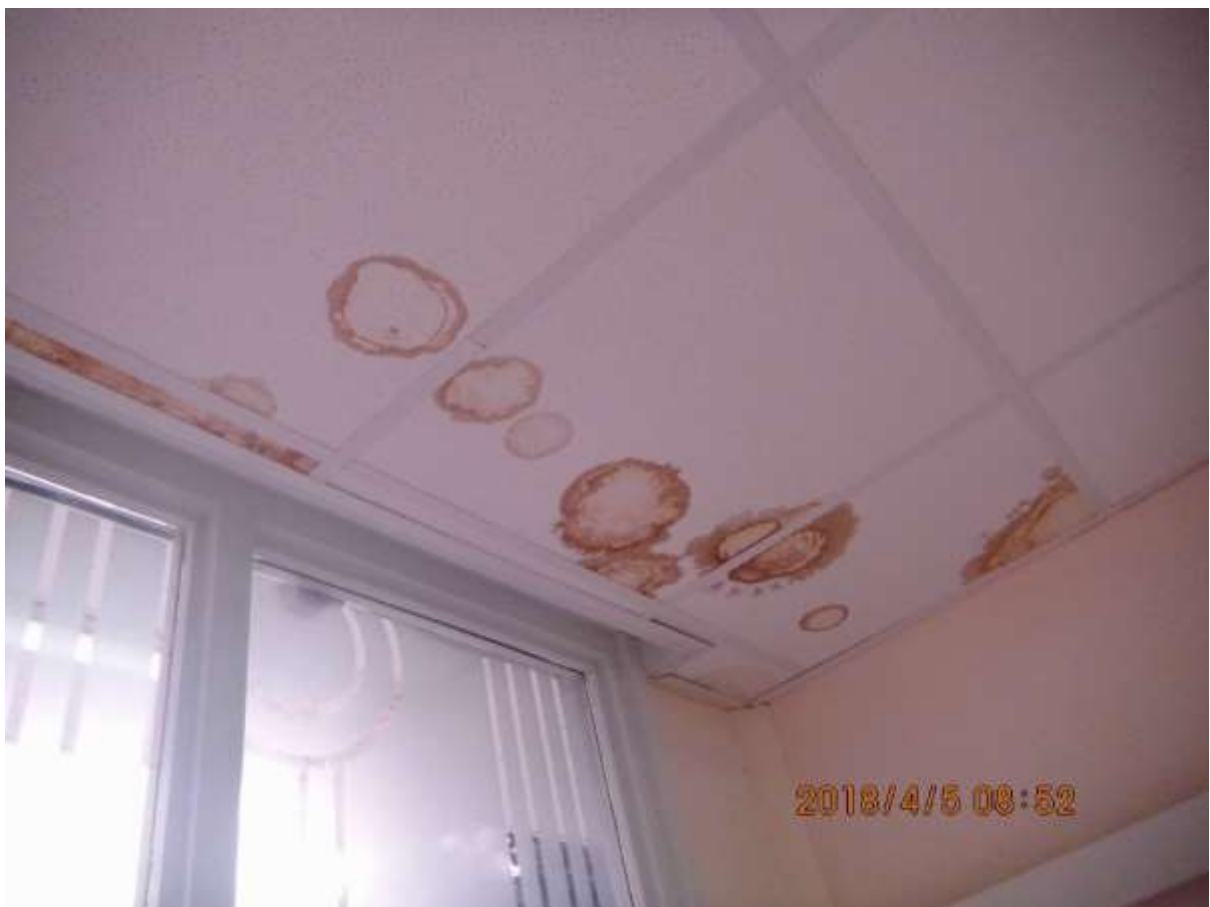
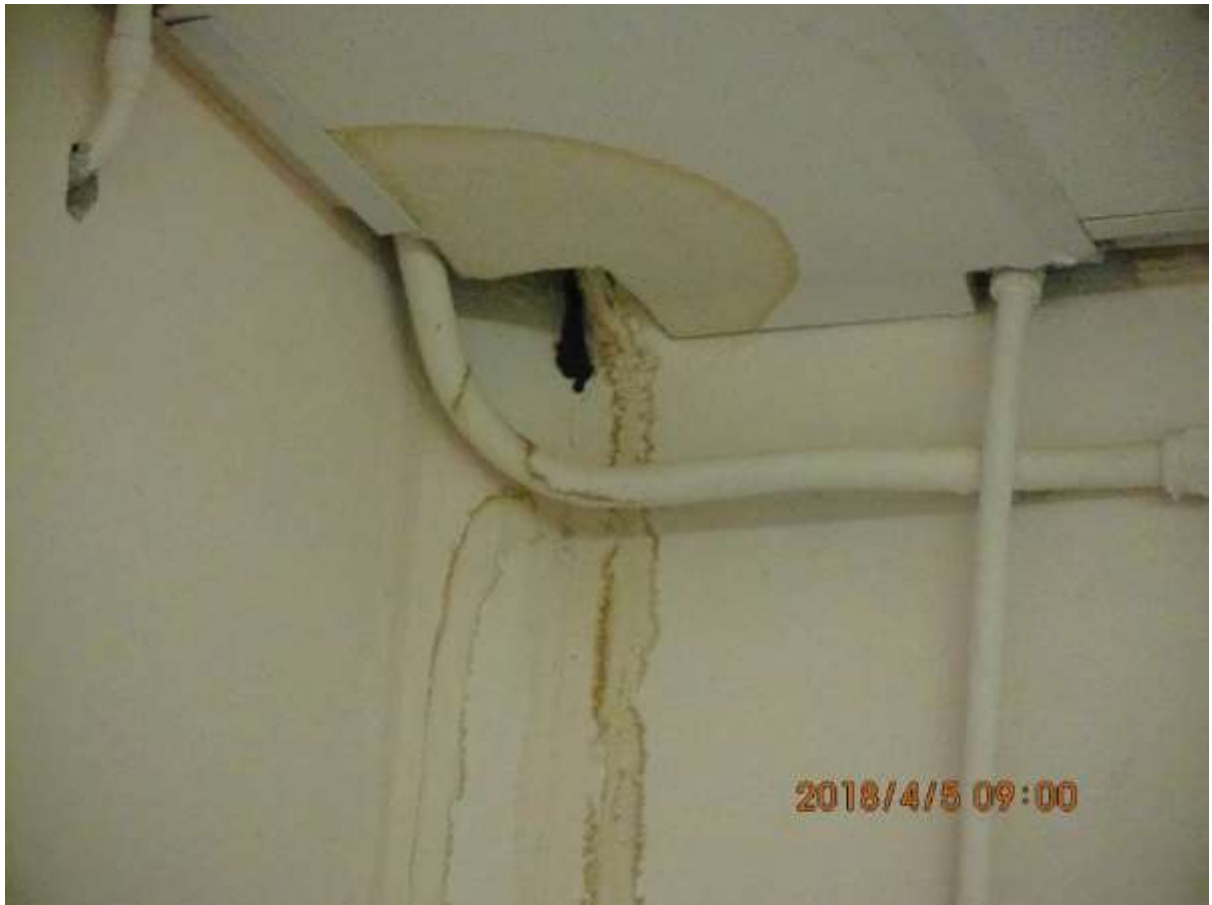
### **B. Plafond en dak**

- De plafondplaten zijn deels totaal verrot, hangen los en moeten gesloopt worden.
- De afvoerbuizen zijn verroest/verrot.
- De zinkplaten zijn verroest/verrot.
- Er zijn lekkages in de gebouwen.

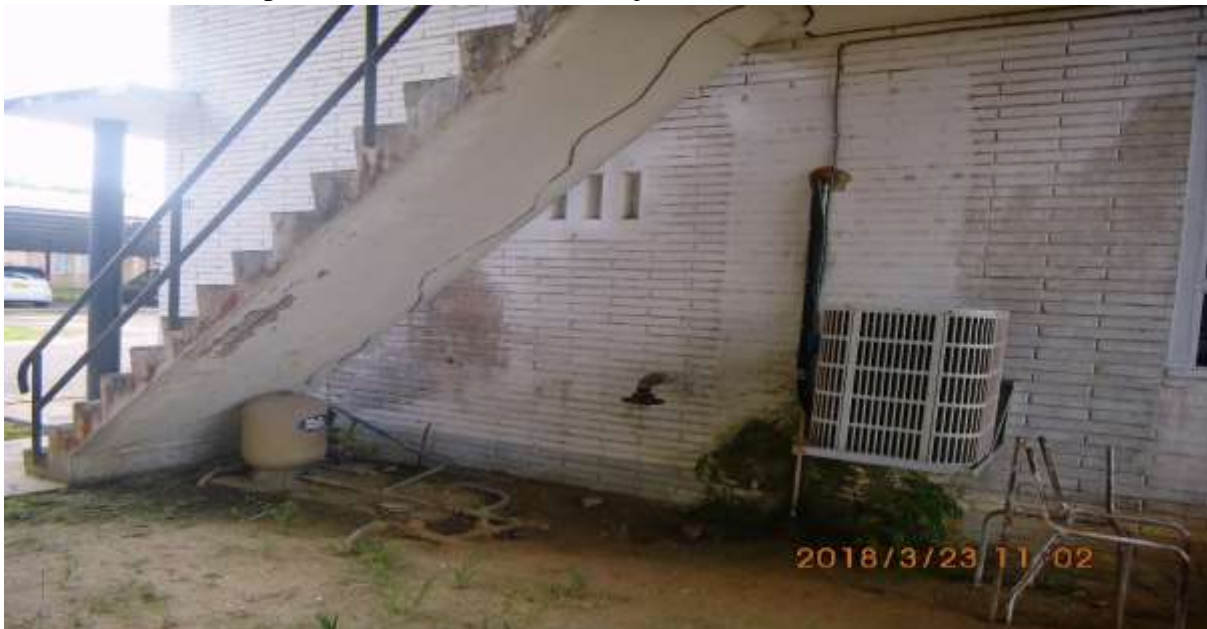
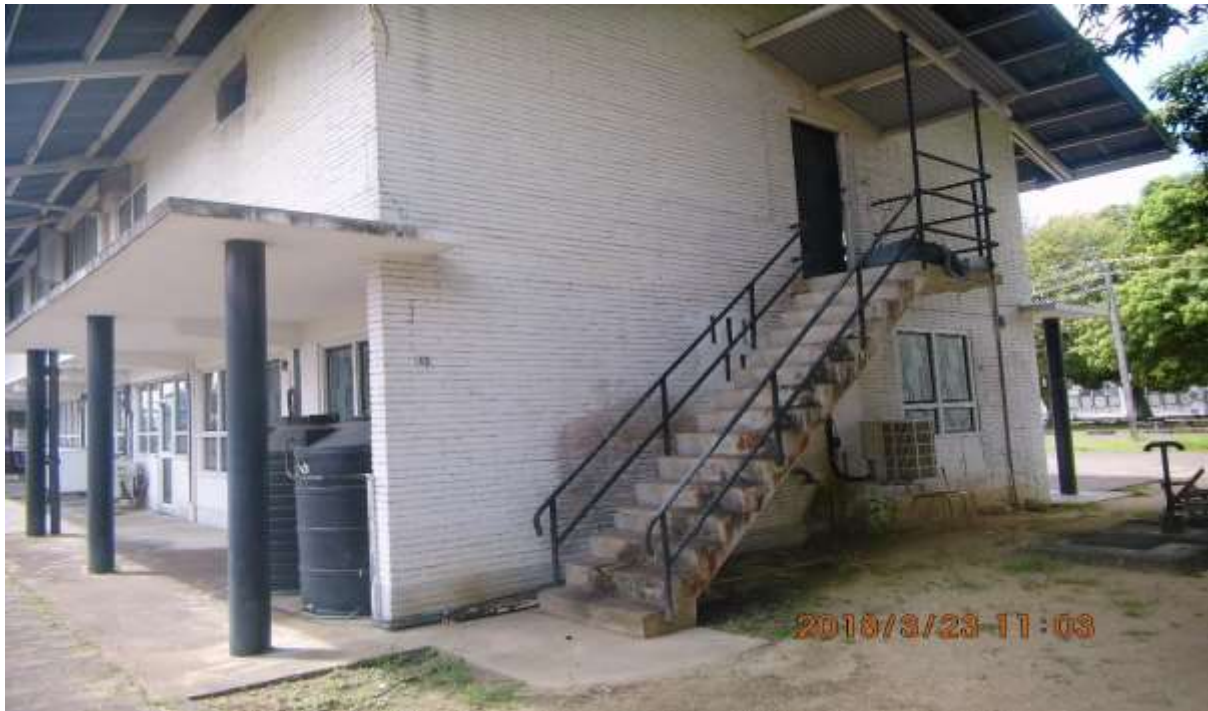
### **D. Trappen/ balustrades**

- De Buitentrap is in een slechte staat. Er zijn tekens van betonrot.
