TECHNICAL ANALYSIS  
FOR THE DESIGN AND CONSTRUCTION  
OF THE MOH AND CENTRAL SERVICES  
INFRASTRUCTURE

Fritz Tjong Ayong, MSc. Arch.

Paramaribo, June 2018

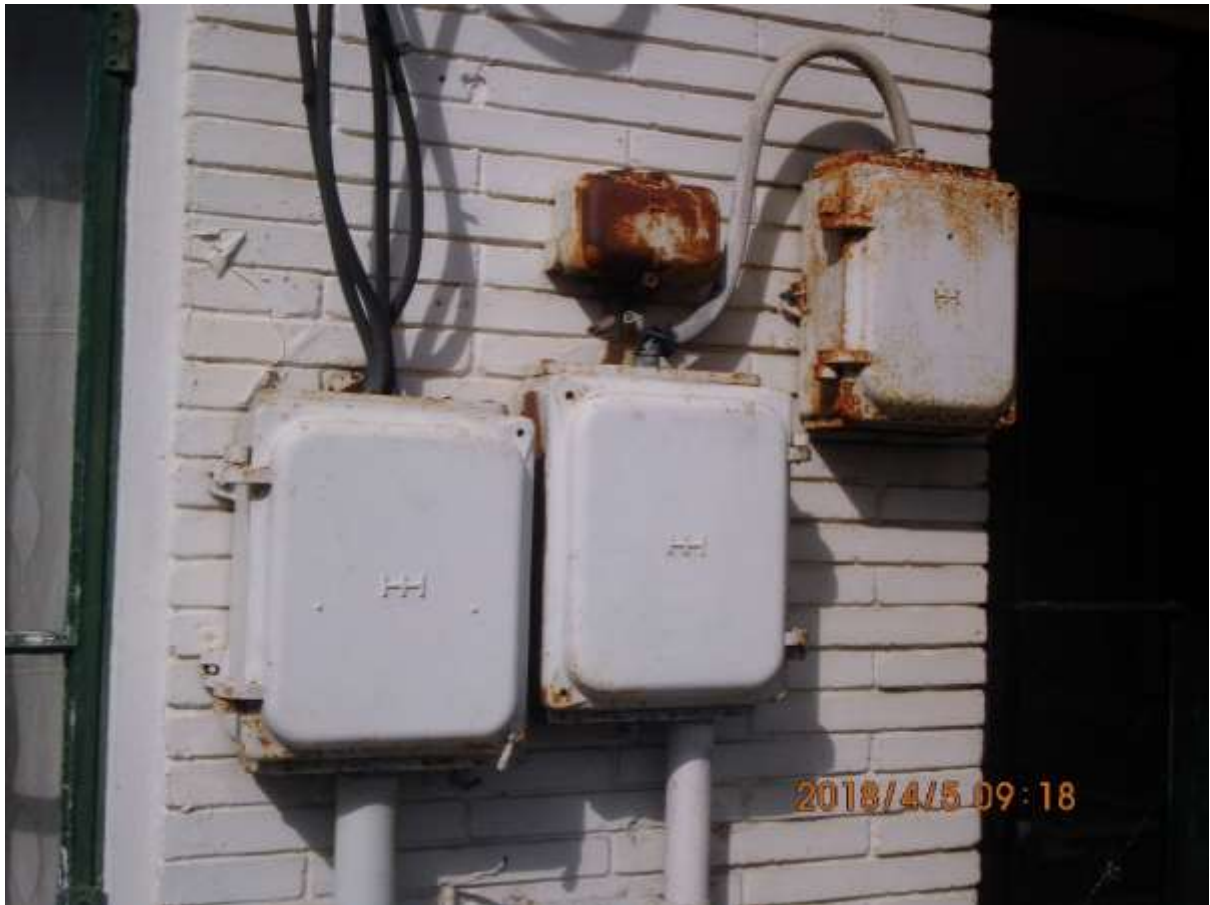
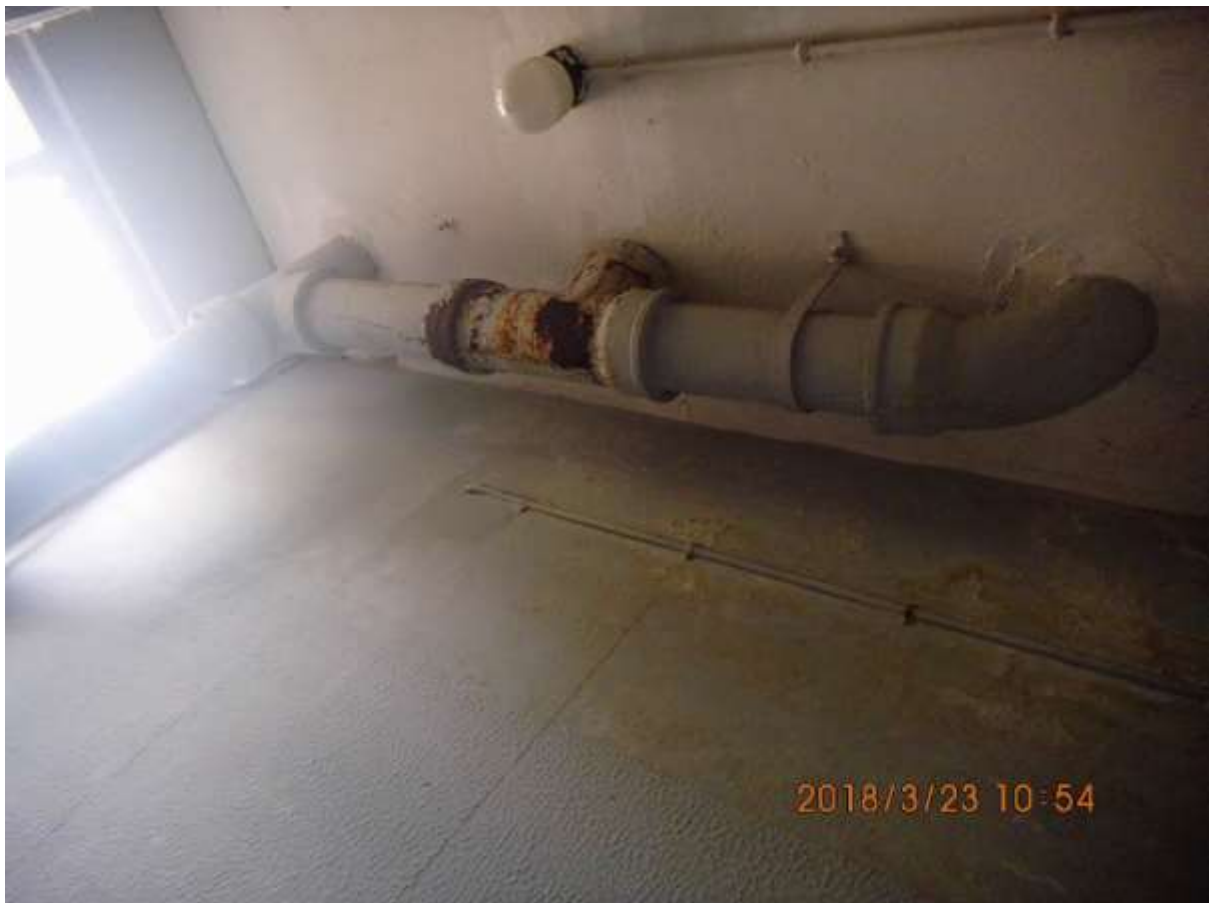
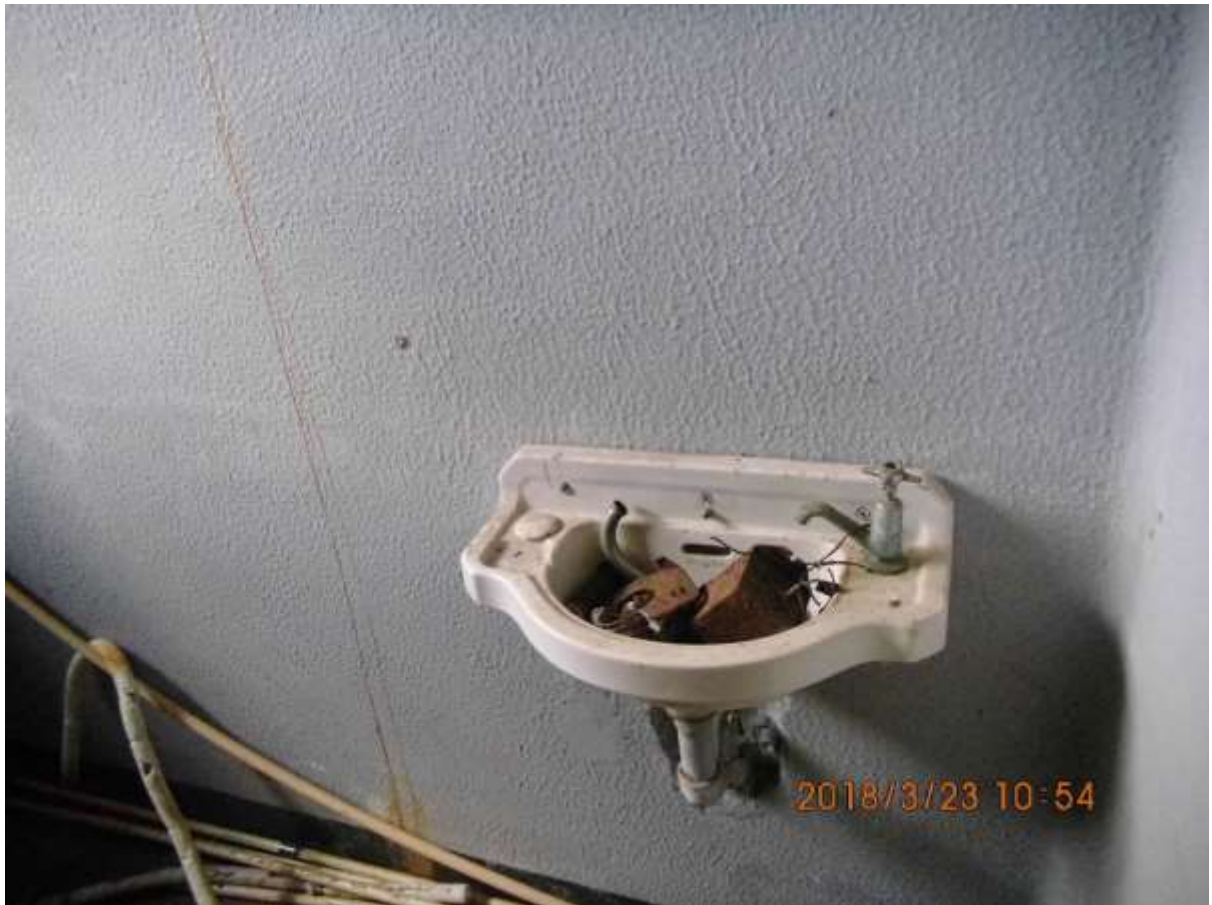
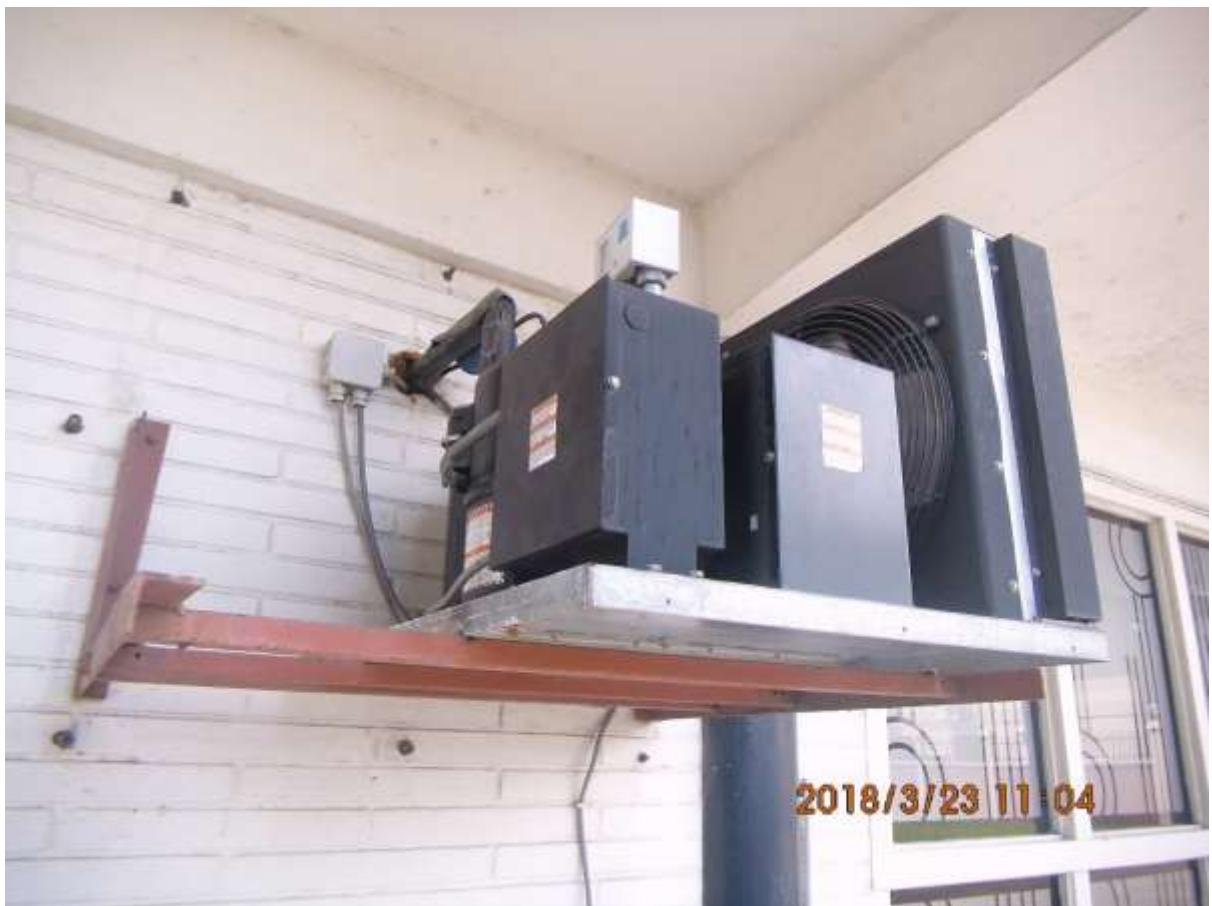
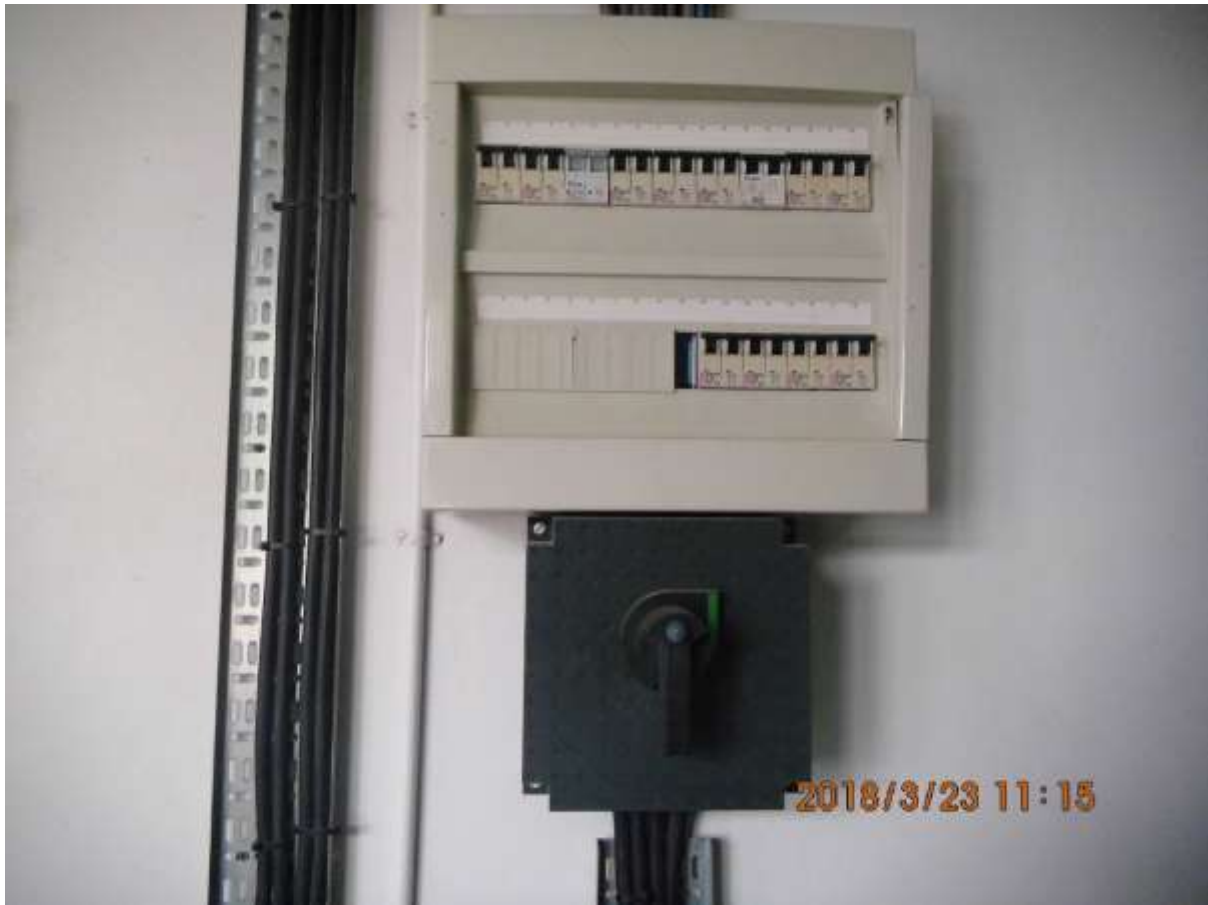
### **E. Installaties**

- Zekeringkasten zijn oud en van het oud systeem. Enkele schakel- en beveiligingskasten zijn wel vernieuwd/nieuw systeem. De subkasten zijn oud en van het oud systeem.
- Bekabelingen zijn al verouderd.

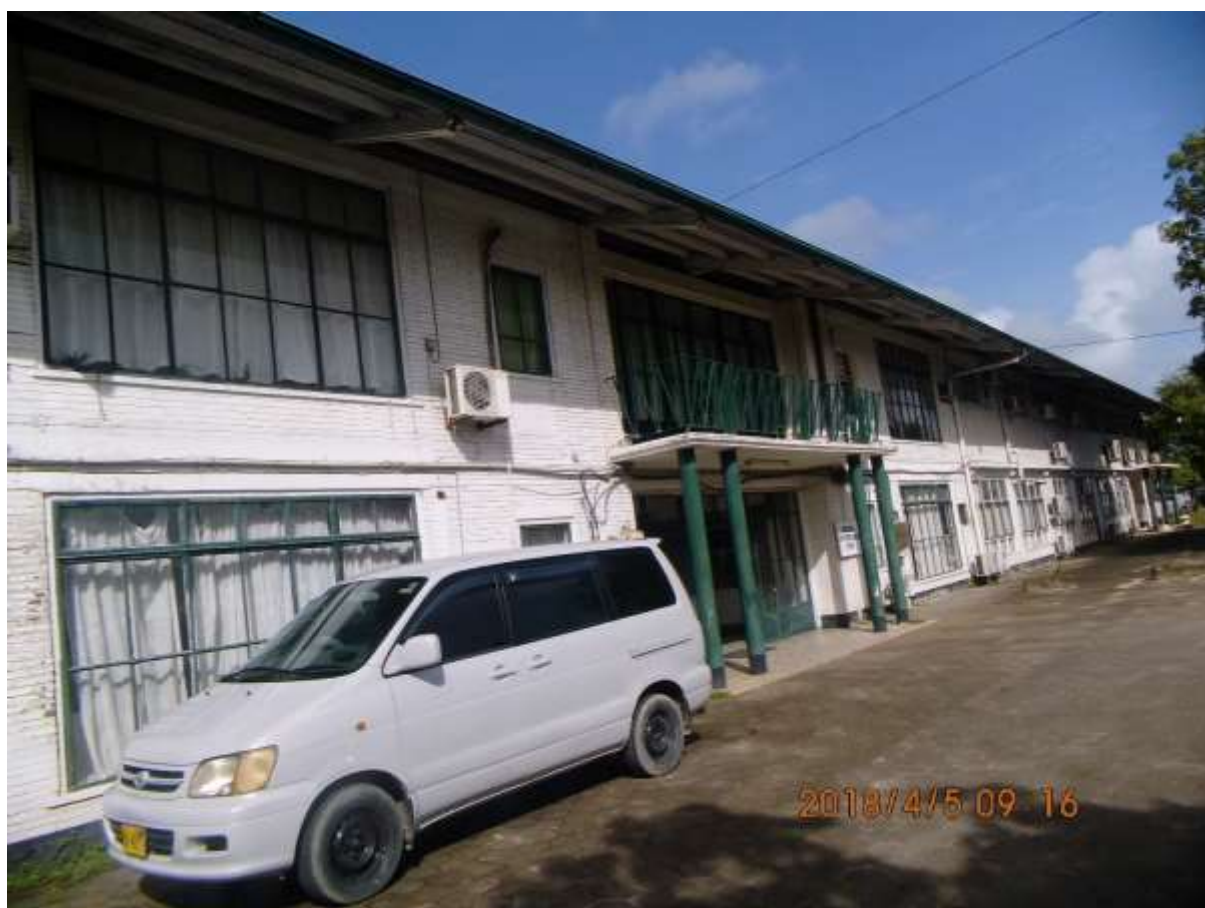
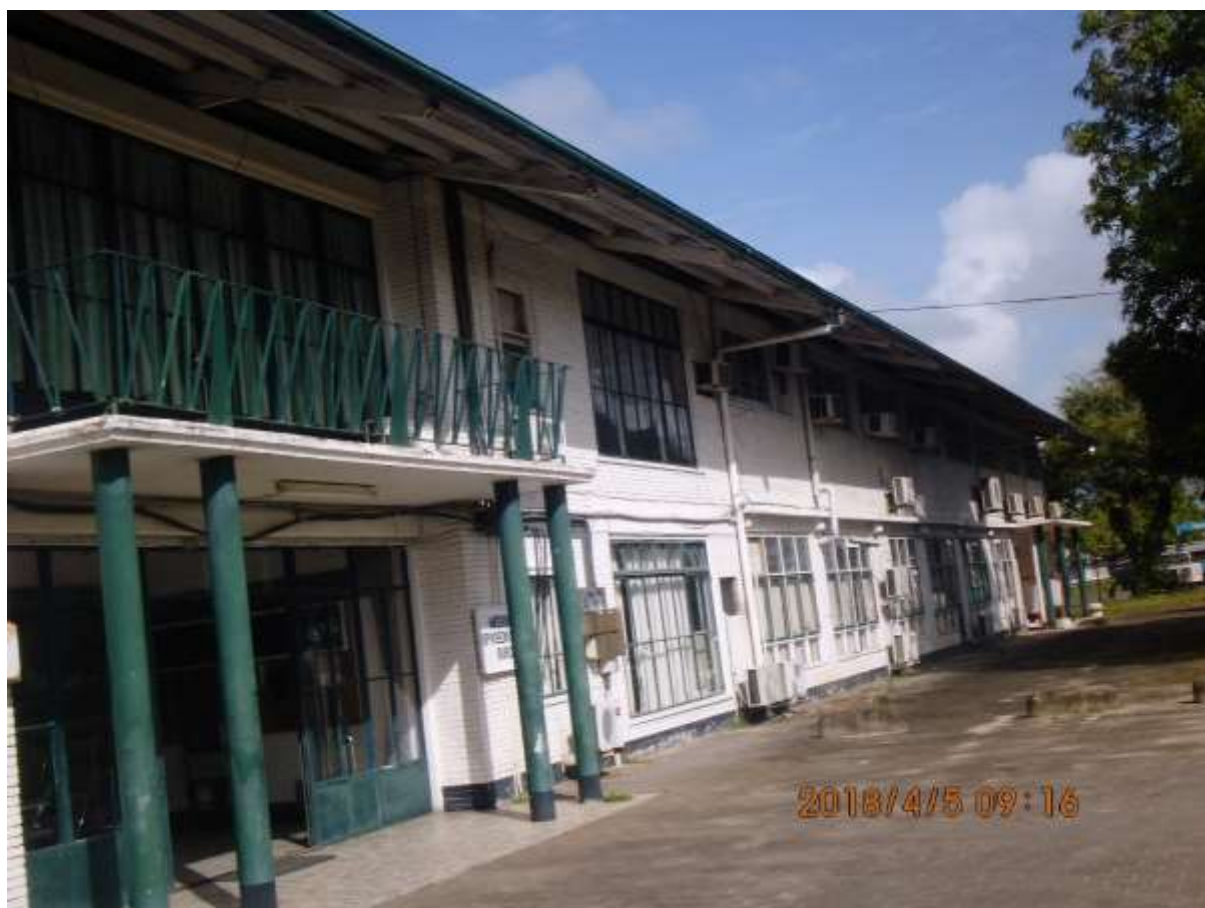
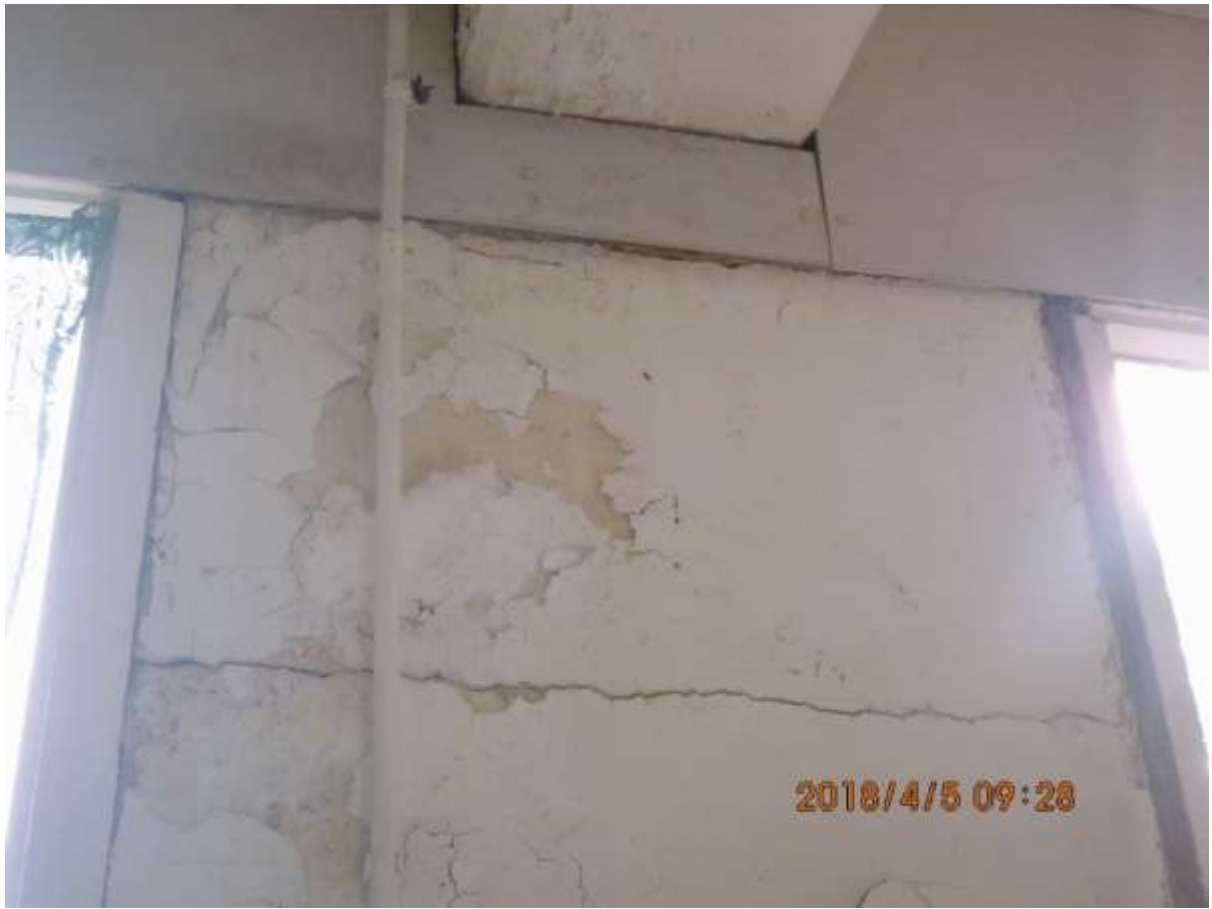
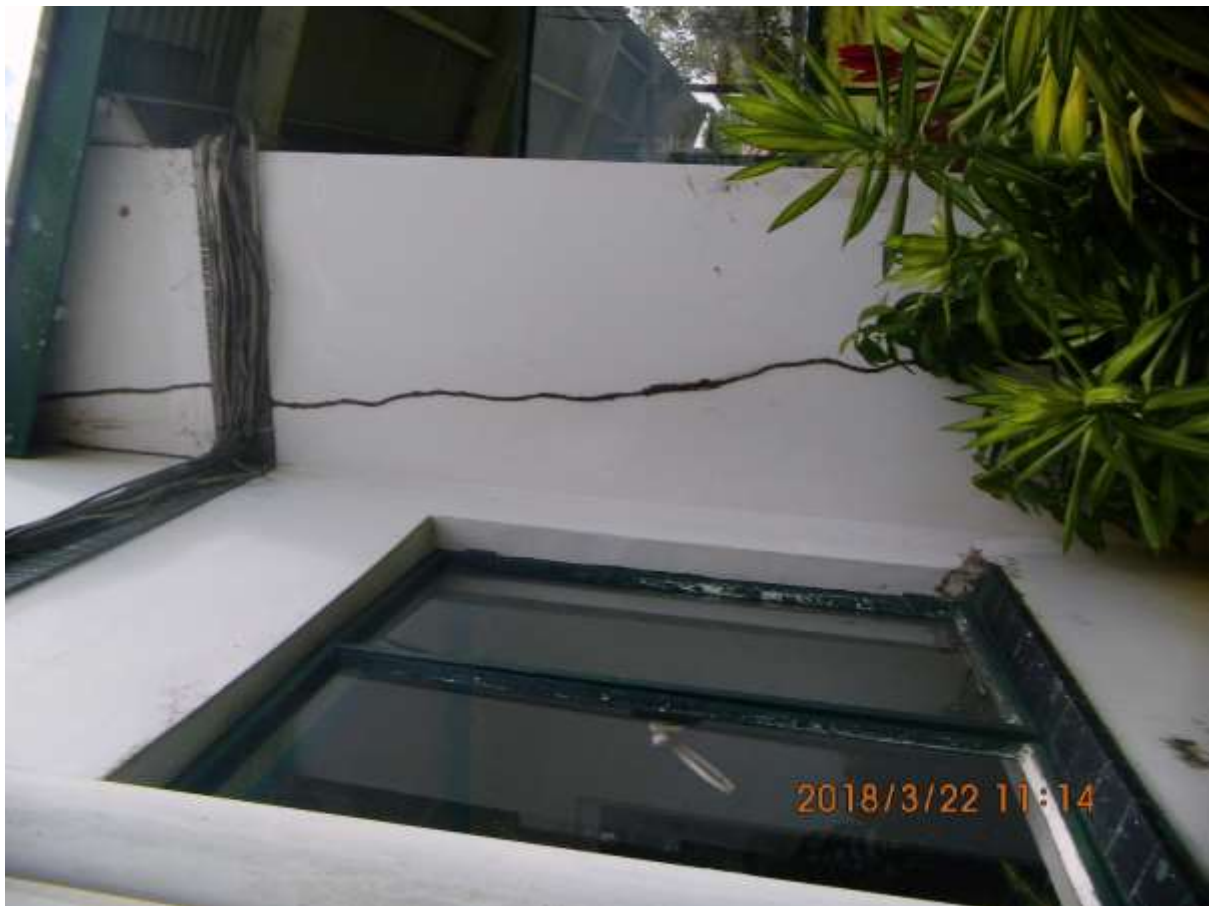
### A. Gevels/wanden

- Gevels: Bakstenen en 4" stenen
- Afbladderend van de verflaag op de gevels
- Scheuren in de muren op enkele locaties
- Geen verzakkingen geconstateerd in het gebouw

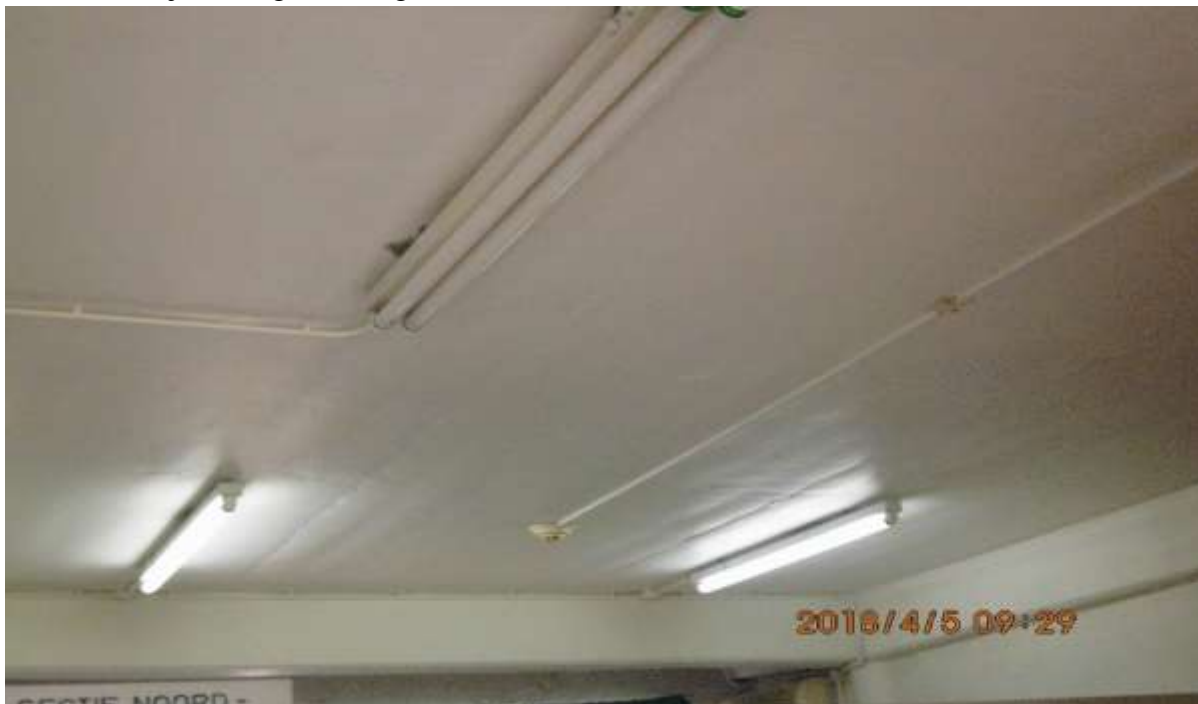
## **B. Plafond en dak**

- De plafondplaten zijn deels totaal verrot, hangen los en moeten gesloopt worden.
- De afvoerbuizen zijn verroest/verrot.
- De zinkplaten zijn verroest/verrot.
- Er zijn lekkages in de gebouwen.

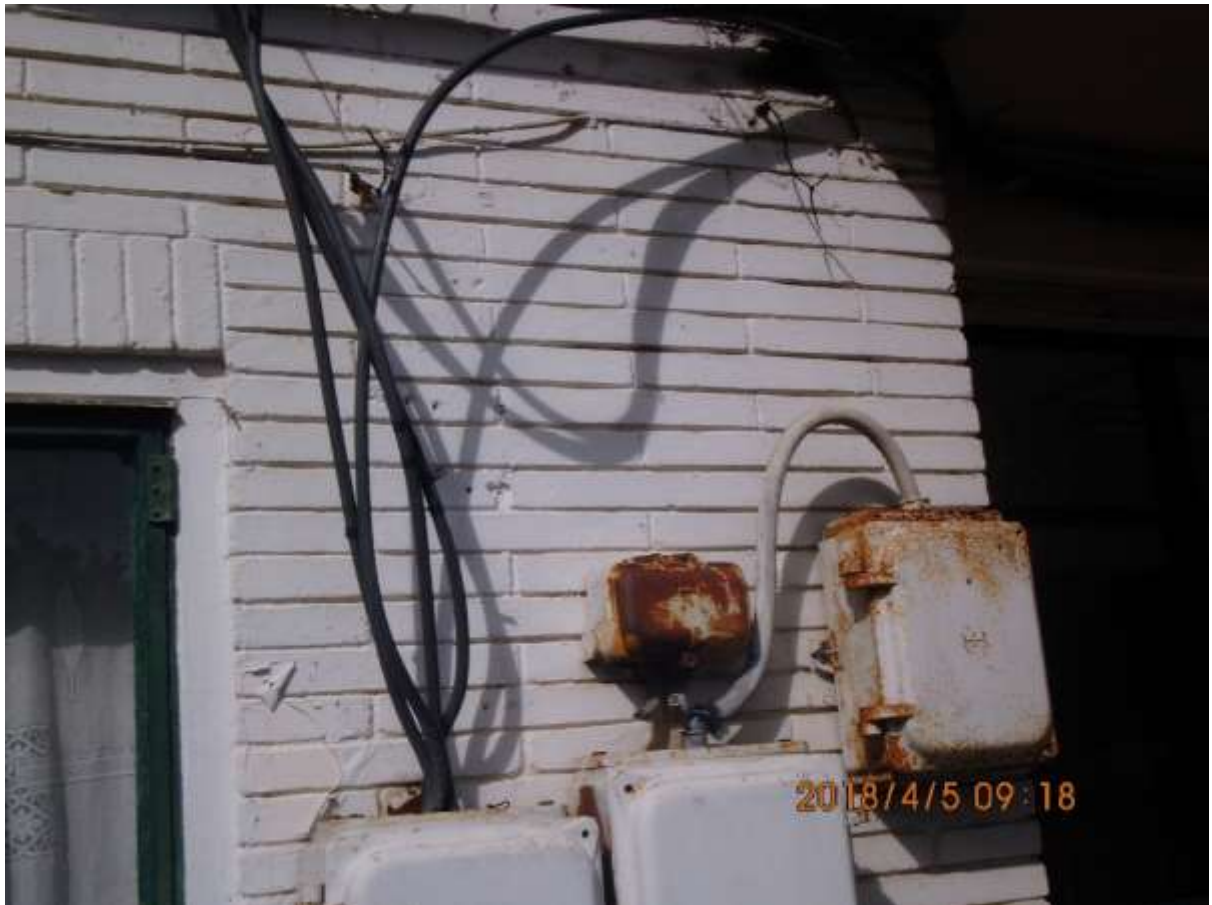
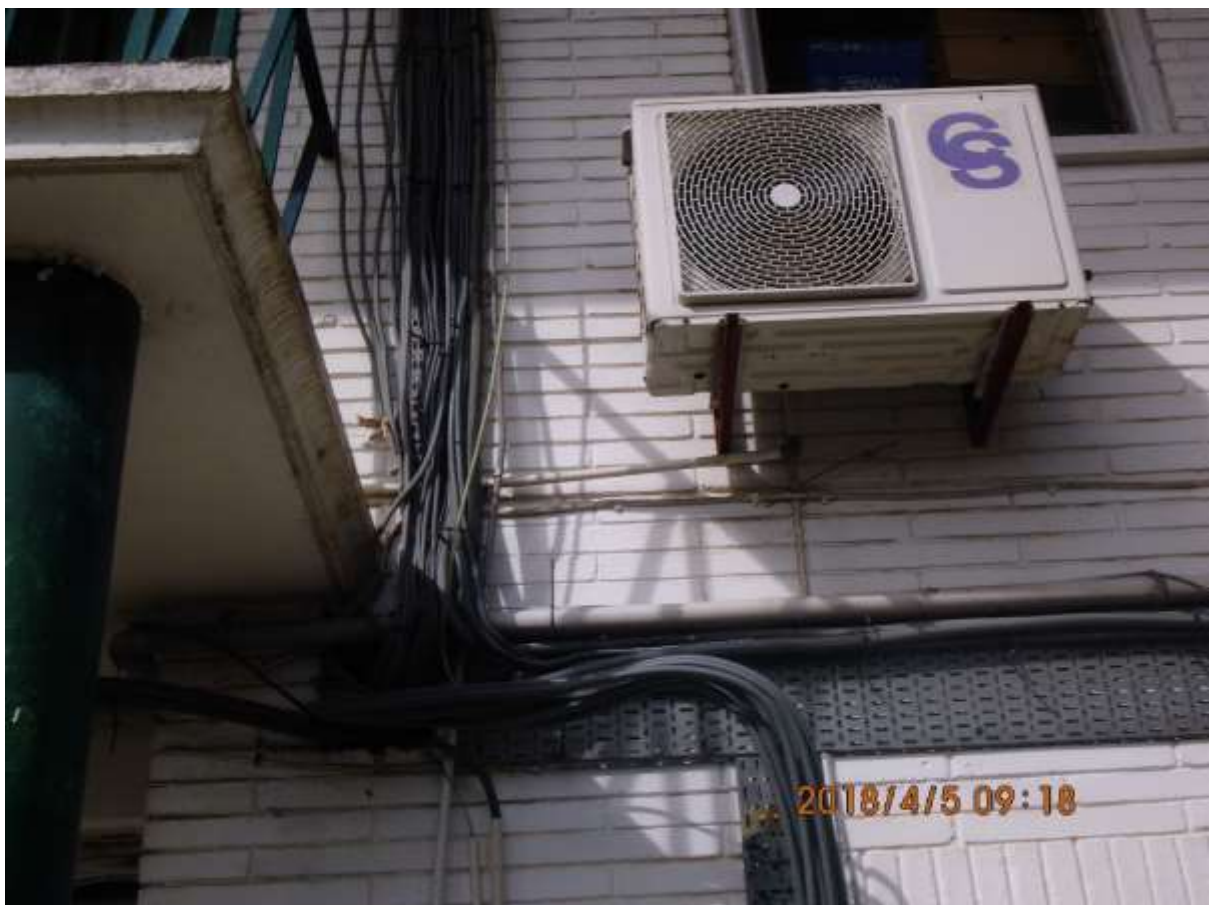
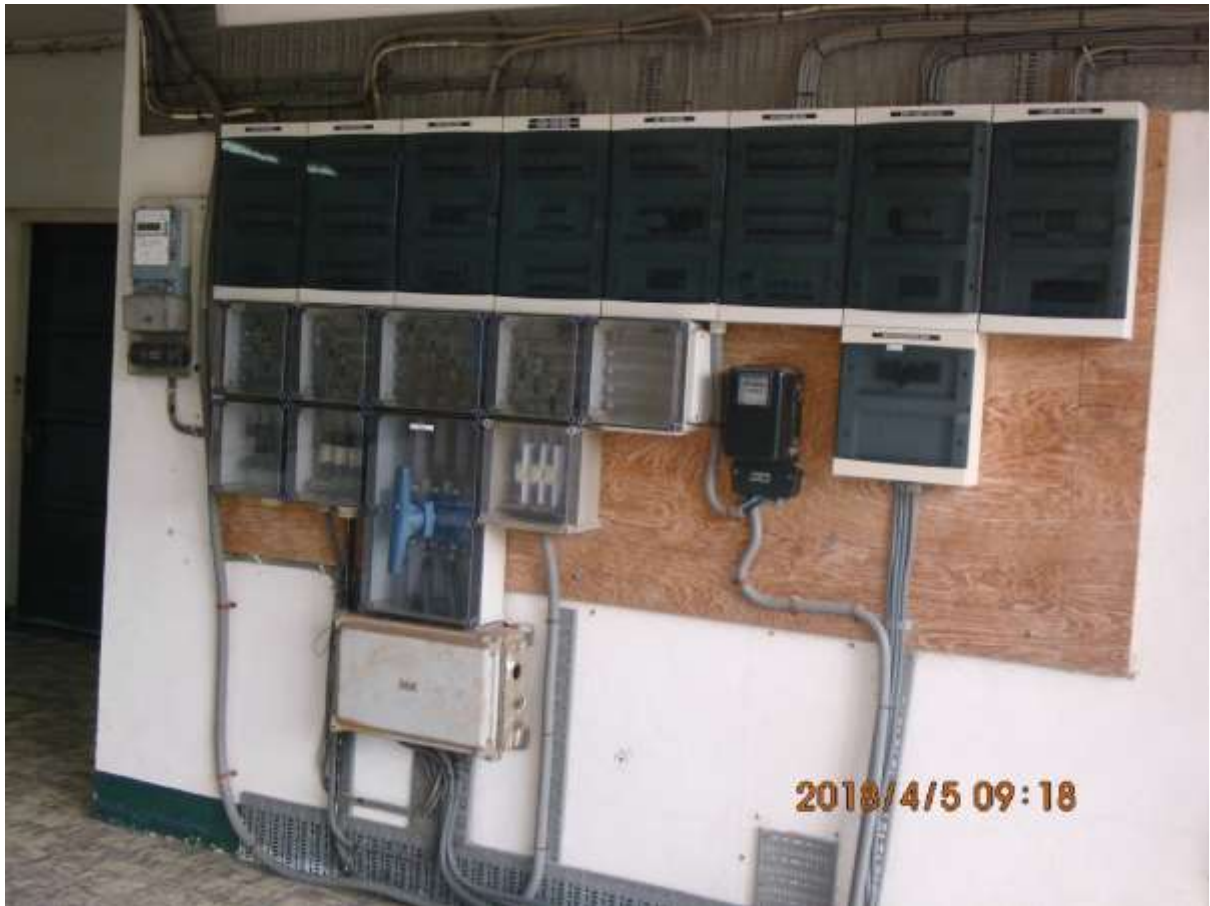
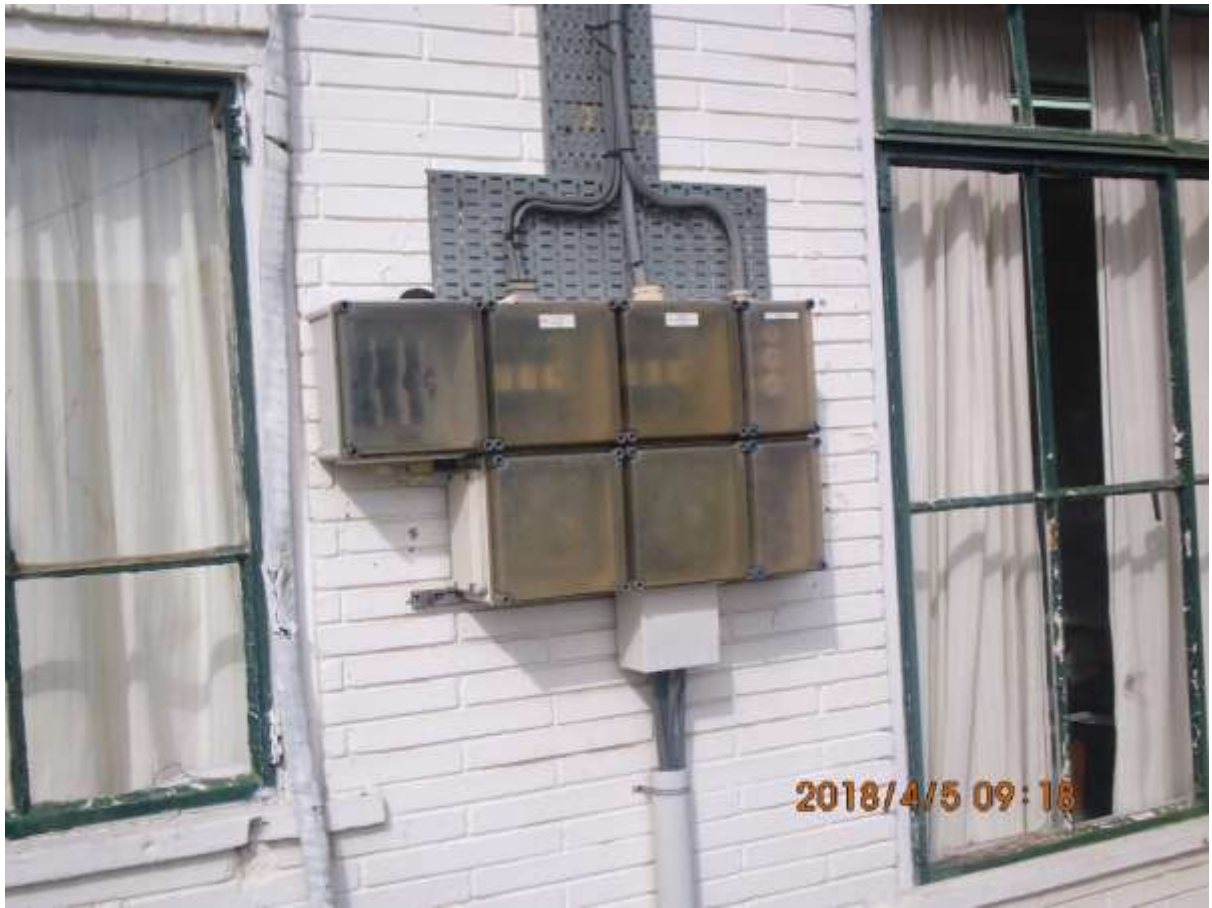
- Zekeringkasten zijn oud en van het oud systeem. Enkele schakel- en beveiligingskasten zijn wel vernieuwd/nieuw systeem. De subkasten zijn oud en van het oud systeem.
- Bekabelingen zijn al verouderd.

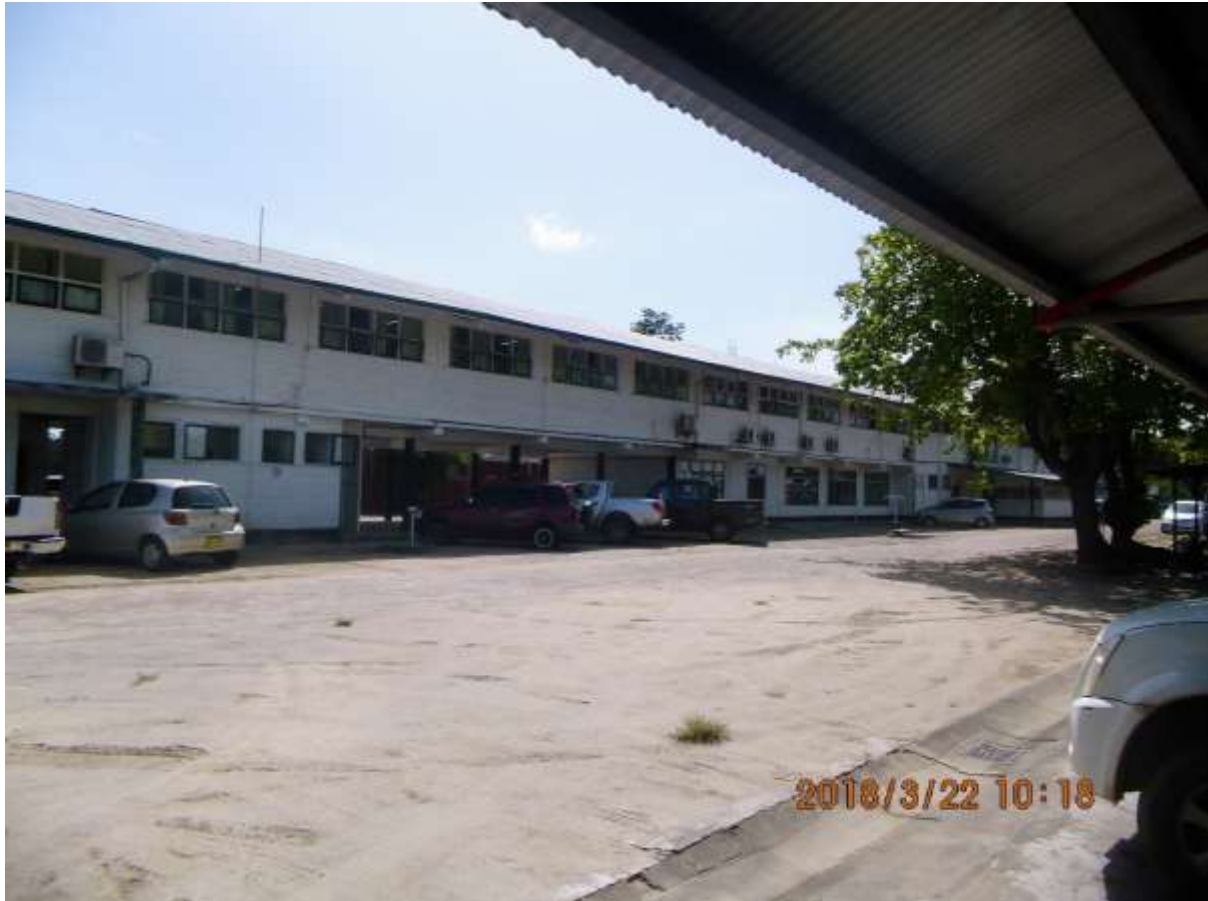
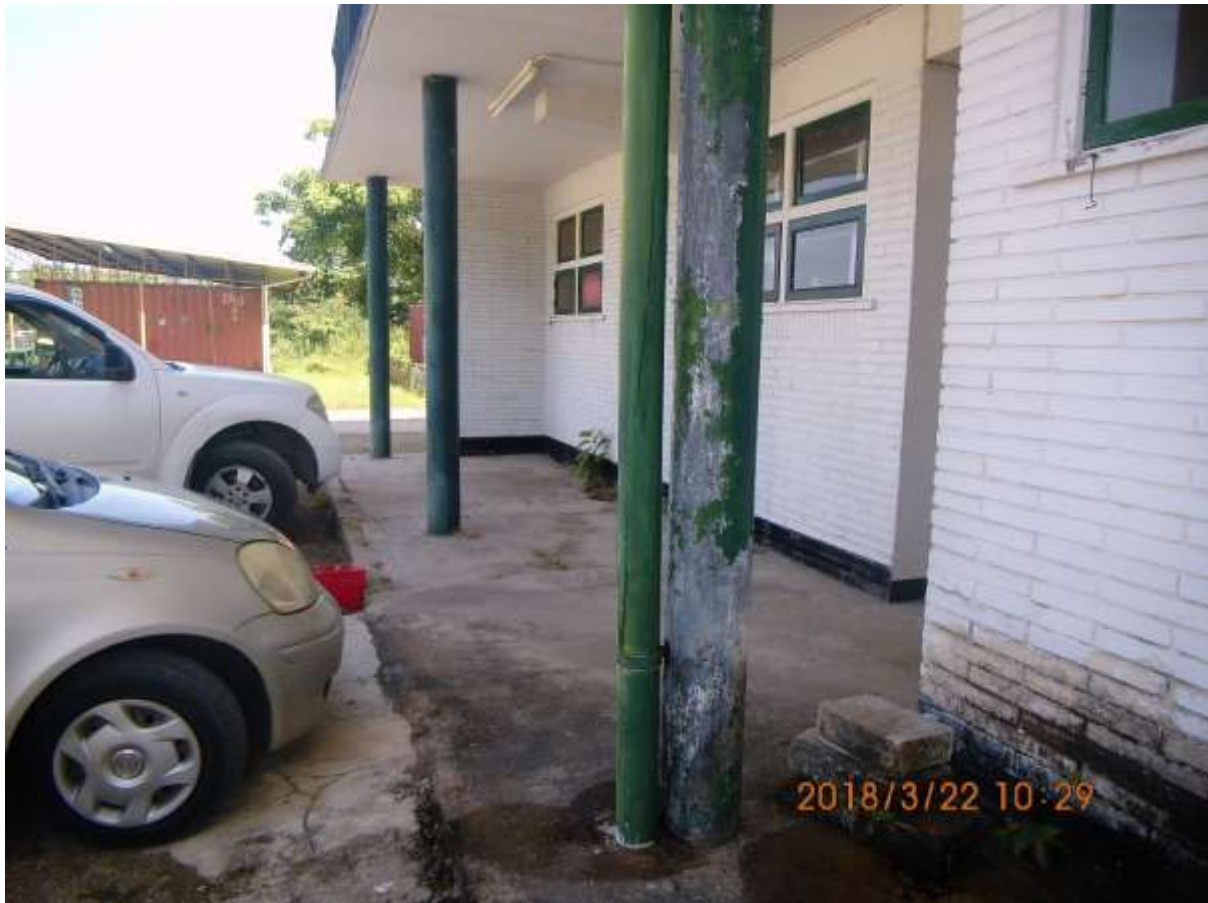
#### **A. Gevels/wanden**

- Gevels: Bakstenen en 4" stenen
- Afbladderende verf op de gevels
- Geen scheuren in de muren
- Geen verzakkingen geconstateerd in het gebouw
