GEOLOGIC HAZARD ASSESSMENT AND RESERVOIR SITE CHARACTERIZATION – REPORTS I & II

August 31, 2018

**PROJECT: GEOLOGICAL ASSESSMENT TO SUPPORT THE PREPARATION OF
THE OPERATION HL-L1135, HAÏTI**

PREPARED FOR:
INTER-AMERICAN DEVELOPMENT BANK

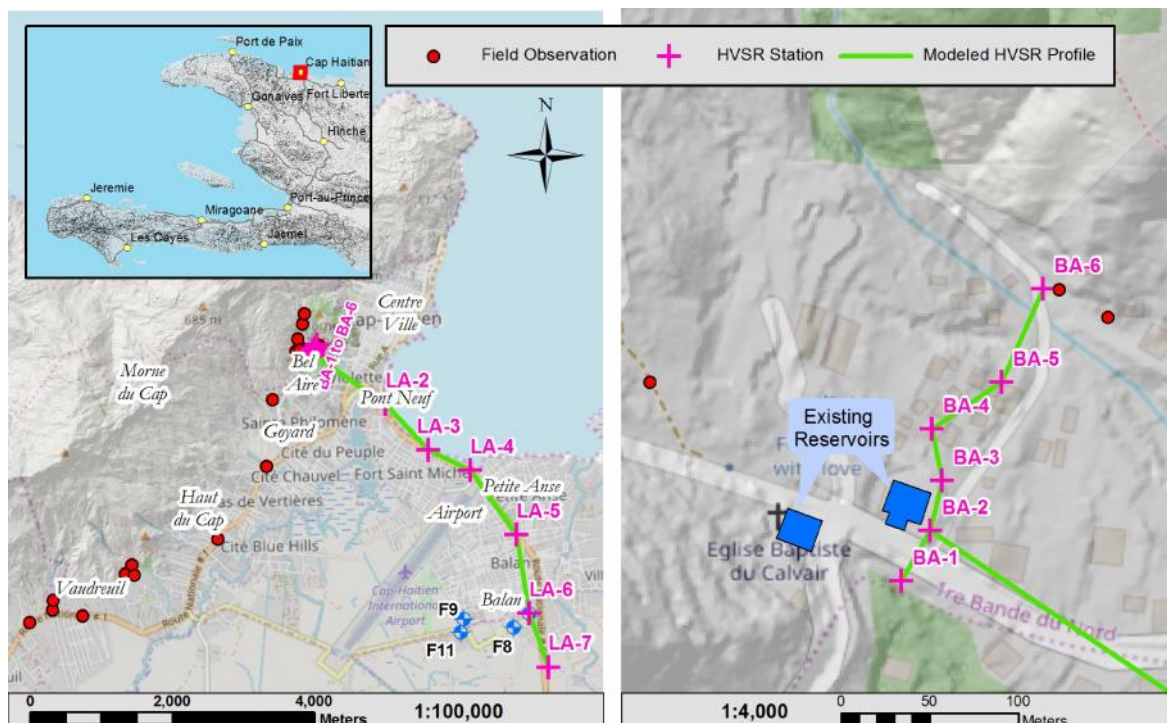
FIGURE 1 – LOCATION MAP OF FIELD OBSERVATIONS AND HVSr GEOPHYSICAL STATIONS

A brief field program was conducted on June 8-9 and July 24-25, 2018 in order to document field observations in key areas, and to assist in filling data gaps to support the hazard assessment. Figure 1 shows the locations of the field reconnaissance activities and where seismic geophysical data collection occurred. It is important to note that no geotechnical borings or laboratory materials testing were performed or acquired as a part of this study. The field program included:

- Geophysical survey along the primary supply line from the F10 supply well to the Bel-Aire reservoirs. A total of seven HVSr stations were completed and modeled to infer sediment thicknesses and characteristics.

- Observation of key locations where mapped hazard zones intersect the supply or main distribution lines. Locations included debris-flow and drainage crossings of the main distribution line along National Route 1, the supply line crossing of Riviere Haut du Cap, and the area uphill from the Bel-Aire reservoirs.

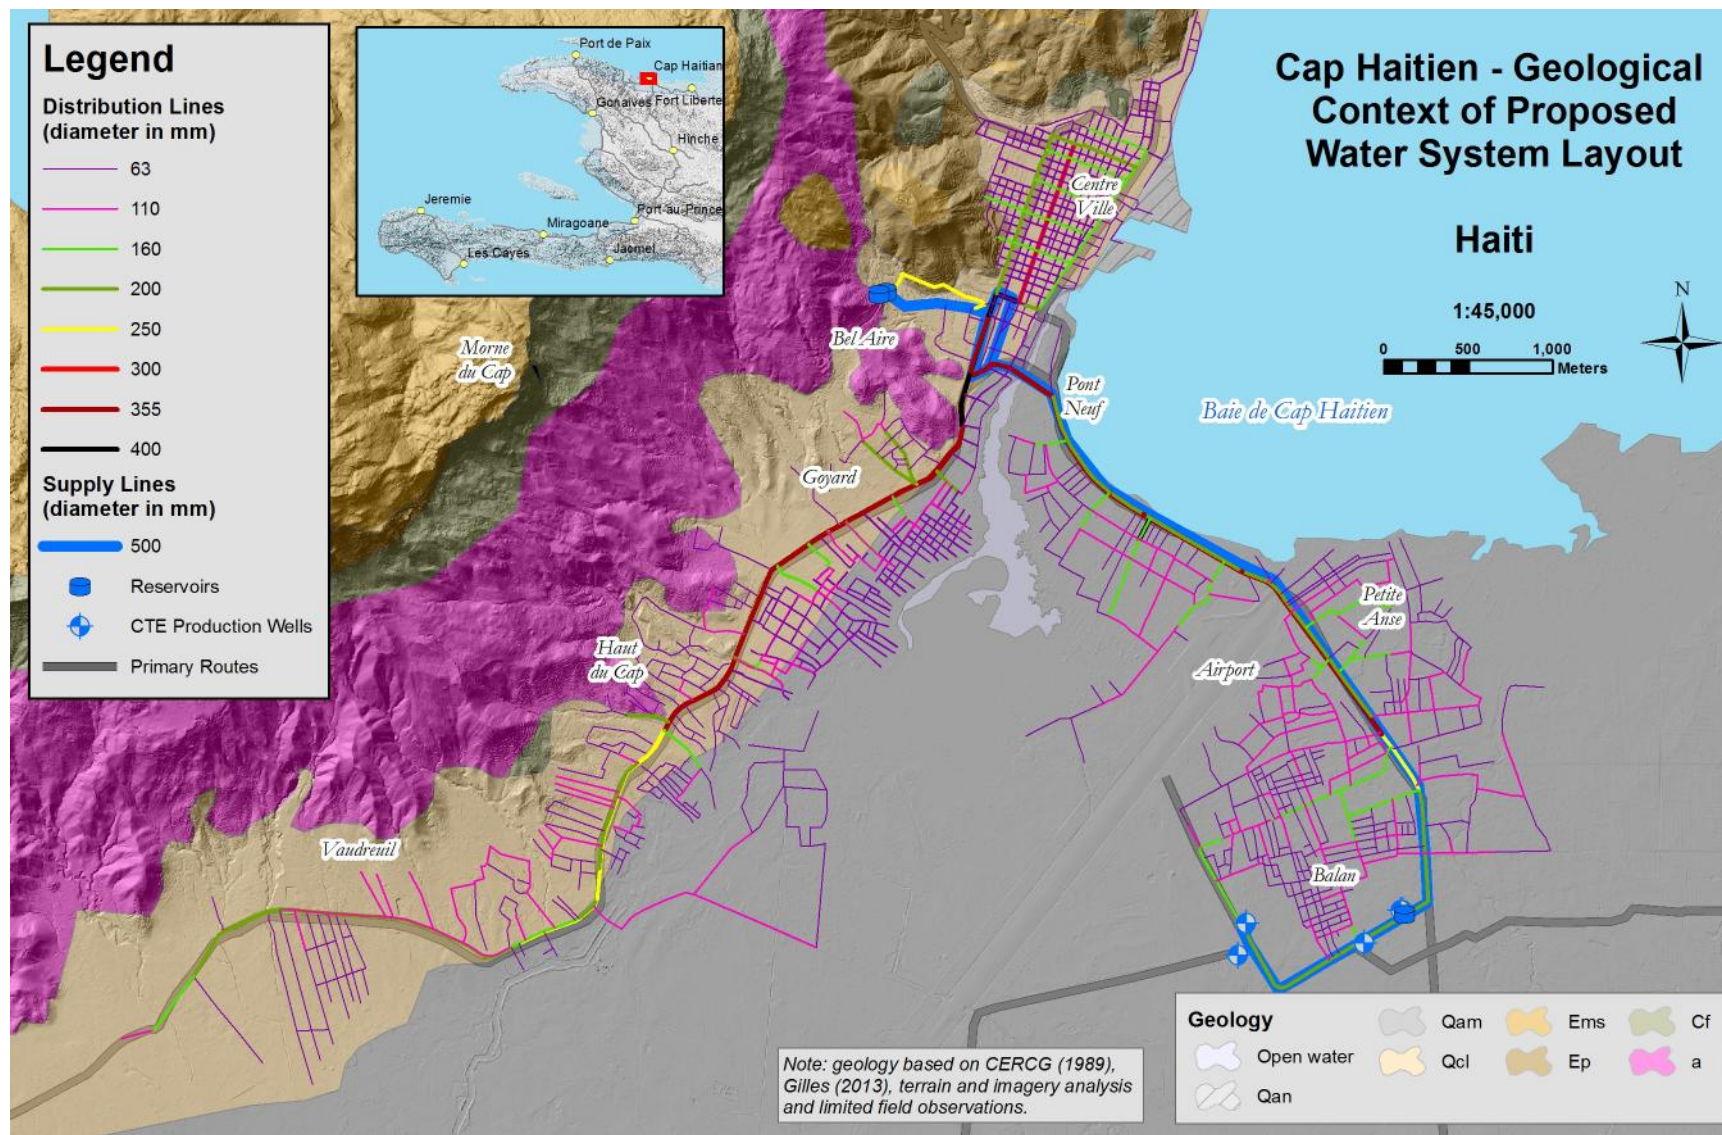
FIGURE 2 – PROPOSED WATER SYSTEM LAYOUT AND GEOLOGIC SITE CONDITIONS

The supply and primary distribution pipelines connect to the reservoir sites from a junction at Route L. At the Route L junction, the proposed distribution system branches into three zones, one to the north (Centre Ville), one to the east (Petite Anse) and the other to the south (Haut du Cap). Figure 2 illustrates the alignment of the proposed water system.

The project site has several different geological settings, primarily due to length and alignment of the supply and distribution pipelines. The site geology is outlined based on synthesis of a modified version of the CERCG (1989) 250K scale geological map with geologic mapping performed by BRGM (Gilles, 2014) in the Morne-du-Cap area, and also supported by field observations and terrain analysis by the authors. There were no soil or geotechnical borings performed, or detailed geological mapping performed to validate or verify the geological units and their contacts. Table 2 describes the geological units present in the project site, and Figure 2 illustrates the surficial geology of the project area.

The reservoir is underlain by a thin veneer of Quaternary-aged colluvial deposits (Qcl) with fractured Cretaceous-aged andesite bedrock below. The thickness of the unconsolidated colluvial deposits is estimated to be between 5 and 10 meters thick under the existing reservoir.

Table 2 describes the geological units present in the project site, and Figure 2 illustrates the surficial geology of the project area.

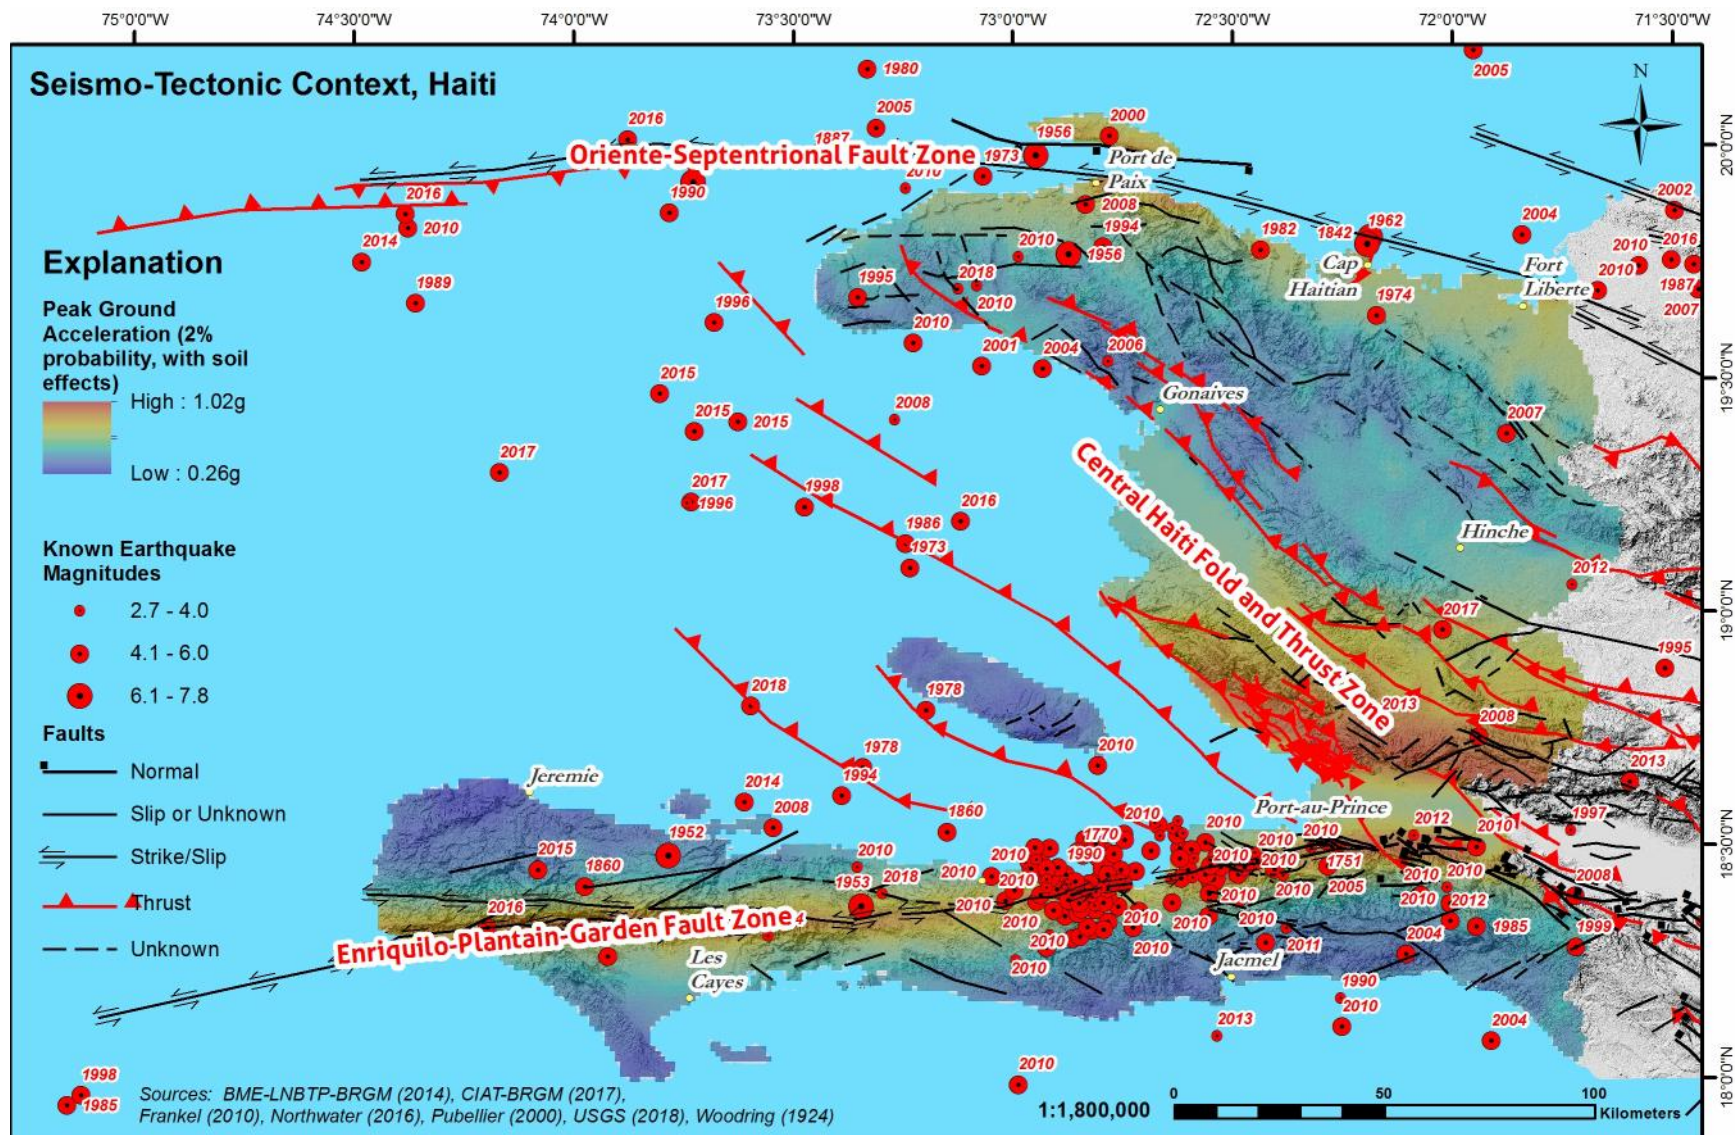
FIGURE 3 – SEISMO-TECTONIC CONTEXT OF CAP HAITIEN, HAITI

The northern coast of Haiti is flanked by one of the two primary fault zones of Hispaniola: the Oriente-Septentrional Fault Zone (OSFZ). Near Cap-Haitien, the OSFZ is primarily left-lateral strike-slip with ancillary thrust, strike-slip and normal faulting (Figure 3). The OSFZ is a very active fault system, with slip rates of up to 9 to 11 mm/year (Calais, 2015). Ruptures along the OSFZ have historically caused major damage to coastal towns like Cap-Haitien (1842), Mole Saint Nicolas (1887), Port de Paix and Jean Rabel (1956). Recent modeling by Torres et al (2016) indicated that the OSFZ could produce a 7.9 magnitude earthquake 10-km from Cap-Haitien at a depth of 20-km. Torres et al (2016) also modeled the destruction to Cap-Haitien from such a rupture, suggesting an estimated 13,500 buildings, or 47% of the city would be destroyed.

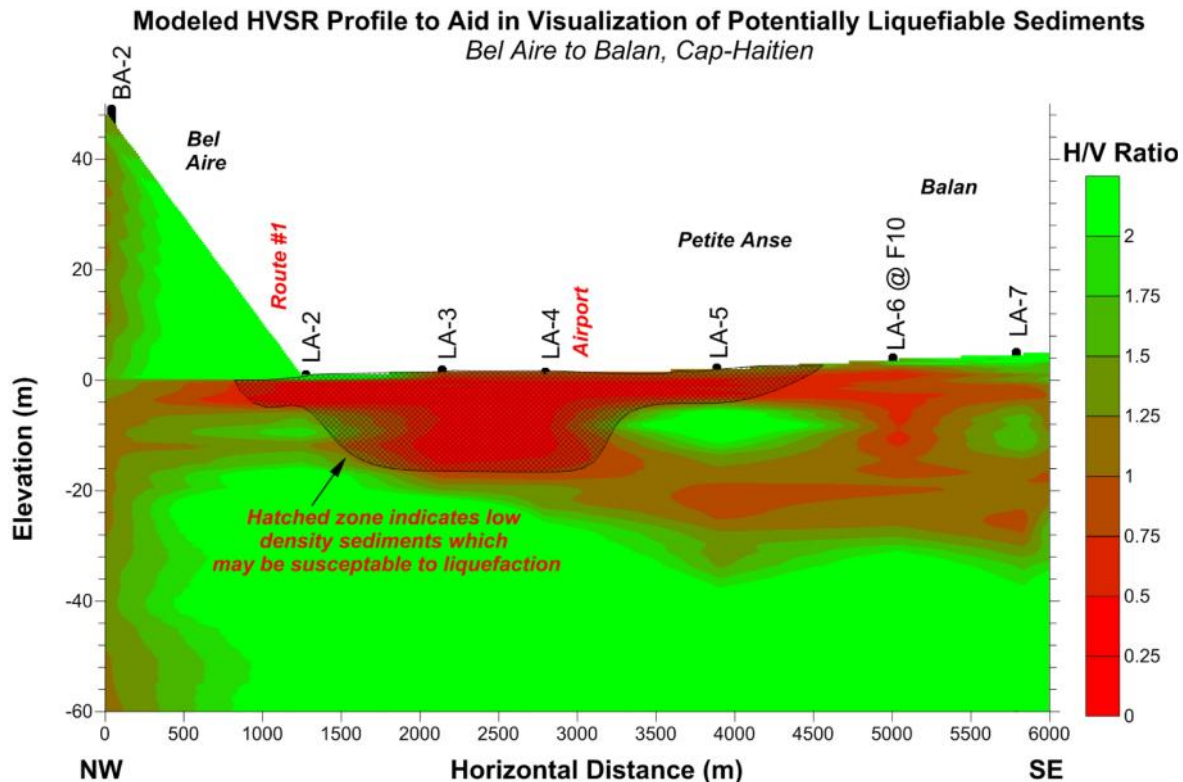
Based on our first-hand knowledge of the alluvial deposits of the Plaine-du-Nord, we consider that some of the stratigraphy may conform to industry standard characteristics of liquefiable soils. The project site is located within a documented hazard zone (Gilles, 2014) which is illustrated in Figure 6. Supplemental HVSR geophysical data (Figure 4) along the main supply line also suggests up to 20 meters of low density sediment from near the Riviere Haut-du-Cap eastward to near the airport. This low density sediment appears to thin southward past the airport towards Balan.

Based on our evaluation, we would regard liquefaction, strain softening, and related hazards as a design consideration for sections of the pipelines underlain by unconsolidated alluvial deposits especially between the Riviere Haut-du-Cap and Petite Anse. A geotechnical investigation that includes borings with sediment characterization and SPT is recommended along the length of the supply line to better characterize the liquefaction hazard and design adequate mitigation structures. The cost of the liquefaction

investigation will likely result in cost-savings relative to the higher cost of installing conservative mitigation measures. We consider the liquefaction hazard to be a greater than the strain softening hazard.
