CONCEPT DESIGN FOR THE REHABILITATION OF GEORGE PRICE HIGHWAY
SEGMENT: BELMOPAN – GUATEMALA BORDER

Prepared by: Cesar Castellon

July 30, 2014

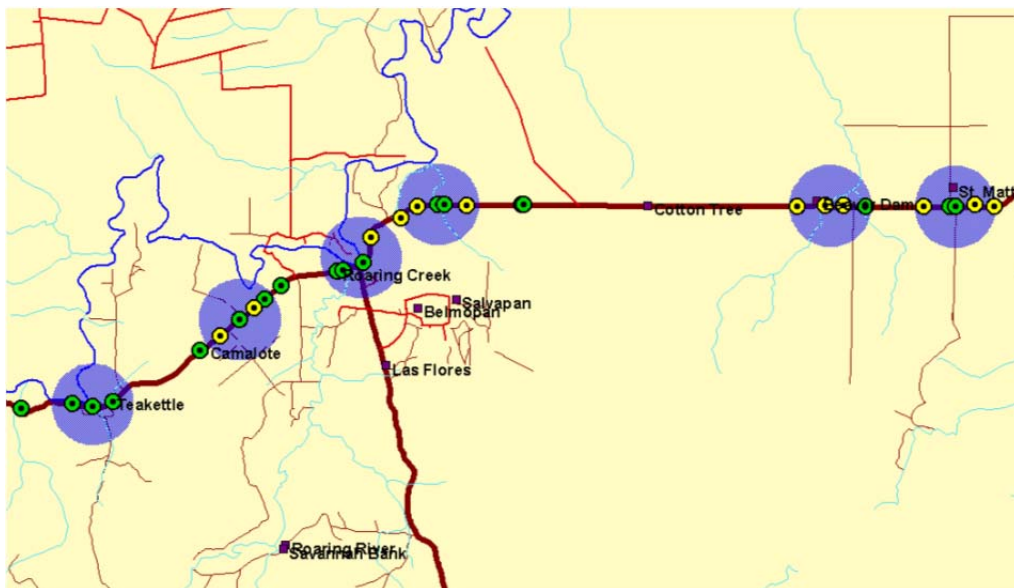
Figure 18: Proposed culverts near Belmopan.

According to the inventory of zones prone to flooding along the GPH, the global study to propose specific interventions to reduce the Belizean road network vulnerability to flooding events¹⁴, detected some areas where apparently there is no presence of culverts. So they recommended 42 new culverts (12,000 ft³/sec) to prevent or minimize flooding on these areas. The next images show the inventory of zones prone to flooding (blue) in HPH, existing culverts (green), and proposed culverts (yellow).
