# **Environmental and Social Impact Assessments for the Rehabilitation of the George Price Highway from Miles 47.9 - 79.4**

Final Report on the  
Environmental and  
Social Impact Study

**Ministry of Works and Transport  
Belmopan,  
July 27, 2014**

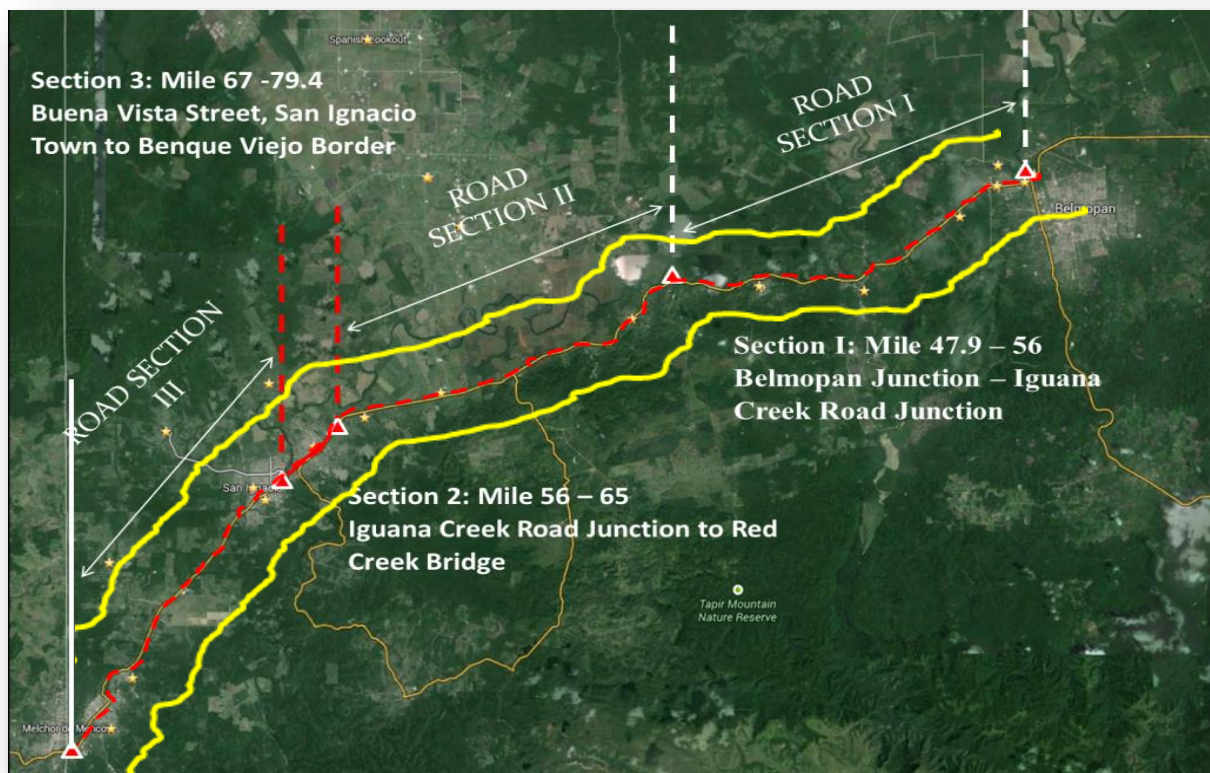
Figure 1.1: Map of Study Area

The Study Area for the GPH ESIA Project is defined as 4 kilometers on either side of the center line of the GPH, beginning at the junction of the George Price and Hummingbird Highways at mile 47.9 and ending at the western border at mile 79.4 near the town of Benque Viejo del Carmen. This 29.5 mile segment of the Western Corridor is partitioned into 3 sections for the purposes of this ESIA, as shown in Figure 1.1.

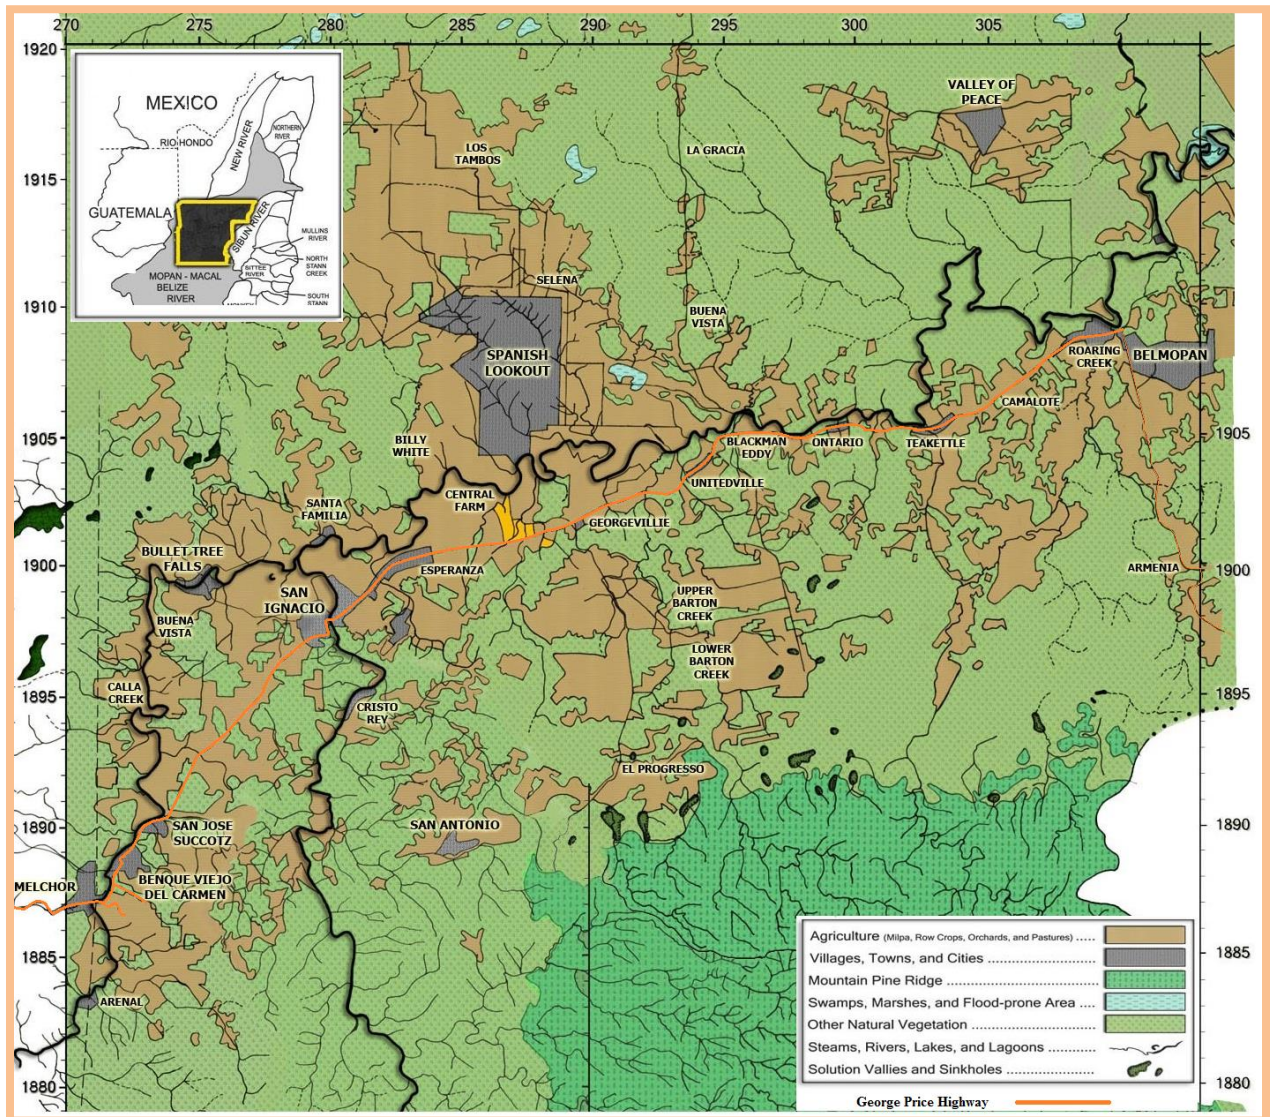
**Figure 1.2: Upper Belize River Basin and GPH, Cayo District, Belize.**

Figure 1.2 is a map of the central and western corridor of the Greater Belize River Basin (GBRB) and the GPH Highway (orange line), showing the location of capital Belmopan, the main district towns of San Ignacio/Santa Elena and Benque Viejo del Carmen, and villages in the proposed GPH rehabilitation zone. The map also shows the extensive agriculture land use in the basin, and the northwestern sector of the Mountain Pine Ridge.

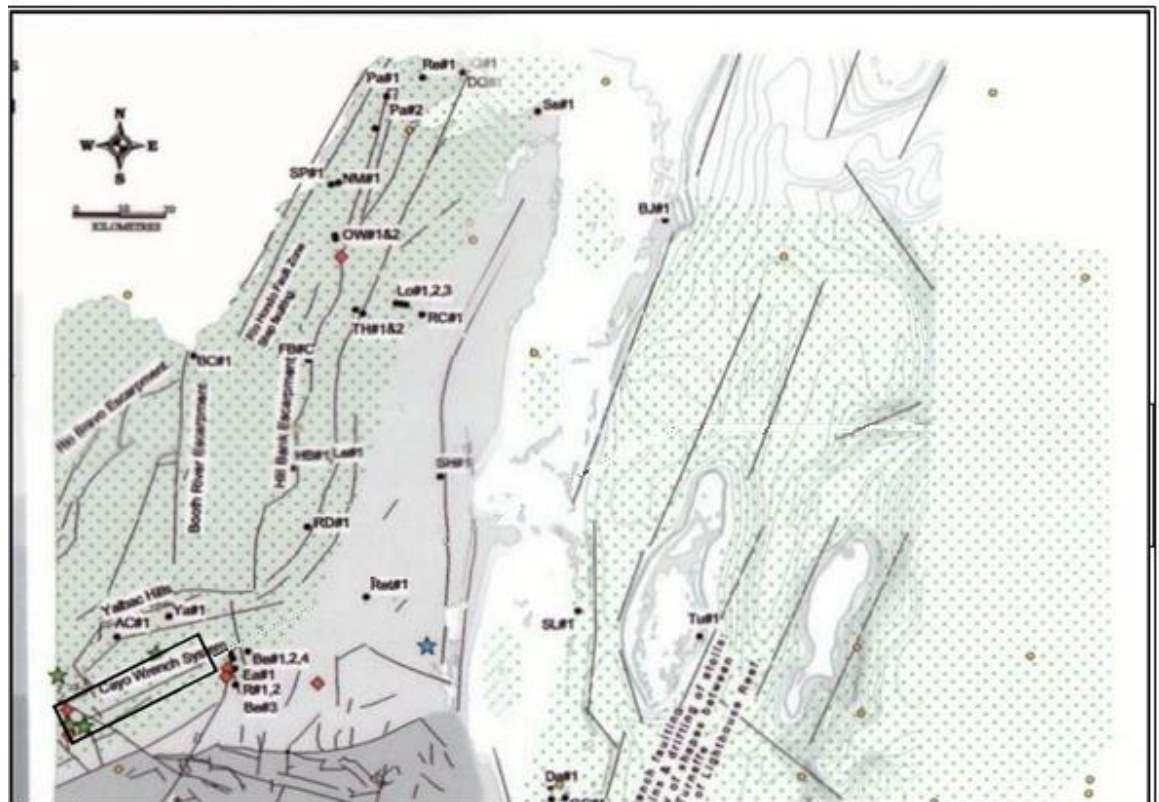
Figure 4.2: Tectonic Map of Belize

The Study area can be considered tectonically inactive as these faults predate all recent deposits and there is no evidence of recent faulting within the study area. However, the project area is subject to the Cayo Wrench system of NE-SW lateral fault blocks, Figure 4.2. This NE-SW lateral wrench system consist of a series of isolated fault blocks and associated escarpments, running near parallel to each other showing massive vertical displacement along the thrust faults.

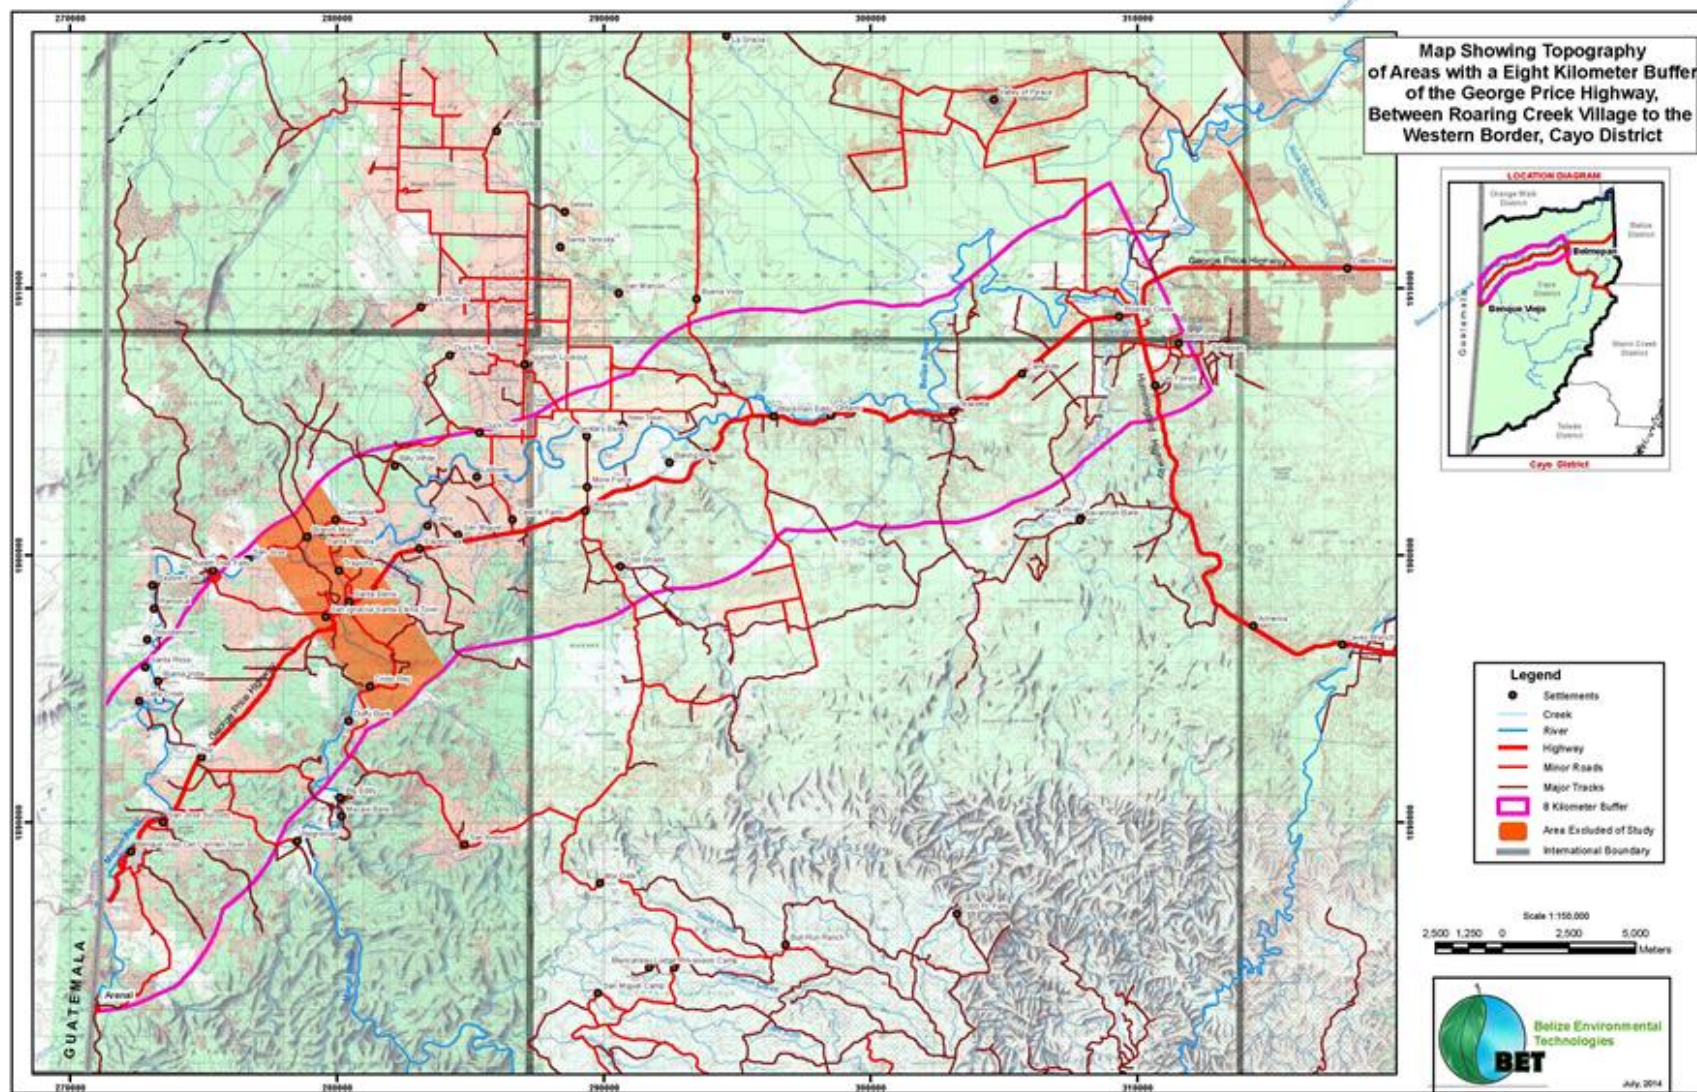
**Figure 4.3: Map Showing General Topography of Study Area**

The topography of the project zone varies from the hilly country of the immediate south and south west of San Ignacio-Santa Elena, in the direction of the western end of the project site around Benque Viejo del Carmen; to the subdued relief of the floodplains of the Macal and Belize River, down to the rolling terrain in the Banana Bank-Roaring Creek area (Halcrow,1998). The hilly country is characterized by rounded hills, reaching about 160 m in the immediate vicinity of the proposed Macal River Crossing, separated by steep, narrow valleys, farther upstream, Figure 4.3. Table 4.1 provides information on the elevations of the watersheds of the GBRB.

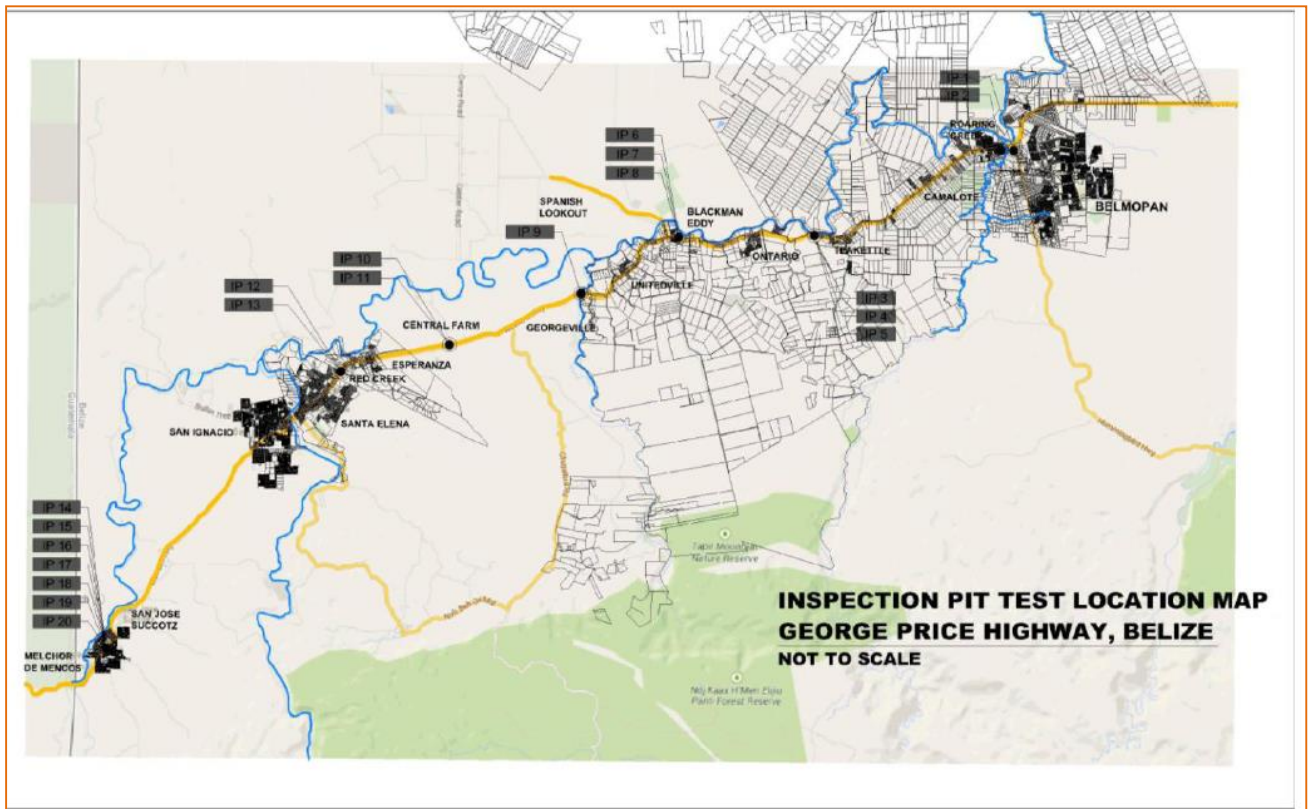
**Figure 4.5: Test Pit Location Map**

Within the study area, a total of twenty (20) test pits were dug to examine material suitability and competencies as well as to identify and describe the various soil types and characteristics within the three sections of the proposed GPH upgrade, Figure 4.5. A more detailed analysis of the results of the Test Pit Survey is further discussed in the ESIA.

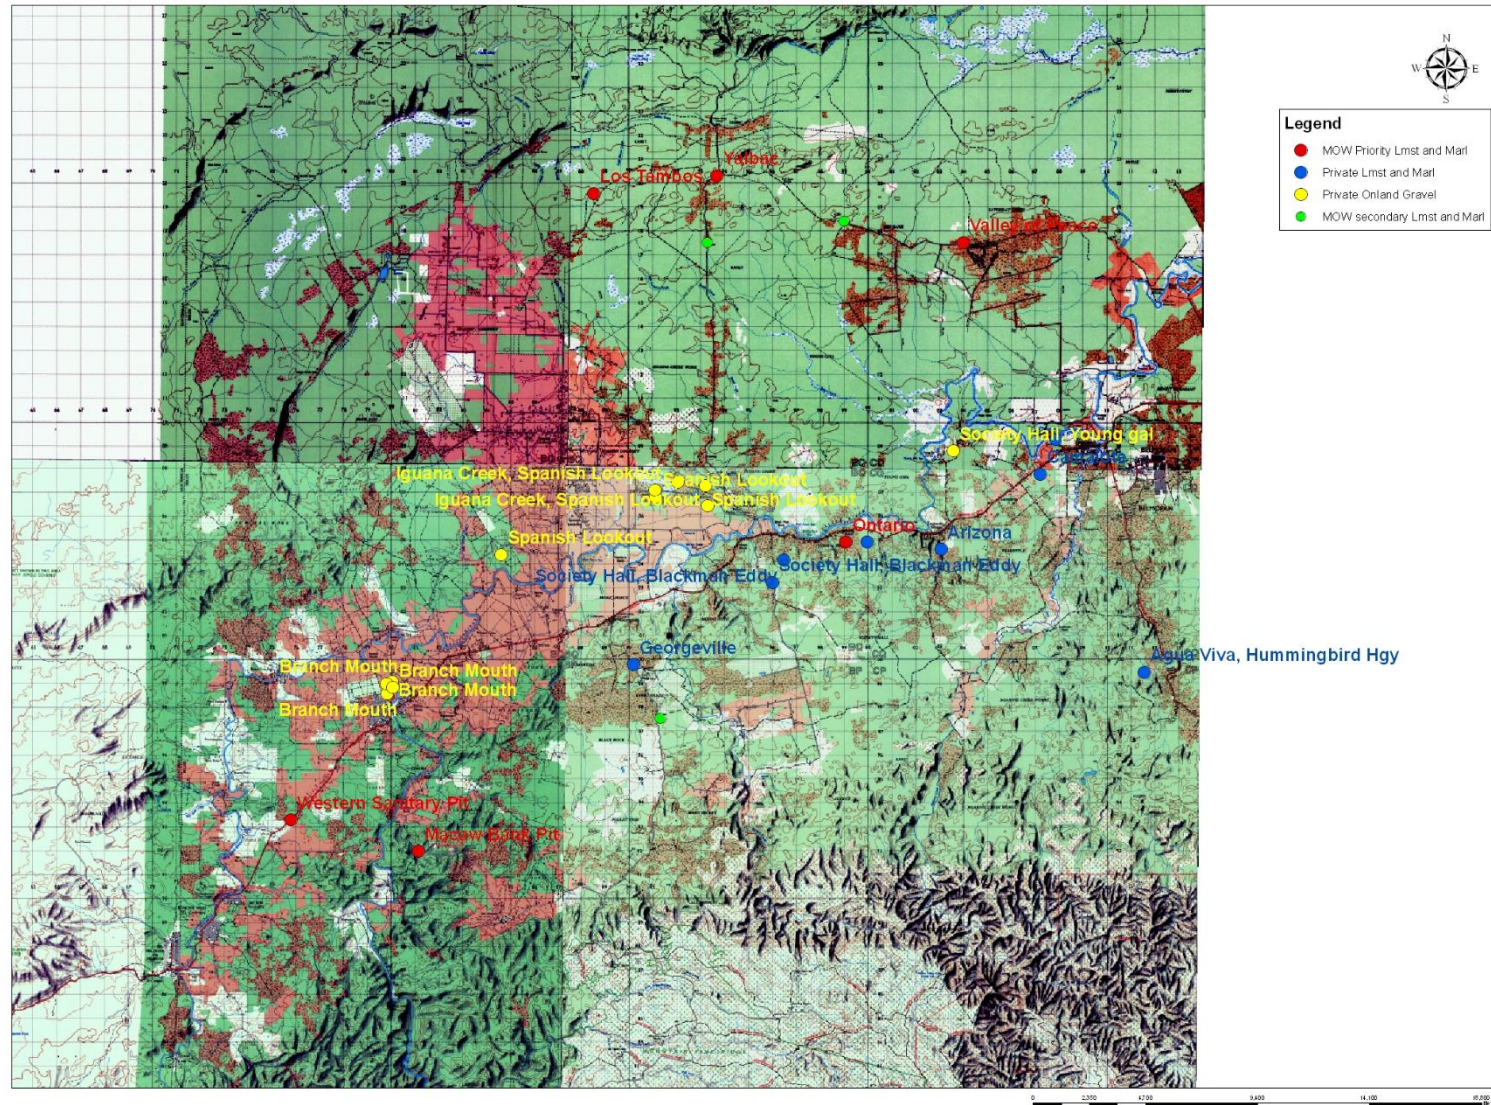
The baseline survey of existing quarries and extraction sites within or near the project area indicated that there were nineteen (19) existing localities for marl and/or limestone and marl, and twelve (12) existing localities for onland sand and gravel or gravel, Figure 4.6. This would indicate that the availability of material would not be an issue.

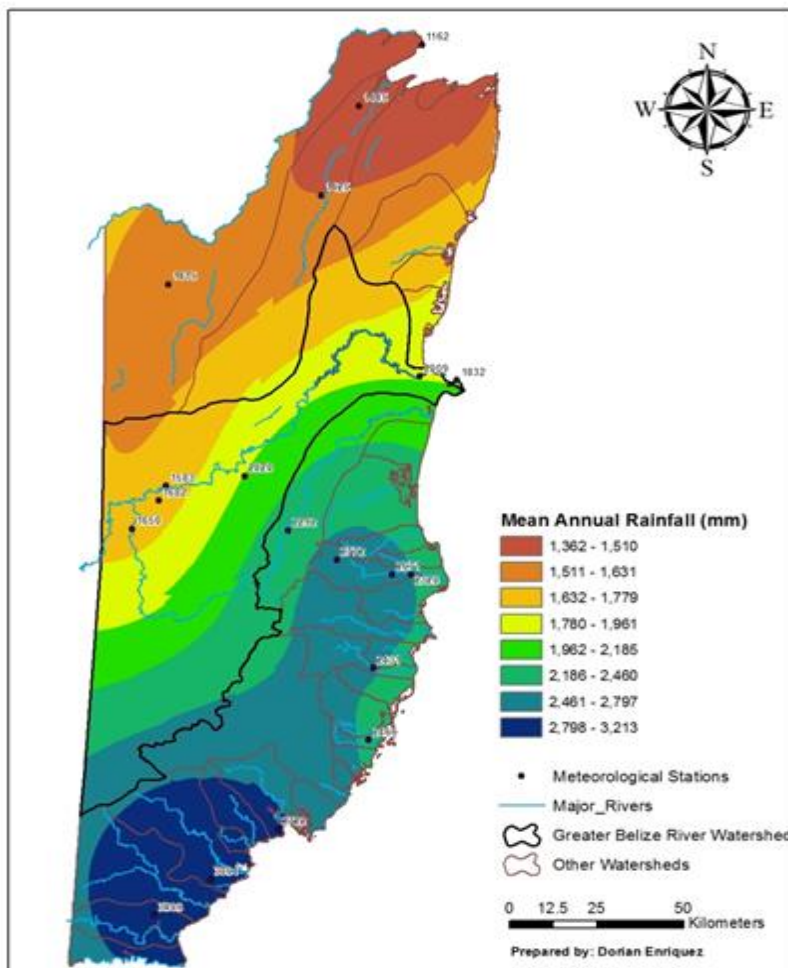
**Figure 4.7 Mean Annual Rainfall over Belize**

There are two distinct seasons: a wet season, which normally commences around mid-May in the south and early June in the north, and lasts until November; and a dry season, which stretches from mid-February until May. Mean annual rainfall increases from the north to the south of the country, with a mean annual of about 1,400 mm (55 inches) in the northern districts to near 3,864 mm (152 inches) in the south, around the Punta Gorda Agricultural Station at 5

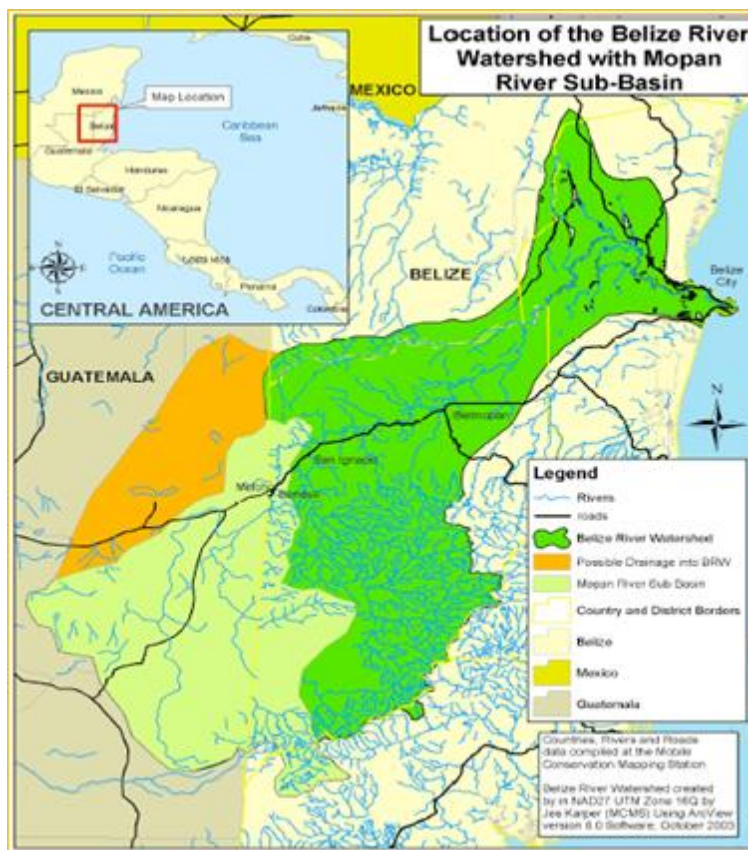
**Figure 4.8: The Greater Belize River Basin**

The Greater Belize River Basin is a trans-boundary catchment system comprising of ten sub-basins. Two of these, the Mopan and Chiquibul are shared with Guatemala, while the remainder is in Belize. Figure 4.8 is a map of the GBRB and portions of the main roads that traverse the basin in Belize and Peten, Guatemala. More on the surface hydrology of the GBRB is presented in the Hydrology Section. Figure 4.9 (a) and (b) are climate charts for Central Farm and Belmopan. The mean annual rainfall range from

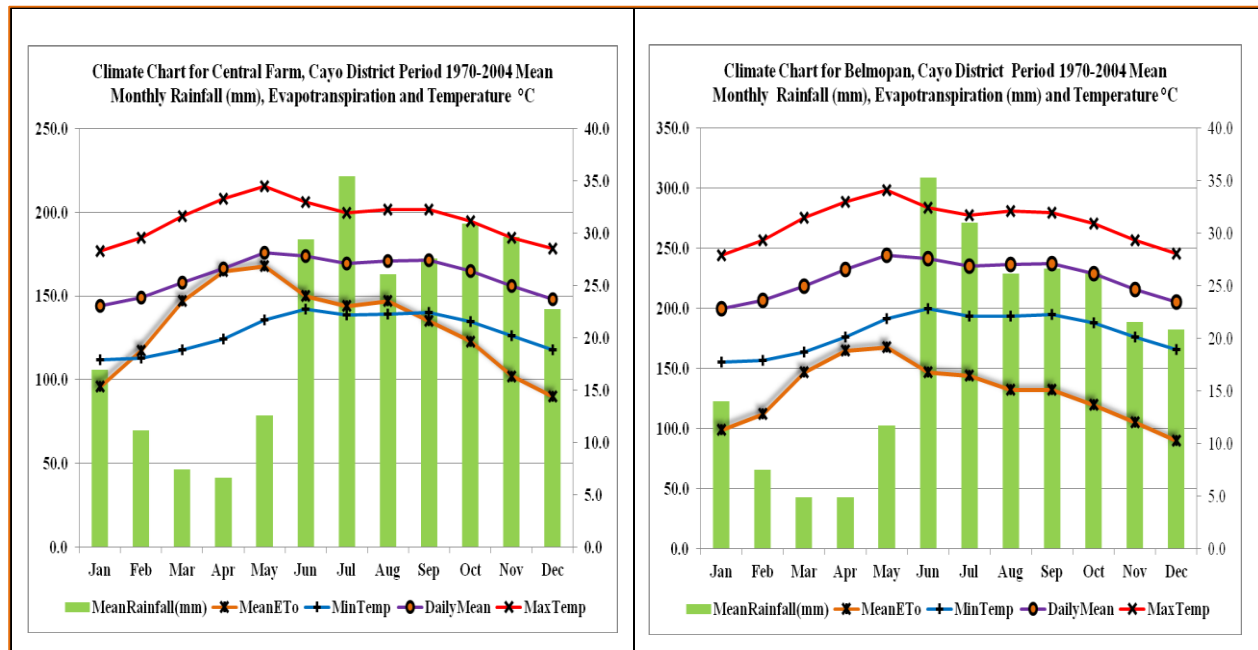
Figure 4.9 (a) and (b): Climate Chart for Central Farm, Cayo District

about 2000 to 2800 mm in the southern Cayo District to around 1600 - 2000 mm in the northern and north-western border. Peak maximum rainfall occurs in July and October at Central Farm and in June and September at Belmopan. Rainfall surplus is evident from June until January. The mean maximum temperature varies from 29°C to near 35°C in Belmopan and from 28 – 35 at Central Farm.

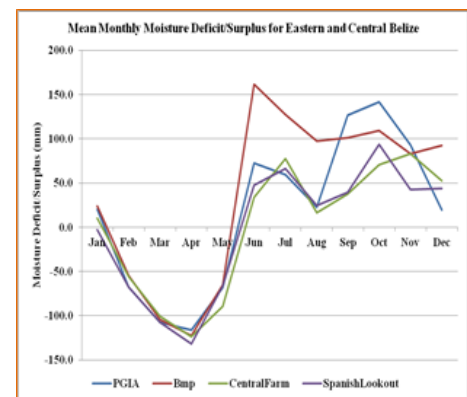
Figure 4.10: Moisture Deficit/Surplus

Figure 6.7 is a Moisture Deficit/Surplus graph (Precipitation P – Evapotranspiration E) for western Belize. Rainfall deficit (Precipitation–Evapotranspiration, P-E) extends from February to May (Figure 6.7). The peak of the water deficit is April. The local climate in the West Central zone is described with a

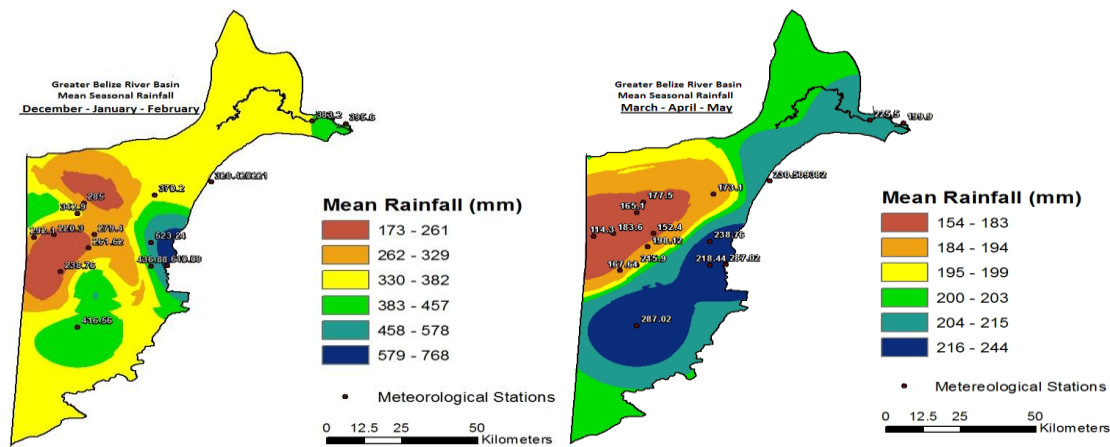
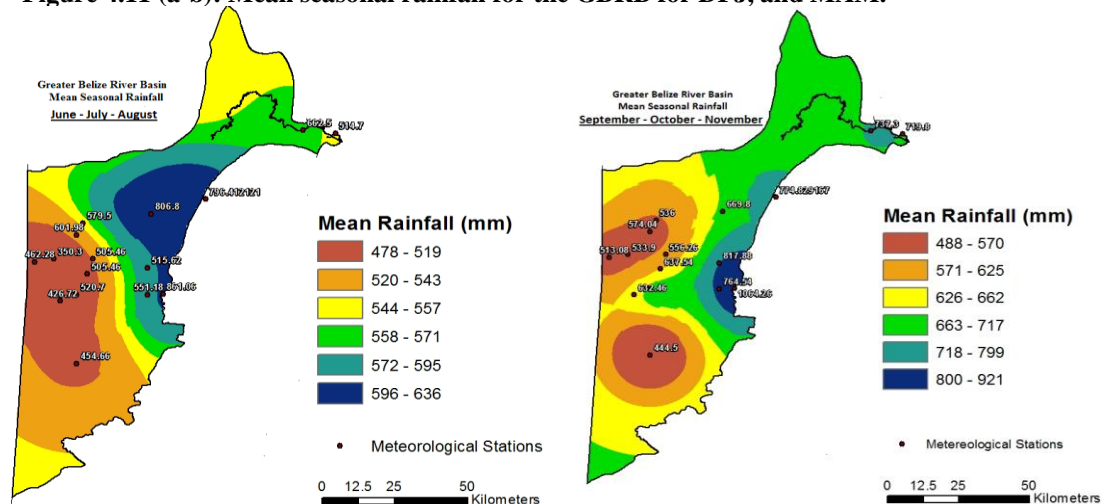
Figure 4.11 (a-b): Mean seasonal rainfall for the GBRB for DJF, and MAM.

Aridity regime is 3 months and the annual Rainfall Deficit is -369 mm at Central Farm to -346 mm at Belmopan. The onset of the rainy season is normally in the first ten days of June. Figures 4.11 (a) – (d) show the mean seasonal rainfall for the Greater Belize river Basin. The higher mean seasonal rainfall in the Basin is concentrated in the elevated terrain of the east-central and southeastern region. During the period DJF, the mean seasonal rainfall in the eastern side of the Basin range from 458 mm – 768 mm, in MAM it range from 200 mm to 244 mm, 572 mm to 768 mm in JJA and 718 mm to 921 mm in SON. The drier region of the Basin is in the northwestern and western areas in DJF, MAM, and JJA, and extends into the higher terrain of the southeast in SON.

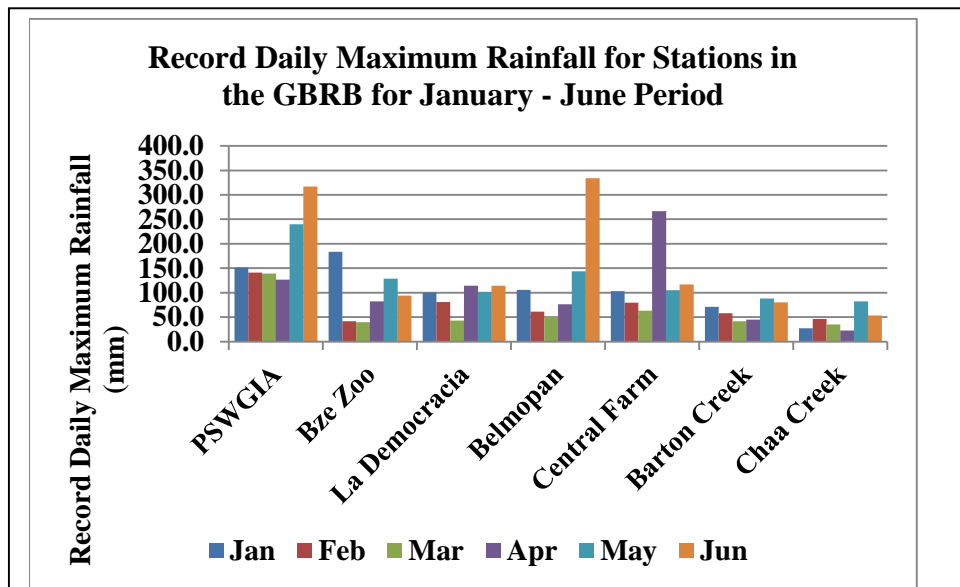
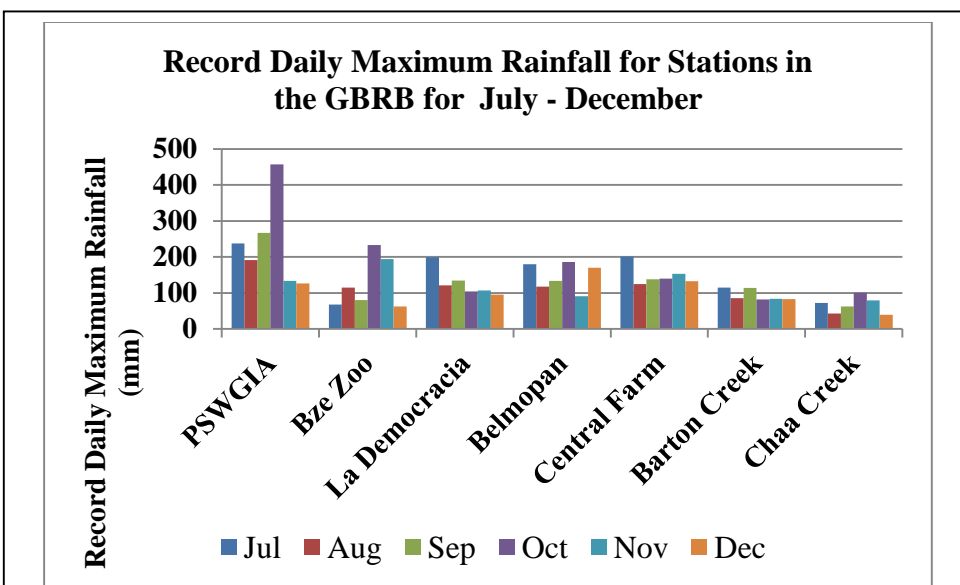
**Figure 4.12: Record Daily Maximum Rainfall in the GBRB Jan-June**

Generally three types of events result in intense rainfall throughout Belize. In June and July tropical waves and disturbance produce widespread thunderstorm activity, which generate intense but localized rainfall. Soil moisture is often below field capacity after the long dry season and runoff would not achieve its full potential, except in urbanized areas. In late August, September and October, Belize normally experience significant and prolonged rainfall during the height of the hurricane season. Substantial runoff occurs, resulting in localized flash floods in the hilly terrain, ponding and inundation along flood plains and low-lying areas. In November through January, significant but less intense rainfall can occur, caused by incursions of frontal systems across the area. During extended and intense dry seasons, ground water table may drop and base flow is the only source of water for the major rivers and tributaries. In the coastal zone of the Belize and Corozal Districts, these recurrent drought conditions result in the advance of the salt-water lens deep into the coastal aquifers. Figures 4.12 and 4.13 show graphs of daily maximum rainfall for some stations in the GBRB prior to 2006.

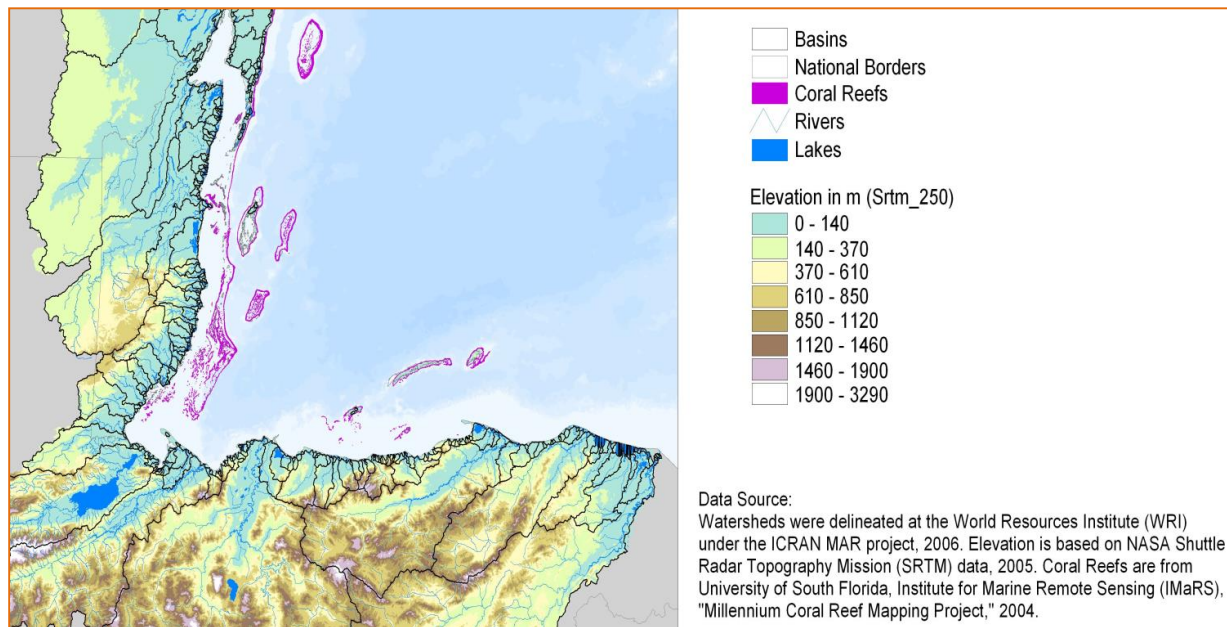
**Figure 4.15: Trans-boundary watersheds of the MBRs (Source: WRI, 2005)**

Figure 4.15 below delineates the watersheds of the Meso-American Barrier Reef System (MBRS), including the GBRB. The elevation is derived from NASA Shuttle Radar Topographic Mission (SRTM) data for 2005. As can be observed, the central and lower reaches of the GBRB

is below 140 m, with the higher terrain of the Maya Mountain ranging from 300 to 850 m draining the southern and south eastern sections of the Basin.

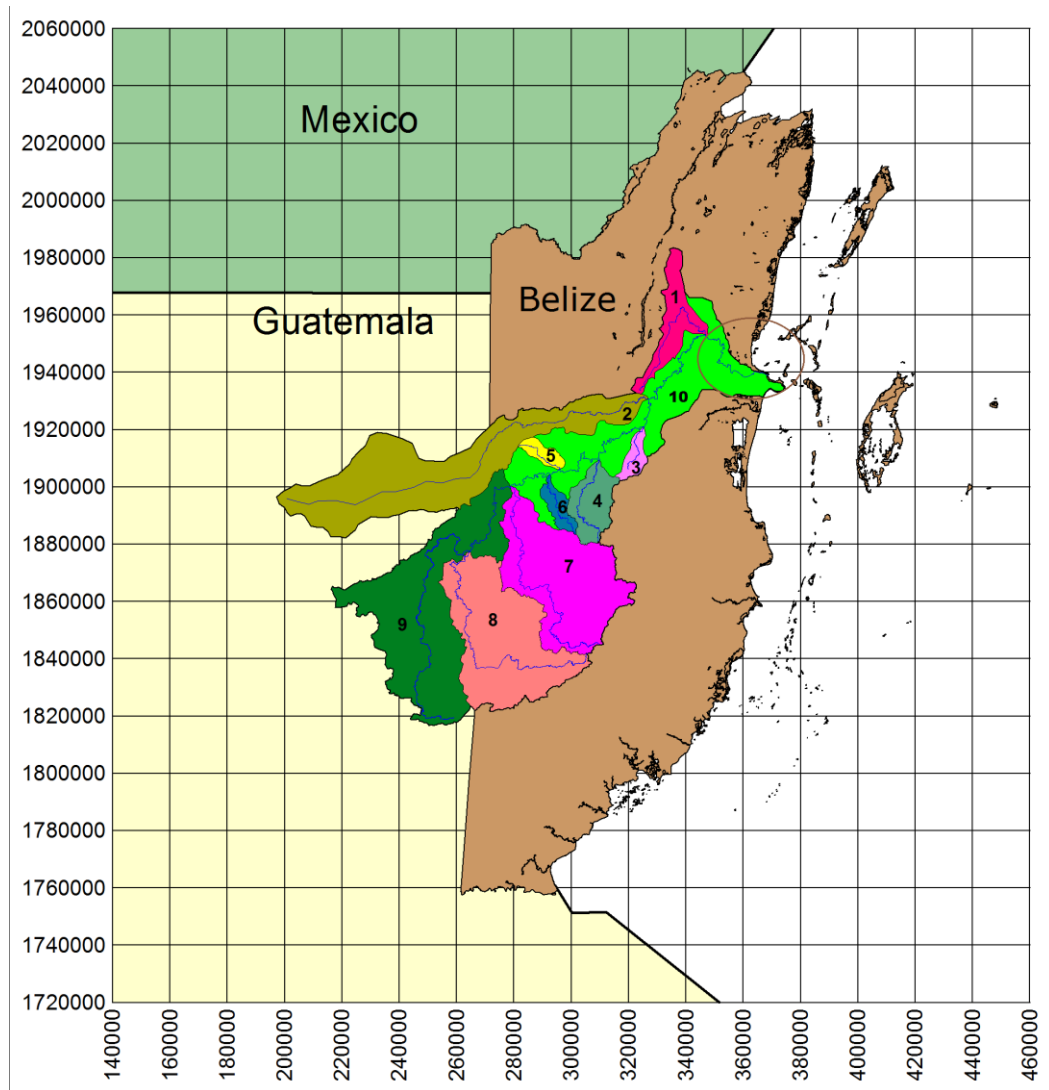
**Figure 4.16 Sub-watersheds of the trans-boundary Greater Belize River Basin in Belize and east-central Peten, Guatemala (TYP SA, 2010).**

In their 2010 study on the vulnerability of the Belizean road systems to flood events, TYP SA identified 10 sub-basins, Figure 4.16. These are: (1) Crooked Tree and Northern Lagoon sub-catchment, (2) Labouring Creek sub-catchment, (3) Beaver Dam Creek sub-catchment, (4) Roaring Creek sub-catchment, (5) Iguana Creek sub-catchment, (6) Barton Creek sub-catchment, (7) the Macal River sub-basin, (8) the Chiquibul River sub-basin, (9) the Mopan River sub-basin, and (10) the Belize River sub-basin. Total area of the GBRB covers about 10,500 km<sup>2</sup>. Almost a third of the watershed (3,300 km<sup>2</sup>) lies within Guatemala and a little over two-thirds (7,200 km<sup>2</sup>) is in Belize.

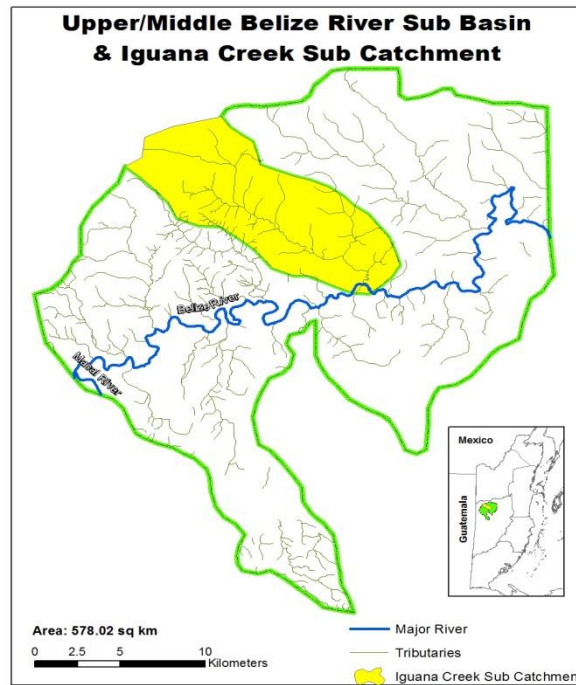
**Figure 4.17: Upper/Middle Belize River Sub Basin and Iguana Creek Sub Catchment**

The Belize River watershed, Figure 4.17, drains an area of approximately 1632 km<sup>2</sup> of the main tributary of the GBRB, with elevation above mean sea level ranging from 200 m at the confluence of its two main tributaries, the Mopan and Macal near Branch Mouth Village in the Cayo District, to sea level at its mouth in the vicinity of Haulover Creek just north of Belize City. The Belize River Mouth and Coastal Zone (BRM&CZ) micro-watershed borders the Crooked Tree/Northern Lagoon system (Sub-basin No. 1) in the north and northwest, and extends southeast to the coast in the Ladyville/PSWGIA area and Belize City. It also merges with the Sibun River watershed in the south along the George Price Highway from Hattieville to the coast just north of Freetown Sibun.

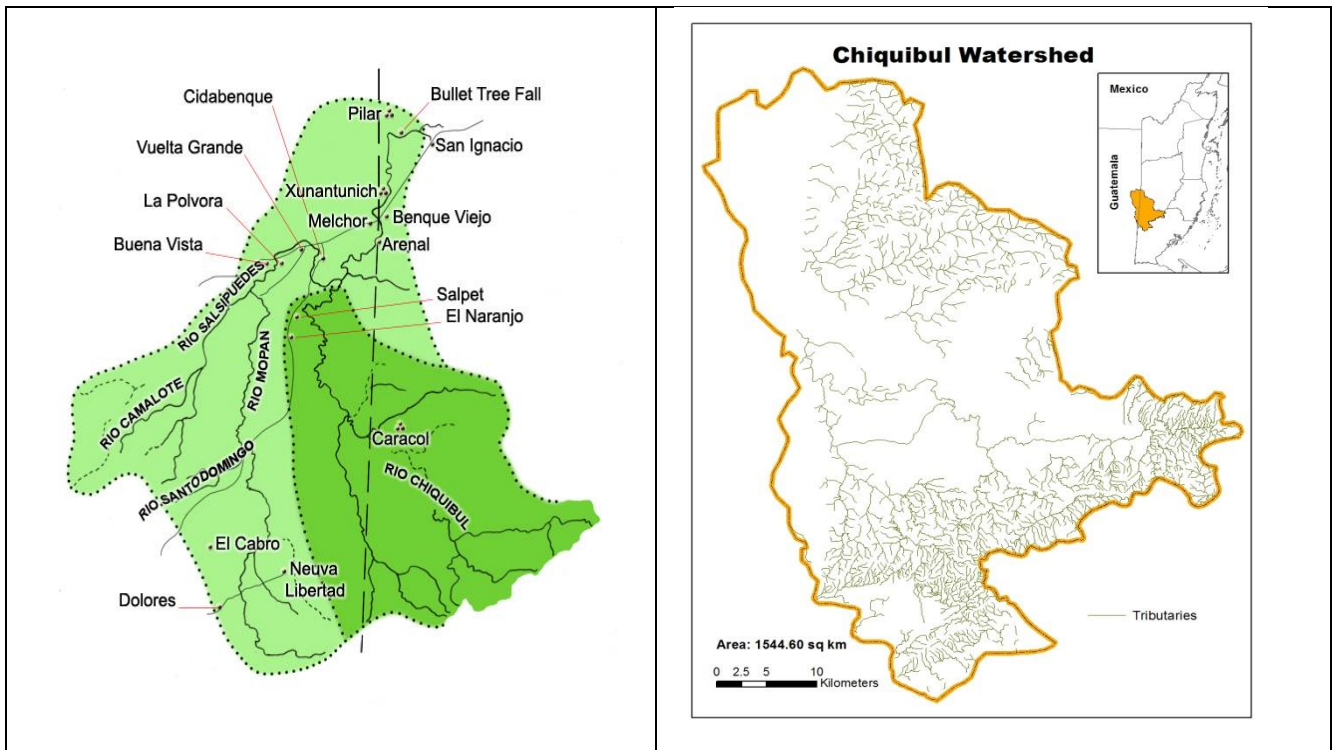
**Figure 4.18: Mopan River Watershed and Chiquibul Watershed**

The Mopan River has its origin in southern Peten, Guatemala in the vicinity of the community of Mopan 1 in the hilly terrain near the municipality of Dolores, Figure 4.18. The Chiquibul Watershed flows through a large karst landscape that is pocked with sinkholes. The mean annual flow in the Chiquibul River is 10 m<sup>3</sup>/s observed near the village of Chiquibul, while the mean annual flow in the Mopan is 36.2 m<sup>3</sup>/s. The two hydrological monitoring stations in these rivers in Peten are: Chiquibul and Arenal Villages, respectively. In Belize the hydrological monitoring station for the Mopan River is at Benque Viejo, and the mean annual flow there is 44.2 m<sup>3</sup>/s.

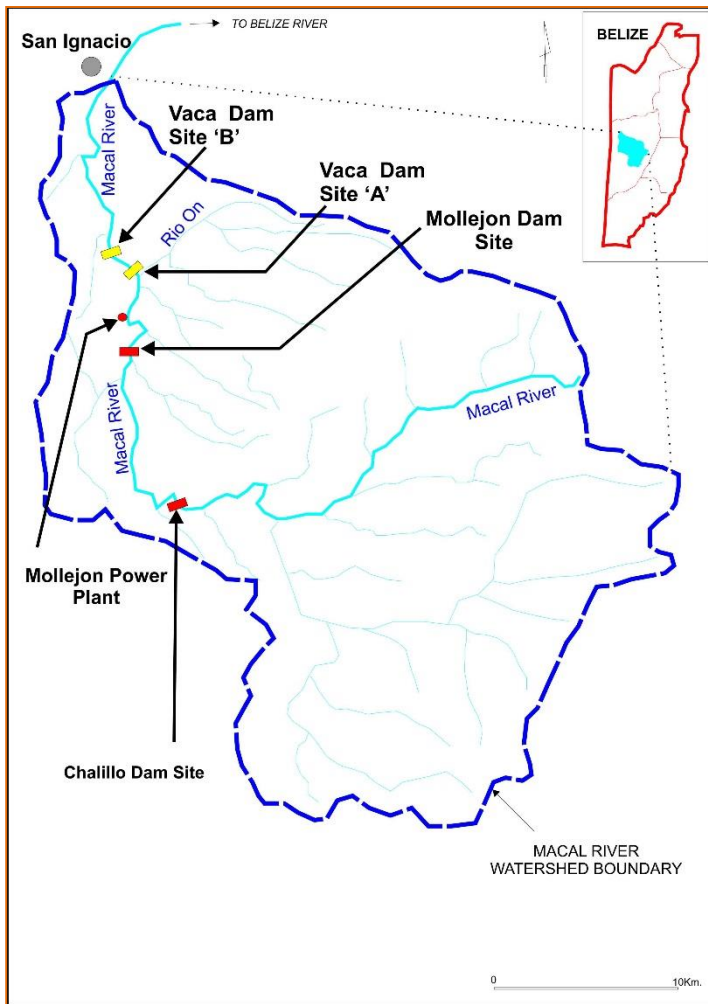
**Figure 4.19: Macal River Watershed Boundary**

The Macal River headwaters are made up of many small headwater streams draining out of the Mountain Pine Ridge, Figure 4.19. Very little human activity is happening here out side of selective logging. There are very few inhabited areas, except for a few resorts, Douglas D'Silva Forest Station and

The flow of the Macal River is regulated by the BECOL's hydroelectric Macal River Upstream Storage Facility at Chalillo, and the Mollejon and Vaca run-of-the-river hydroelectric plants down stream of the Chalillo dam site. At full capacity the Chalillo reservoir stores 120 million cubic meters of water.

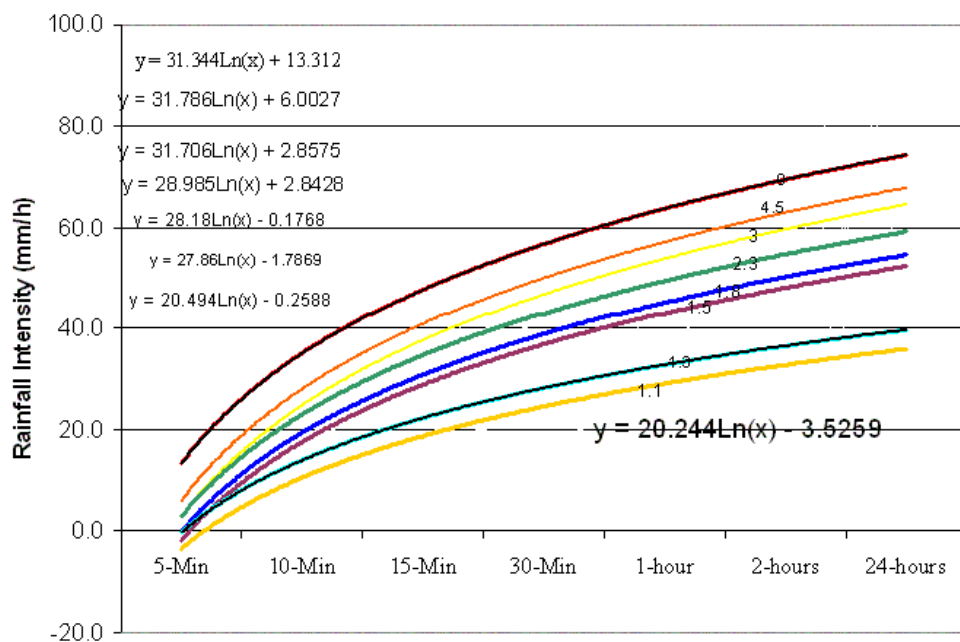
**Figure 4.21: Rainfall intensity and Return Period for Central Farm (Source: R. Frutos)**

Rainfall intensity for Central Farm and Philip Goldson International Airport and Central Farm computed from historical for these stations using the Gumbel EV1 distribution are presented in Figure 21 and Table 4.9 below. Rainfall intensities are related to the severity of rainstorm events and the rate of runoff once the soil reaches field capacity. This effect is directly related to the occurrence of flash floods in the Basin which is a frequent phenomenon along many sections of the ROW of the GPH.

Rainfall intensities and Depth-Duration-Frequency (DDF) curves have engineering applications for culvert and bridge designs.

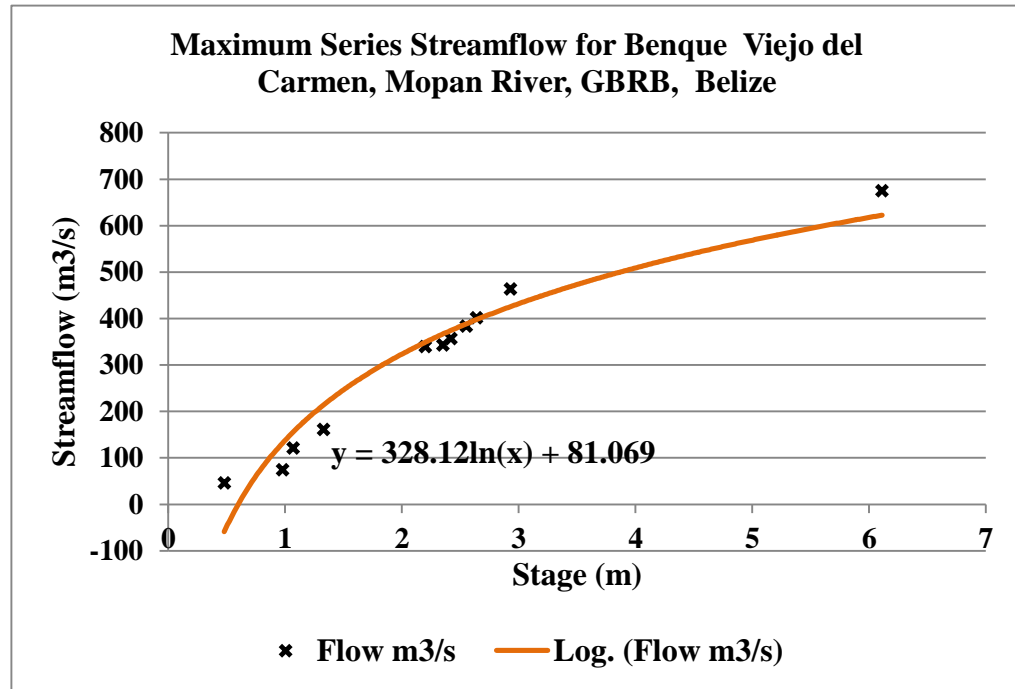
Figure 4.22: Maximum Flood Series and Stage for the Mopan River at Benque Viejo

The daily maximum stream flows were generated by some of the historic flood events in the Mopan River. A graph of the data is presented in Figure 4.22. Table 4.11 is a list of these floods and the date of occurrence.

An analysis of the maximum streamflow series for Benque was done using three Extreme Value distribution approach, namely the Gringorten Equation, the Weibull Distribution and the Gumbel EV1 Distribution.

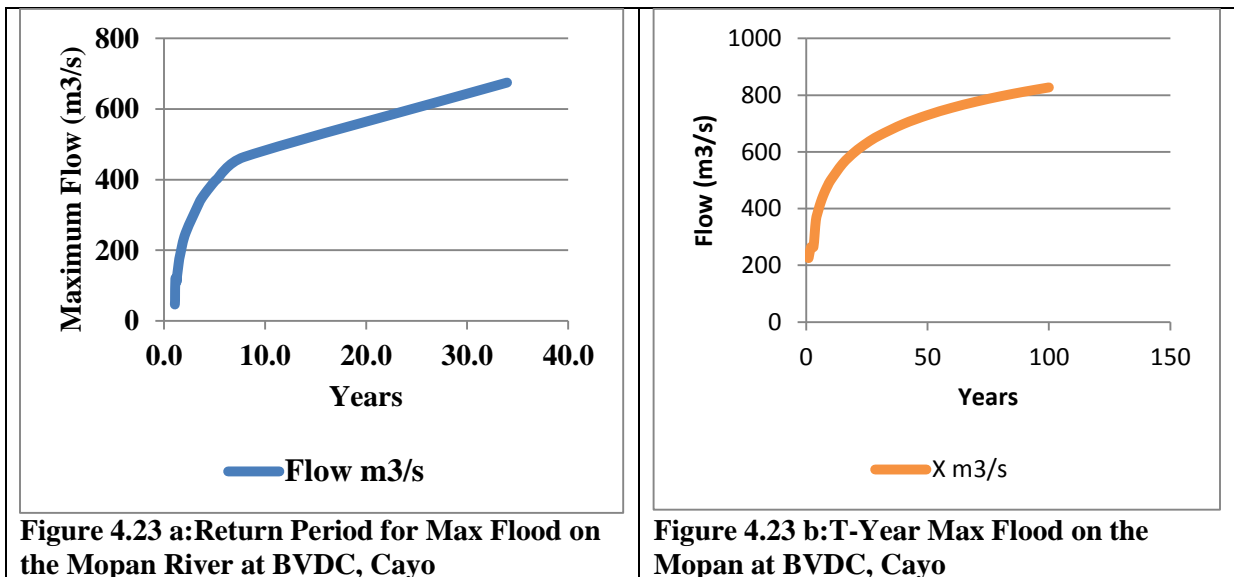
The stage and flow for the TD 16 flood at Benque was evaluated from re-assessment of the watermark at the observation site, since the flood level surpassed the 5-meter river gauge that was in place at that time.

The evaluated stage was 6.11 meters and the computed stream flow estimated from the maximum flow series logarithmic curve was 674.6 m<sup>3</sup>/s. The return period from the analysis was 33.9 years, Figure 4.23 (a) for a TD 16-type flood with the Gumbel EV1 distribution. Folks in the area indicated that similar flood events in the Mopan occurred with hurricane Hattie in 1961

and in 1946. An analysis of the T-Year Maximum flood was also evaluated and the resulting curve is presented in Figure 4.23 (b).
