# **Environmental and Social Impact Assessments for the Rehabilitation of the George Price Highway from Miles 47.9 - 79.4**

Final Report on the  
Environmental and  
Social Impact Study

**Ministry of Works and Transport  
Belmopan,  
July 27, 2014**

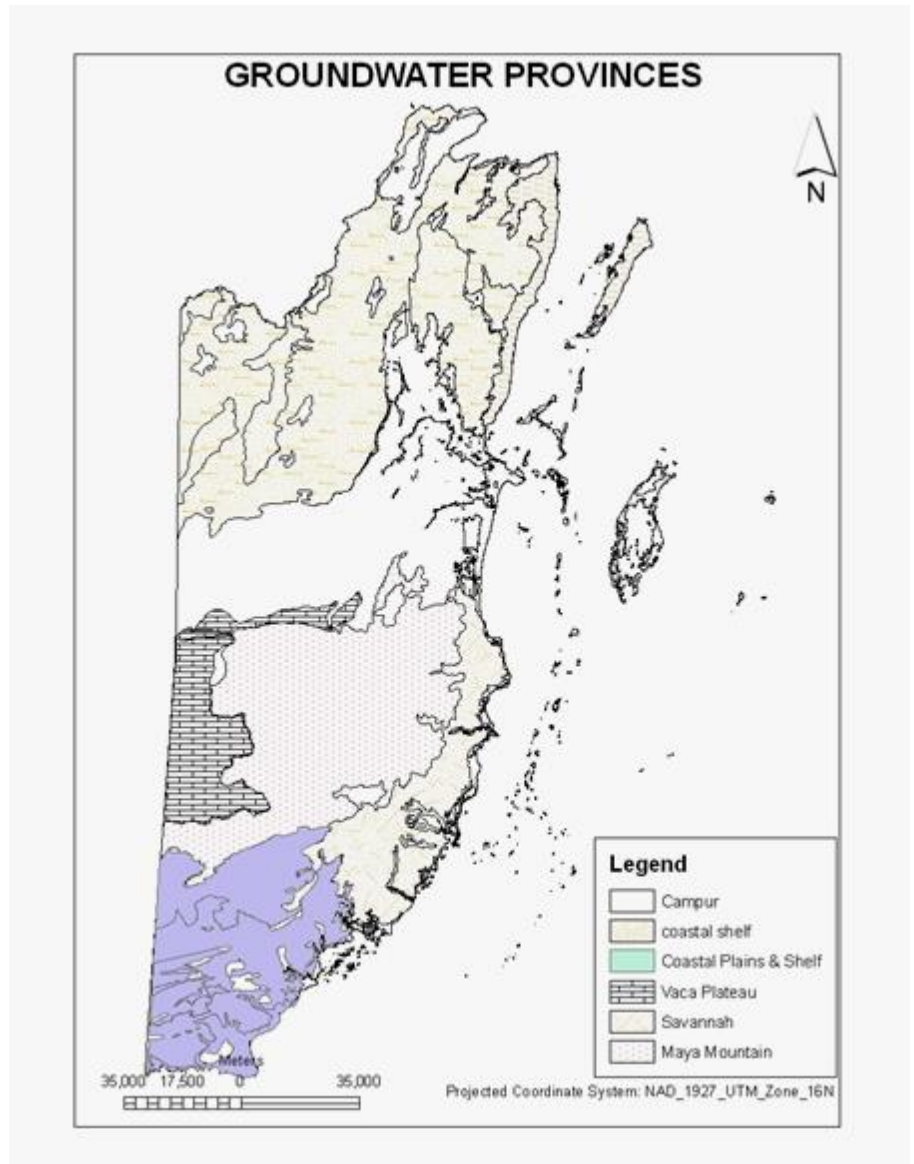
Figure 4.24: Ground Water Provinces of Belize

Groundwater is product of the rainfall regime and the geology of the landscape. Belize's geology is predominantly limestone, with the notable exception of the Maya Mountains that is composed of igneous, metamorphic, and sedimentary rocks that are from 125-320 million years old. Three main groundwater provinces dominate the GBRB from mid to upper Belize River, the Macal and Mopan River sub-basins (Buckalew, *et al.* 1998). These are the Campur, the Vaca and the Maya Mountain provinces, Figure 4.24.

**The Vaca Plateau Province** straddles the western border in the northern Cayo district and includes the western slopes of the Maya Mountains. It is composed of fractured and karstic Triassic superior limestone and dolomites. Springs are abundant and aquifers may be semi or unconfined. Aquifers are recharged from surface runoff in the Chiquibul drainage basin.

**The Maya Mountains Province:** The Maya Mountains Province is composed of late Carboniferous-Permian volcanic material. The rocks have been metamorphosed with abundant dense granitic intrusions. No major aquifer material is expected in this region; however, weathered and fractured metamorphosed mudstones, claystones, phyllites and slates may have exploitable fresh water.

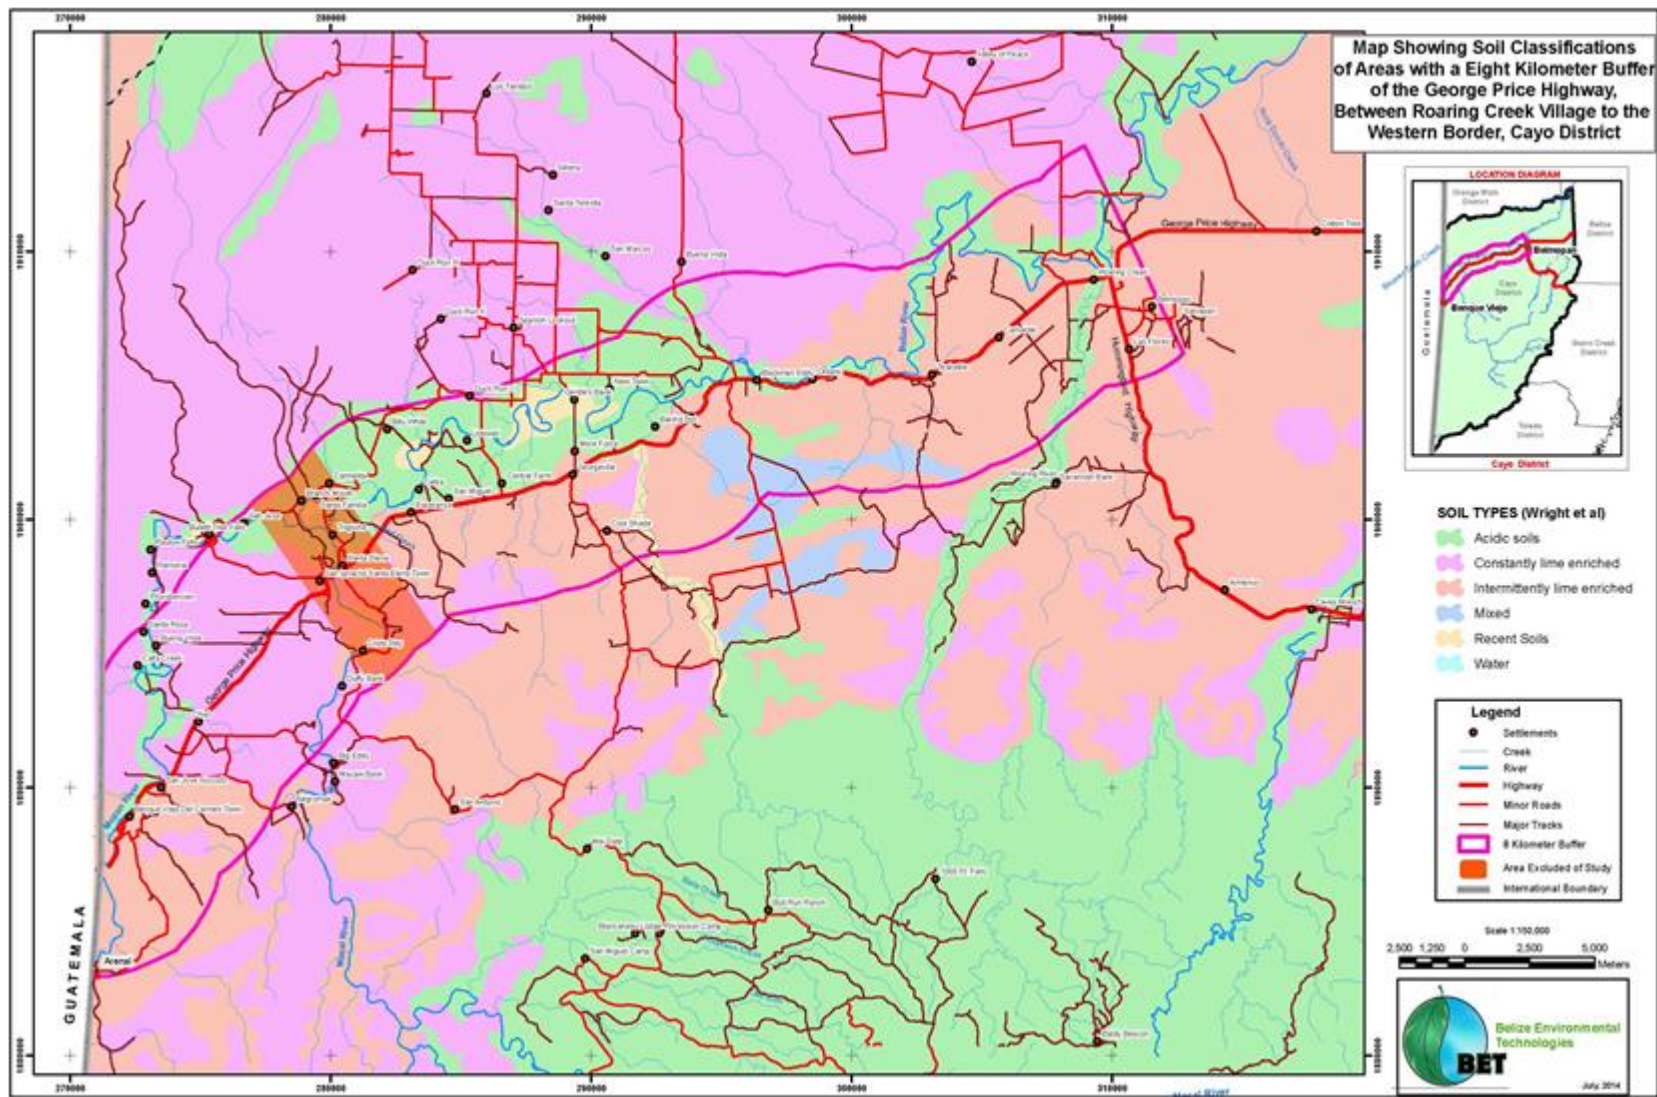
Figure 4.25: Soil Types of Area of Interest.

The area is underlain by Cretaceous limestone, which is a part of the larger block extending into the Vaca plateau, Figure 4.25. However, the natural floristic patterns along this corridor have been seriously disturbed and altered by past and present human settlements and activities.

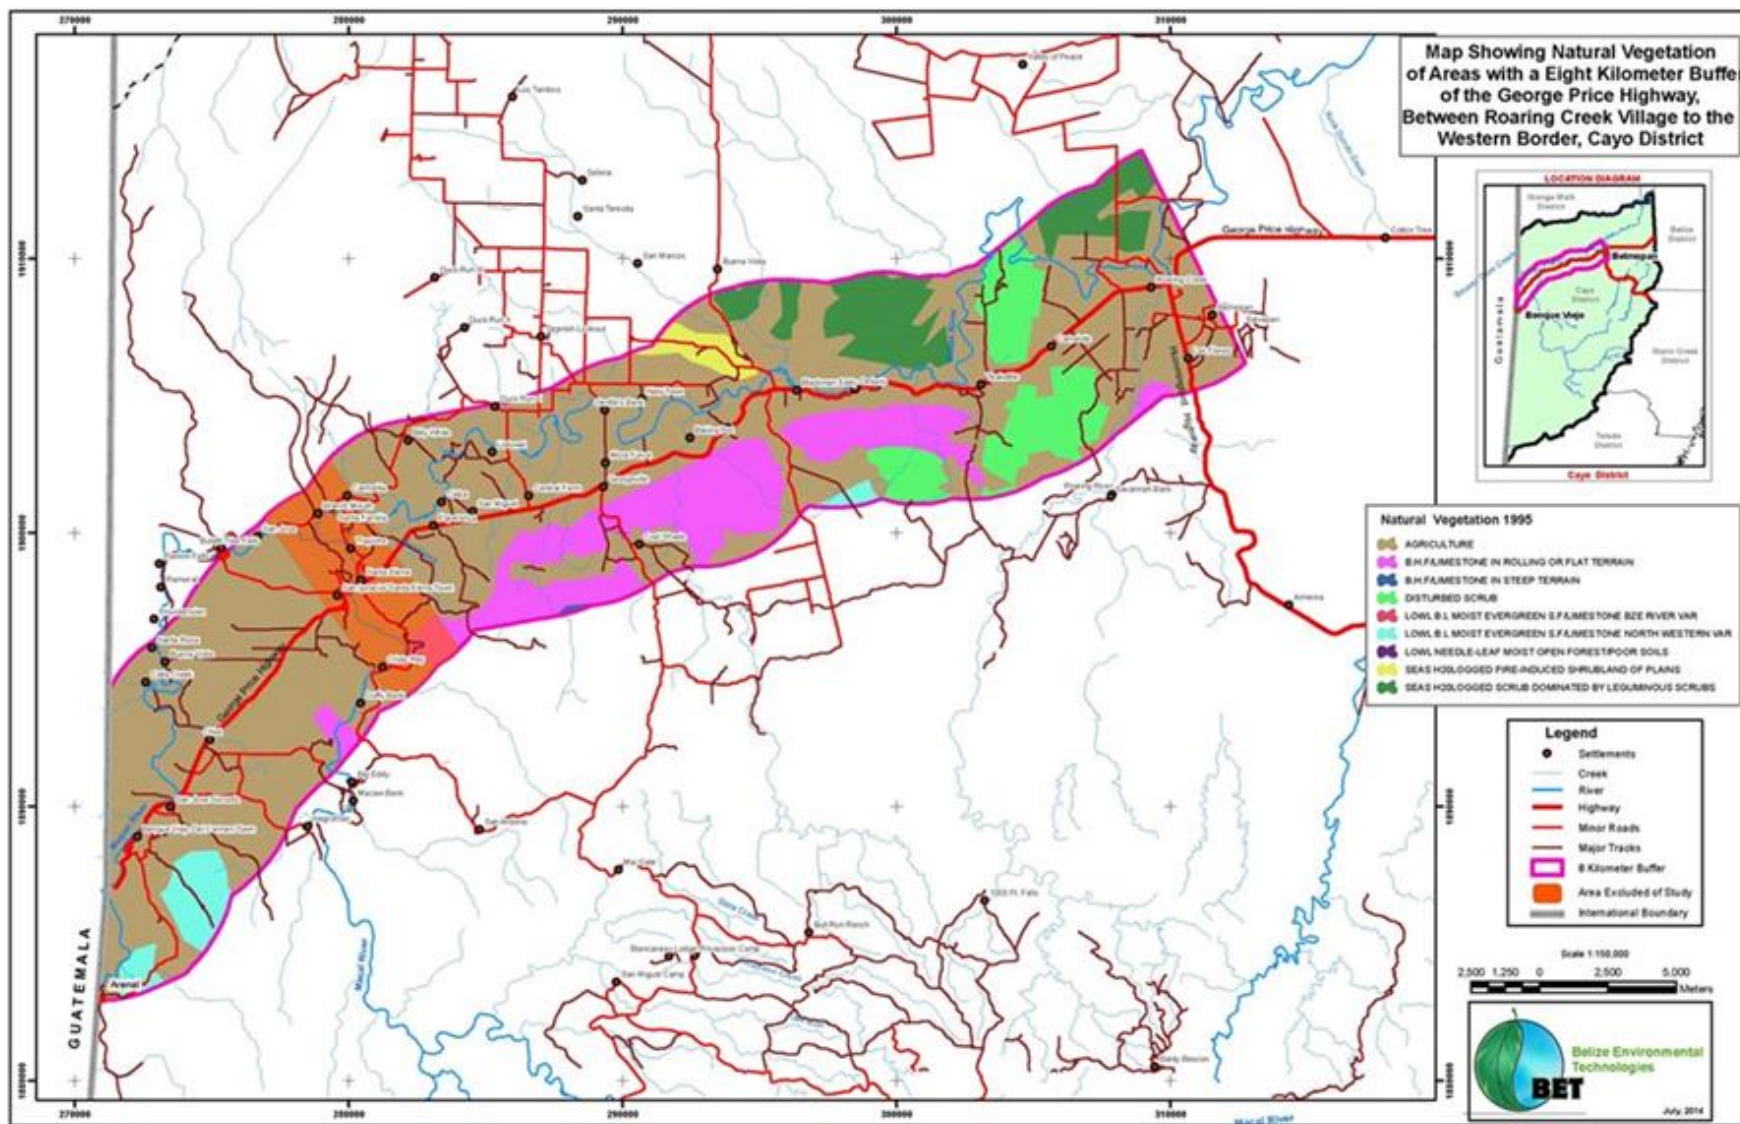
Figure 4.26: 2001 Forest Cover, Vegetation and Settlements.

In the 1950's, the Mennonites entered into an agreement with the then Governor of British Honduras to settle in Belize. Their contribution to the then colony was to develop the agricultural sector particularly in rotational grain crops and chickens. The Mennonites have since cleared the forests in the western and north-western banks of the upper reaches of the Belize River particularly in areas of Spanish Lookout, Duck Run 1, 2 and 3 and Iguana Creek. These areas are now transformed and used for intensive agriculture to grow rotational crops such as corn and beans. Extensive areas are also used for cattle ranching. In these areas under intensive agriculture, few trees are found. Occasionally, isolated cotton trees (*Ceiba pentandra*) and the Guanacaste trees (*Enterolobium cyclocarpum*) are found and these serve as shade for livestock. Figure 4.26, illustrates the vegetation cover of study area.

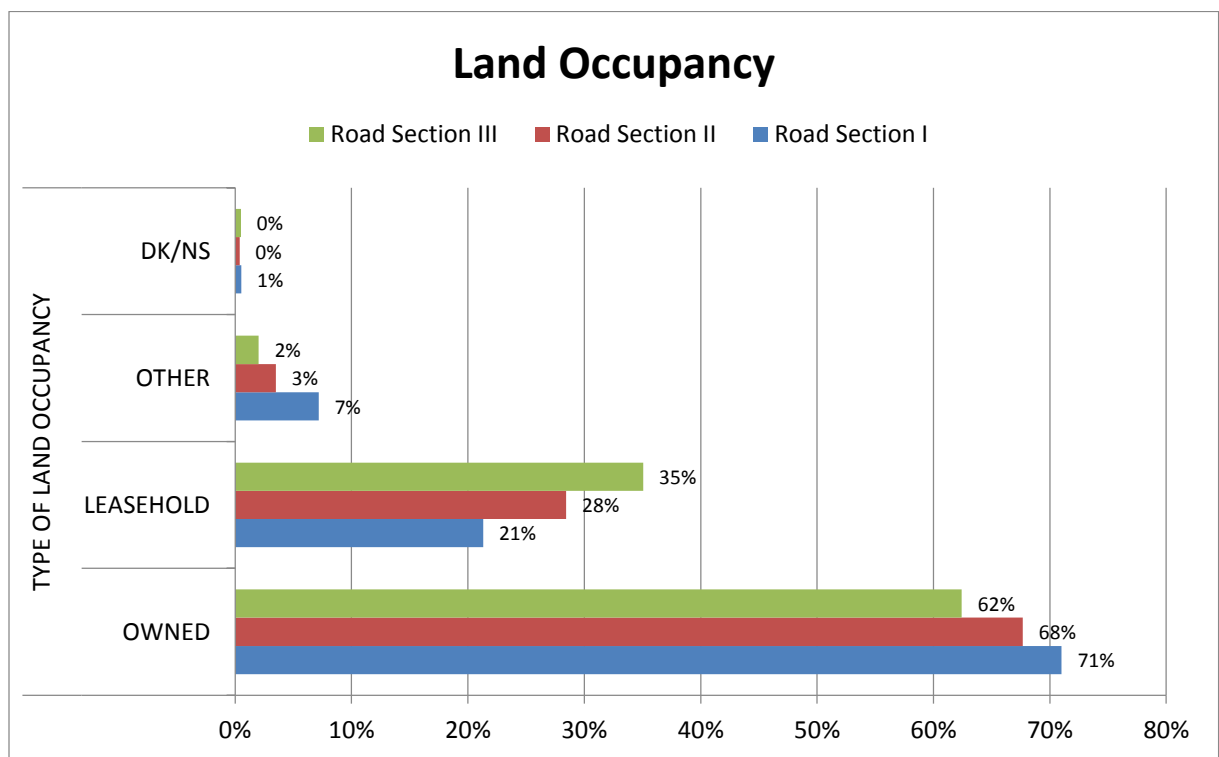
**Figure 5.10: Land Occupancy Rate**

On the average, just fewer than 70% of residents in the Area own the land on which their dwelling is built; a significantly higher proportion of residents in Road Section III only have a leasehold title to their land. Distribution across the road sections is presented in Figure 5.10.

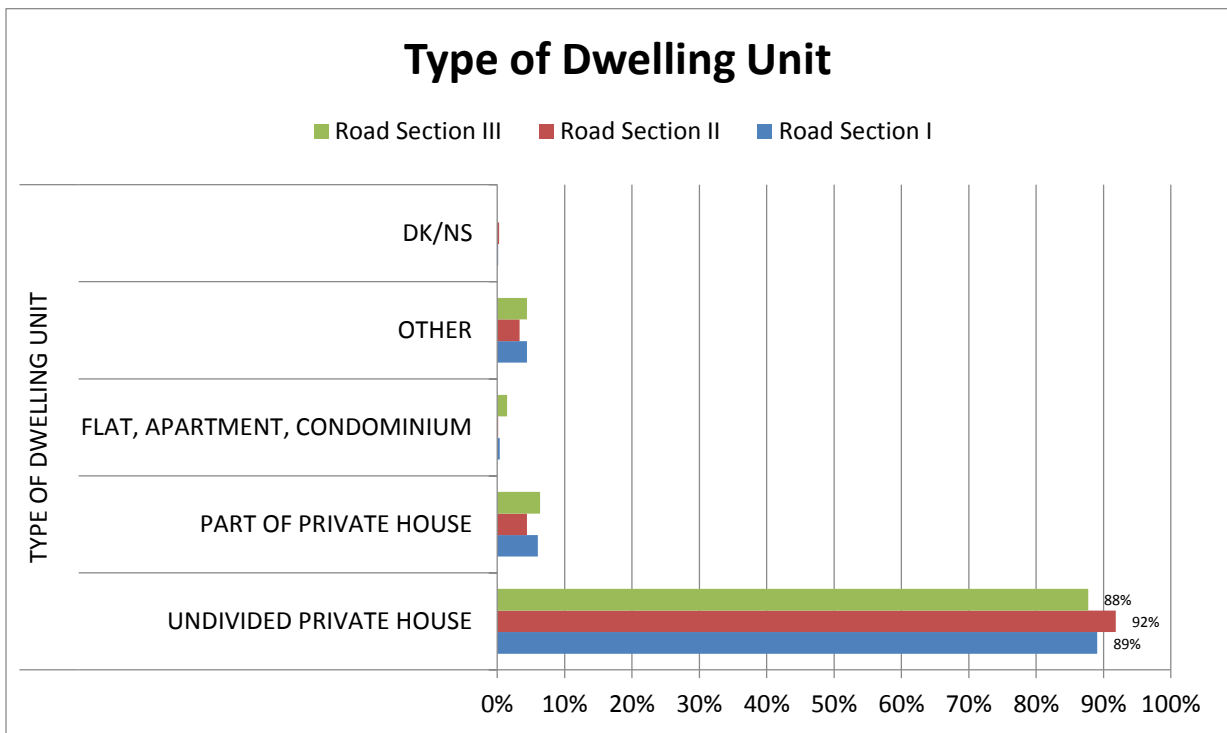
**Figure 5.11: Dwelling Unit Type**

With respect to dwelling units, on the average 9 in every 10 are categorized as an undivided private house. Approximately 25% of dwellings pre-date Independence, while the vast majority of the units were constructed prior to the new millennium. An estimated 50% of residents own their dwelling unit free of mortgage and an additional 17% own with mortgage. Distribution of dwelling unit type, year built and occupancy are presented in Figures 5.11, 5.12 and 5.13 respectively.

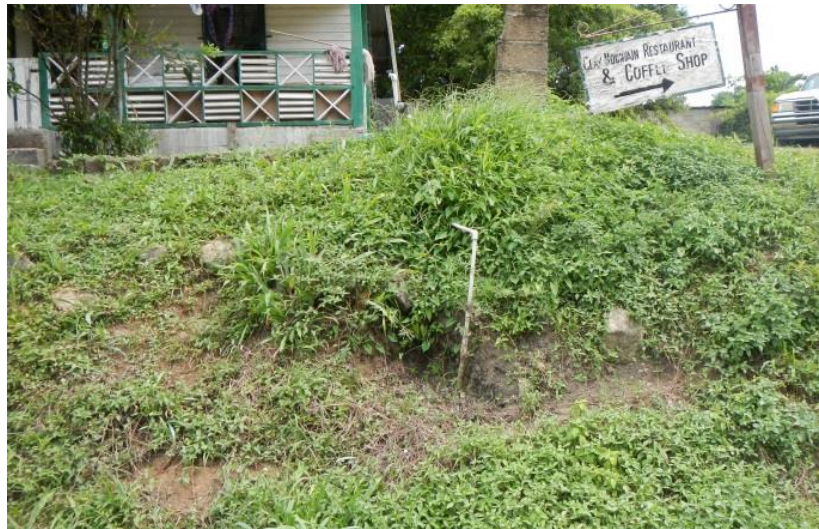
Figure 5.2: Exposed Water Infrastructure along ROW.

The vast majority of households (> 85%) enjoy water piped directly into their dwelling or yard; for the most part, water pipes are in close proximity to the existing ROW, Figure 5.17. A lesser number of households access water from dug wells, streams/rivers. Distribution is as shown in Figure 5.18.

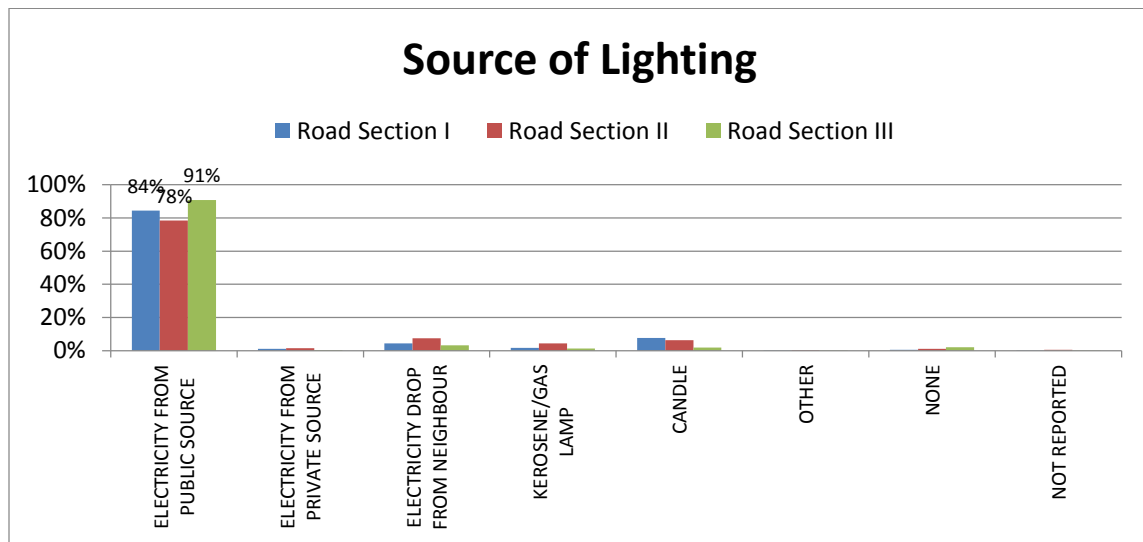
Figure 5.4: Lighting Source

With respect to lighting source, vast majority of households (> 85%) receive electricity from public source, i.e. national grid; few HH are dependent on kerosene lamps/candles, Figure 5.19.

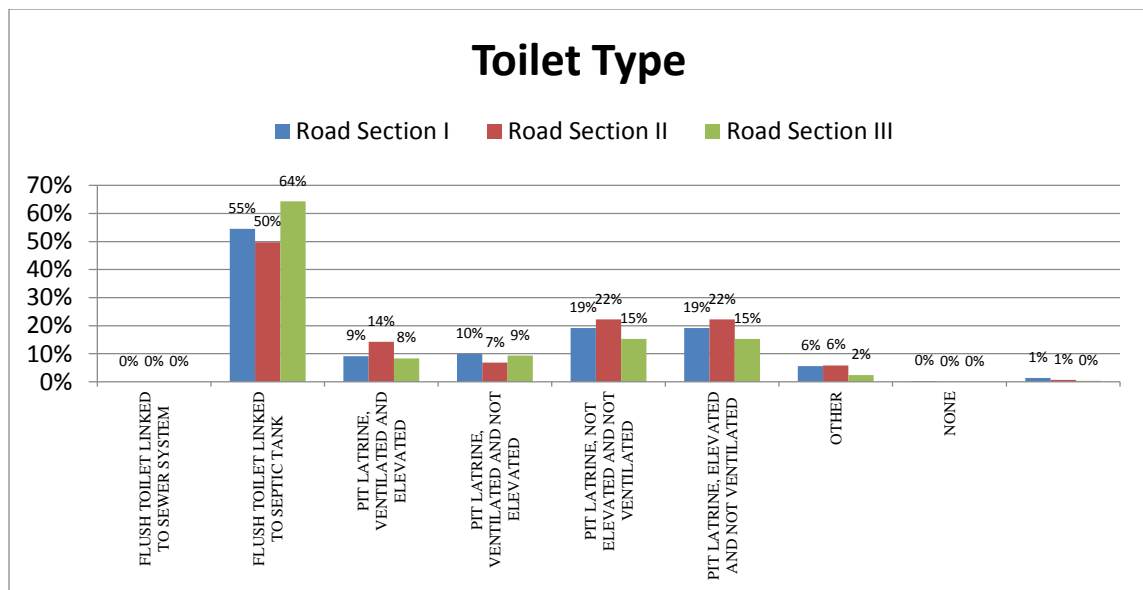
Figure 5.5: Toilet Type

Majority of households (> 50%) in the Area have flush toilets linked to septic tanks with the remainder making use of varied forms of pit latrines for excreta disposal, Figure 5.20.

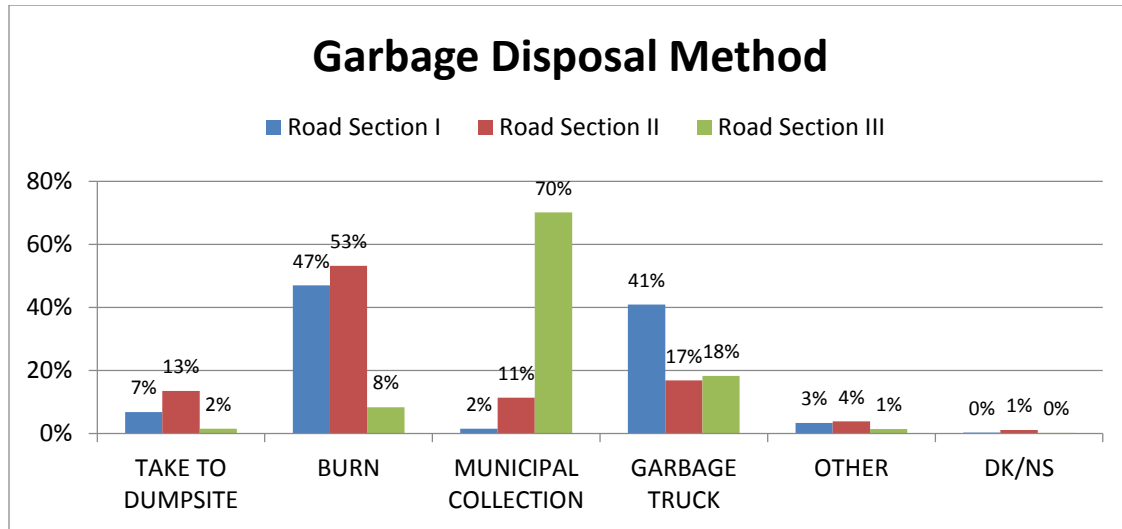
**Figure 5.6: Garbage Disposal**

Significant proportion of households within road Sections I and II report the burning of garbage as a primary means of disposal while other make use of the garbage collections service provided by local government, Figure 5.21.

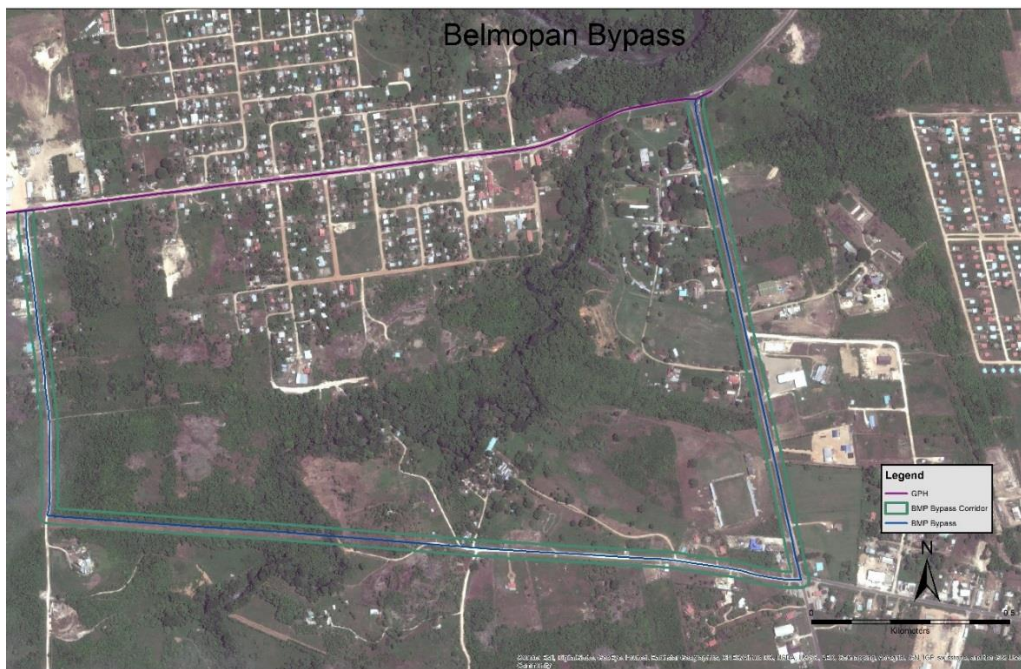
**Figure 5.8: Belmopan – Roaring Creek Bypass**

Bypass 1 is located within the limits of Belmopan City and Roaring Creek Village. This bypass has three sections starting at the GPH/Hummingbird Highway running in a southern direction for 1240m to the junction of the Hummingbird Highway and Butte Rows at the Quality Poultry Products Belmopan distribution center. From this juncture, the bypass turns in a westerly direction along Butte Rows for a distance of 946m where it joins an existing power line corridor leading west across the Roaring Creek River for a distance of 966.6m and a total distance of 1912.6m. The third section of the bypass extends from the junction of the power line corridor and the Roaring River Drive (RRD) headed in a northerly direction for 770.9 m to the junction of the RRD and the GPH. The bypass encompassed a total of 3923.5m, Figure 5.23.

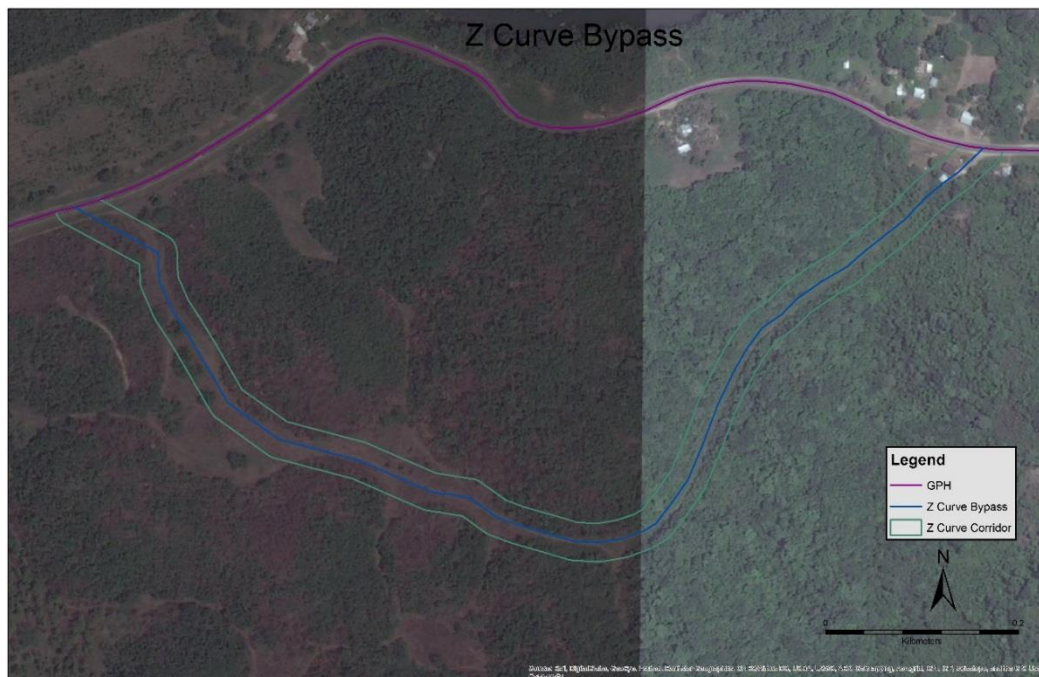
**Figure 5.9: Z-Curve Bypass**

Bypass 2 is located at the western edge of Teakettle Village in an area locally known as the Z-Curve. The possible route identified encompasses an old road access starting just east of the Z-Curve and diverting to the south along the base of ‘Lucy’ Hill to the west of the Z-Curve; this bypass area encompasses a total length of 1283m, Figure 5.24.

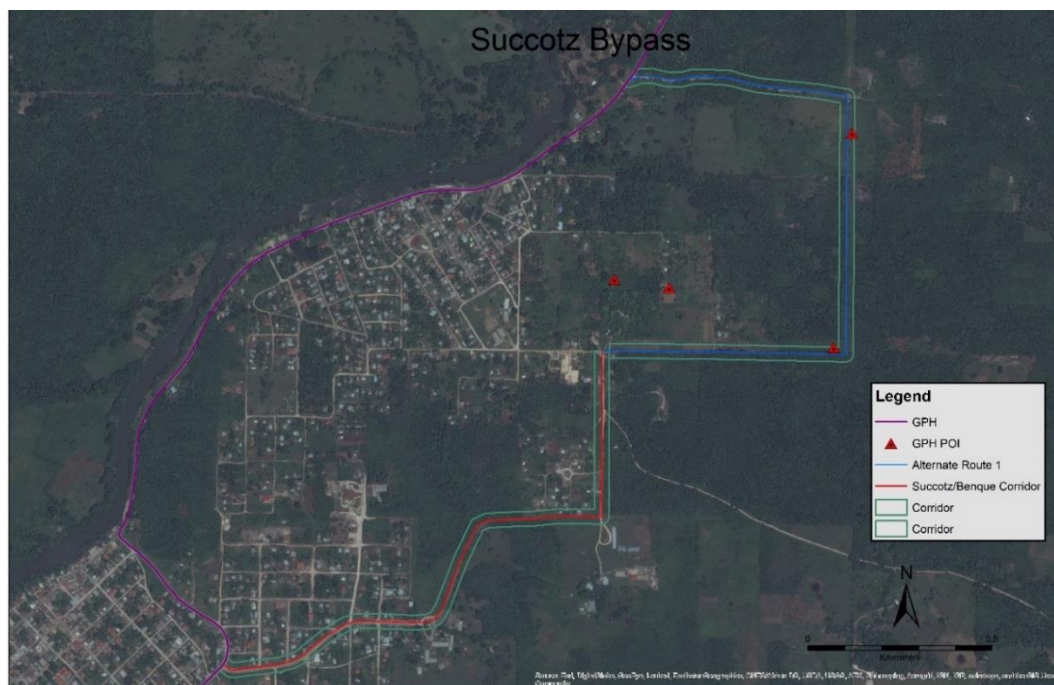
**Figure 5.10: Succotz Alternate Route 1**

Alternate Route 1 starts at the junction of the GPH and the old Negroman Road, just south of the Trek Stop and heads east along the old Negroman Road for a distance of 590.7m. From this point the route turns south for 665m then west for 287.5m along an existing power line corridor. At this point the route converges with an existing feeder road and continues west for 379m to the point where all the routes converge. Alternate route 1 encompasses a length of 1951.2m, Figure 5.25.

Bypass 3, Alternate Route I: Along the proposed Alternate Route I, three small mounded features were identified through LiDAR analysis. However, the pedestrian survey determined that these features were in fact modern bulldozed piles created during the construction of the power line corridor. It must be noted however, that a visual inspection of the area indicated ceramic scatters that must be interpreted as partially or wholly destroyed ancient archaeological features along the corridor. Extreme caution should be taken in the areas of GPS coordinates E. 274592 N. 1890593 and E. 274542 E. 1890012 if this route is decided upon.

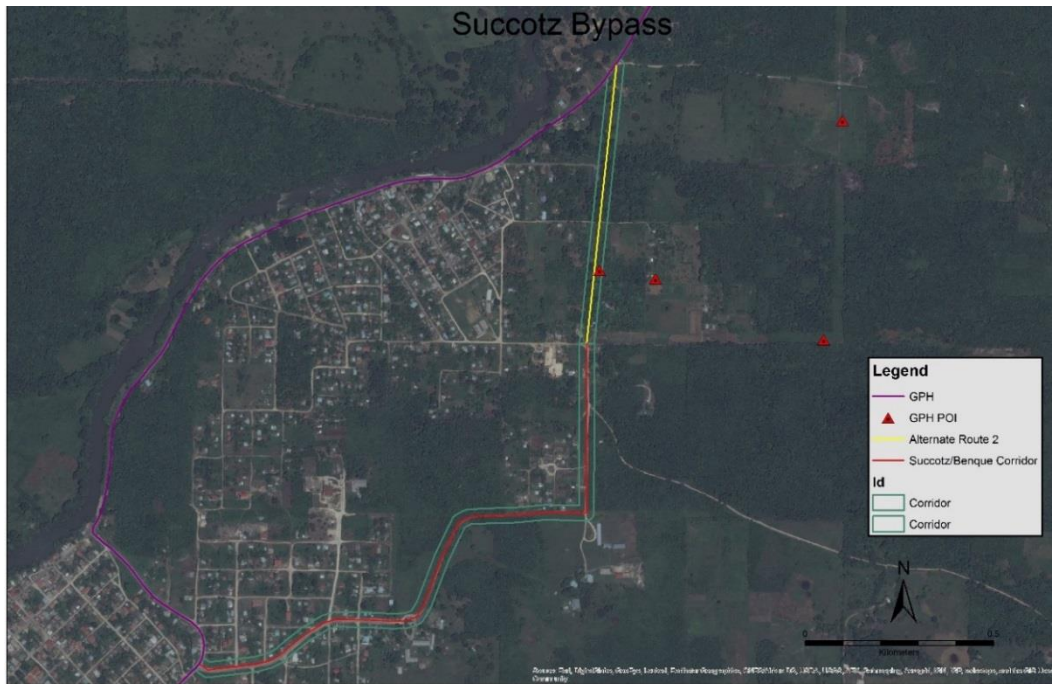
**Figure 5.11: Succotz Alternate Route 2**

Alternate Route 2 starts at the old Negroman Road and extends for 741.6m south where it converges with the other alternate routes.

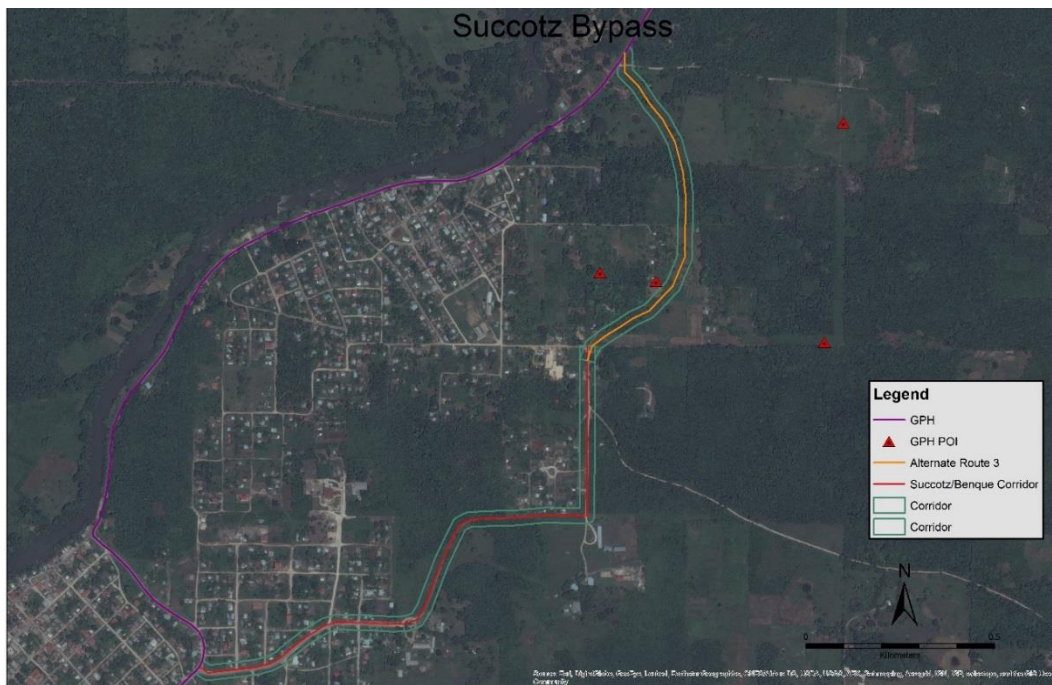
**Figure 5.12: Succotz Alternate Route 3**

Alternate Route 3, like Alternate Route 2, also starts at the old Negroman road and extends to the south in the form of an arc to the point of convergence of the routes. This route measures 910m in length, Figure 5.27.

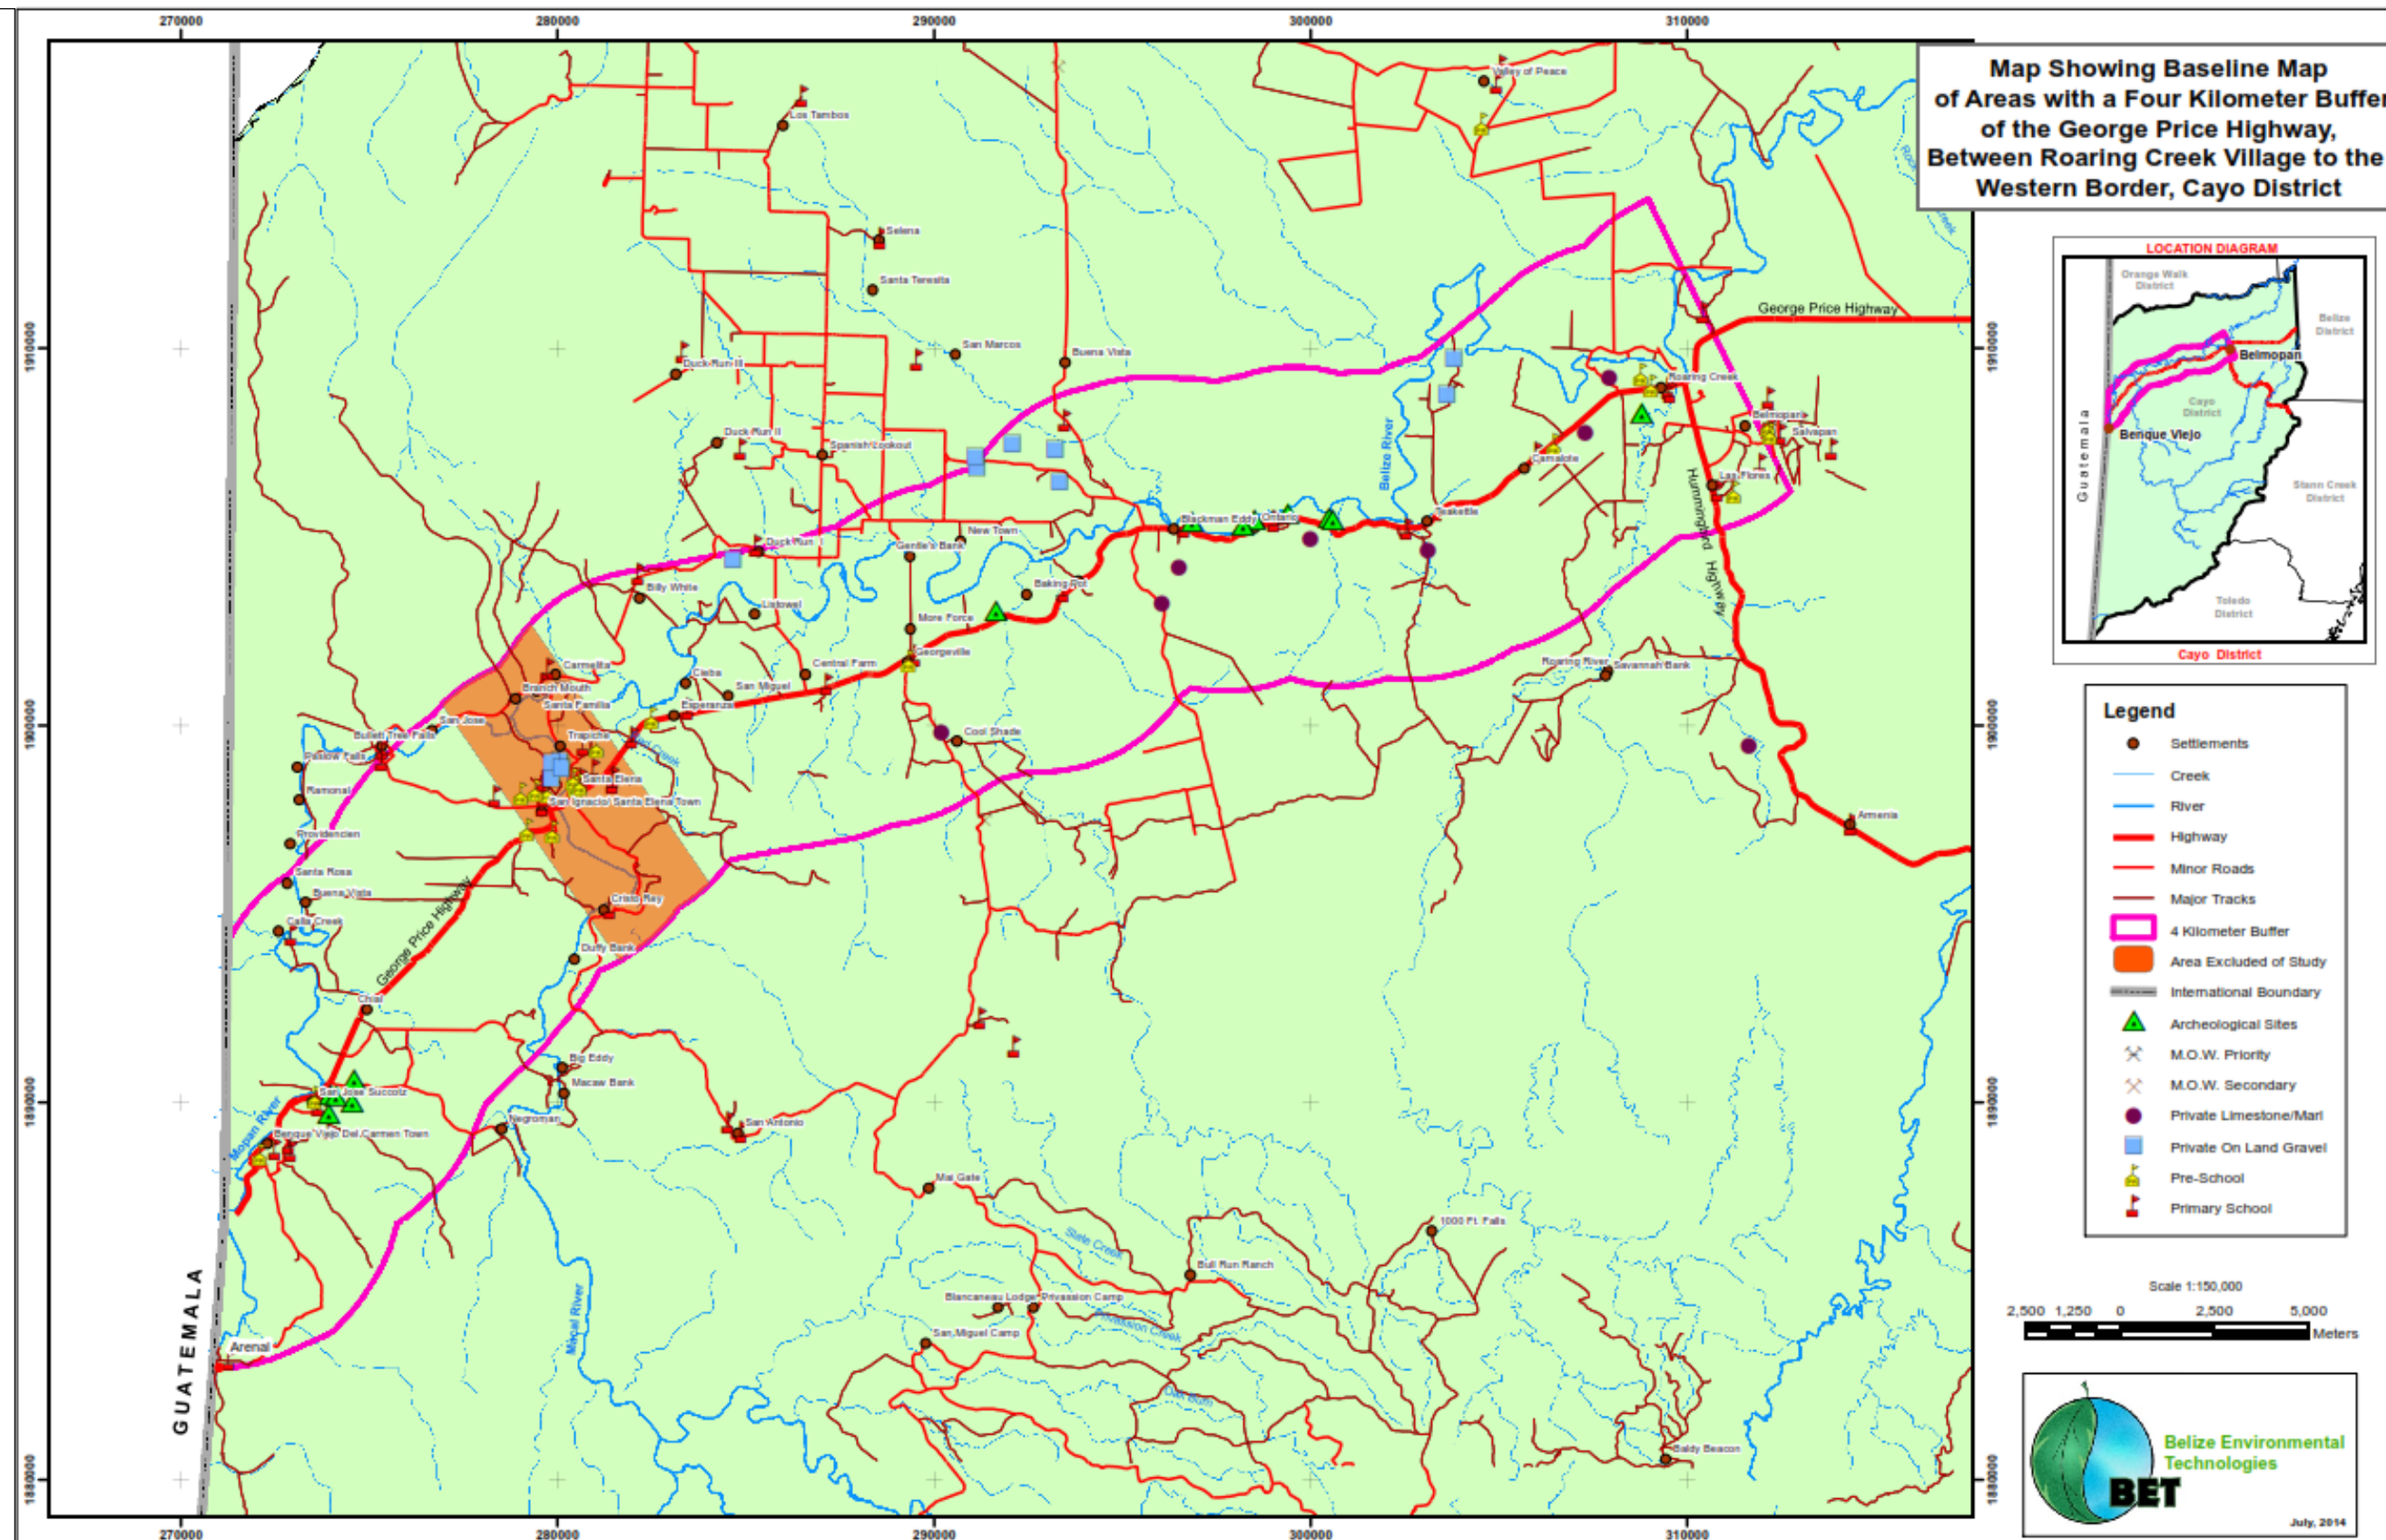
Figure 5.30: Baseline Map showing Archaeological sites, schools etc.

The site center of Warrie Head is located on the north side of the George Price Highway, about 200 meters west of the bridge and about 1.5 kilometers west of the Z curve. The site, which is located on private property belongs to John Searle Sr., was first reported by a Harvard University project in 1954 (Willey et al. in 1965: 310-312). The site is composed of at least three plaza groups and several other solitary mounds. The assessment indicates that there are two sets of mounds belonging to the Warrie Head settlement that can be impacted by the road rehabilitation project. The first of these is located on the south side of the road at GPS point E 300477 N 1905479. This mound appears to have been previously damaged by past widening of the carriageway. The other mounds are part of a small plazuela group and are located across the road from the solitary mound within the Searle property. Their GPS coordinates are E 300583 N 1905461. Although the mounds are situated just inside the wire fence of the Searle’s farm, any widening of the highway in this area will certainly damage them, Figure 5.30.

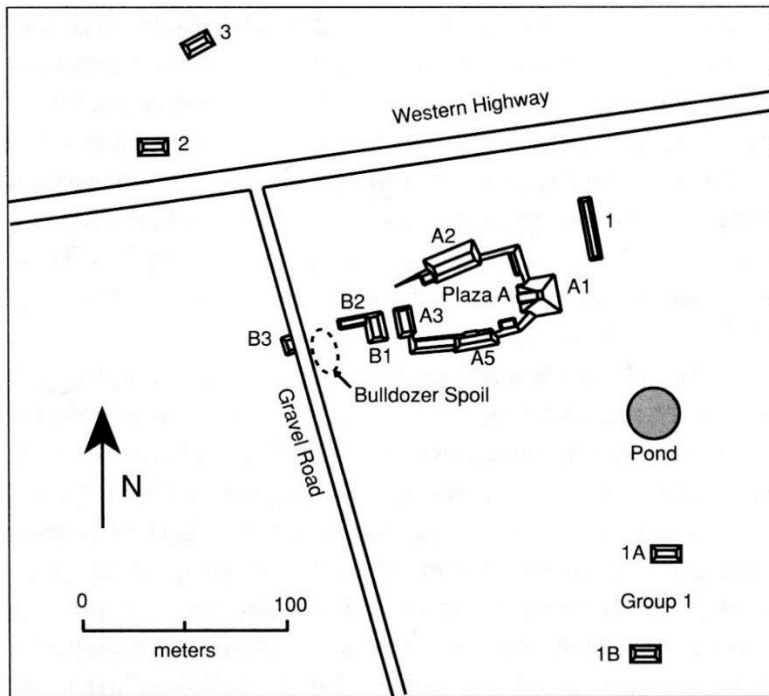
**Figure 5.31: Map of Ontario Site**  
E 296830 N 1905387.

The Ontario Site is located at the eastern entrance of Ontario Village, just south of the Highway near its entrance to the village, Figure 5.31. The site was first recorded by the Belize Department of Archaeology in 1969, and then investigated by James Garber in the late 1990's (Driver and Garber 2004:297-301). While the site core is beyond the 100 feet corridor, there are two plaza groups and a solitary mound on the western edge of the village that could likely be affected by the road rehabilitation project. The GPS coordinates for these mounds are as follows: E 299385

N 1905622; E 298502 N 1905452; E 298190 N 1905301. West of Ontario, near the entrance to Blackman Eddy Village, there is another plaza right along the southern edge of the Highway. The Assessment determined that previous road works totally destroyed the northern mound of the courtyard and damaged a section of the eastern mound. The GPS coordinates for the mounds are

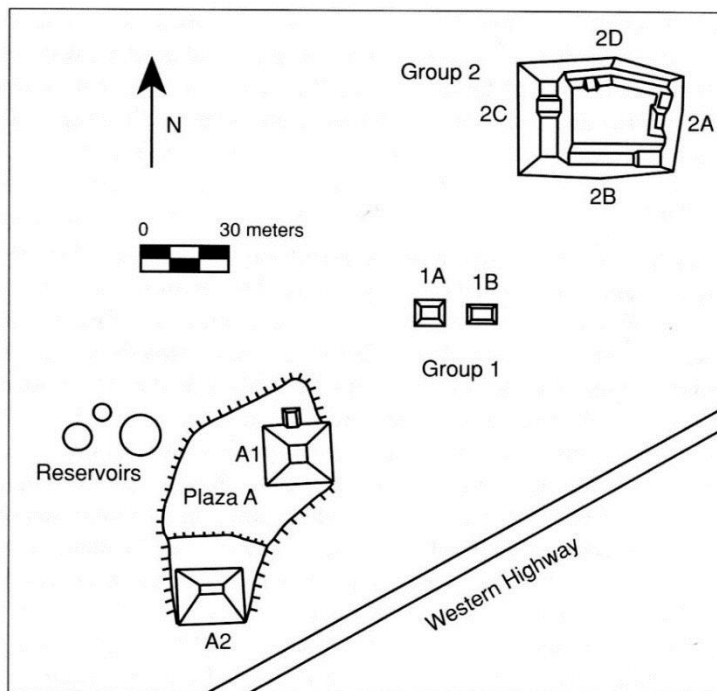
**Figure 15: Map of Floral Park**

The site of Floral Park, Figure 5.32 is located about 100 meters west of the Barton Creek Bridge. The site consists of two main mound groups (A and C) with two small mounds (B1 and B2) in between. Floral Park was first reported by Willey et al (1965:310) and briefly explored by James Garber in the 1990s (Driver and Garber 2004). While there is limited concern for potential damage to Group C, the same cannot be said for Group A. Indeed, Structure A2, which is connected to Structure A1 by a low sacbe (causeway) was already damaged by previous widening of the Highway. This mound is a significant structure that likely served as a small temple or shrine. It is therefore imperative that road works avoid this building. GPS coordinates

for this mound are E 291633 E 1903038.

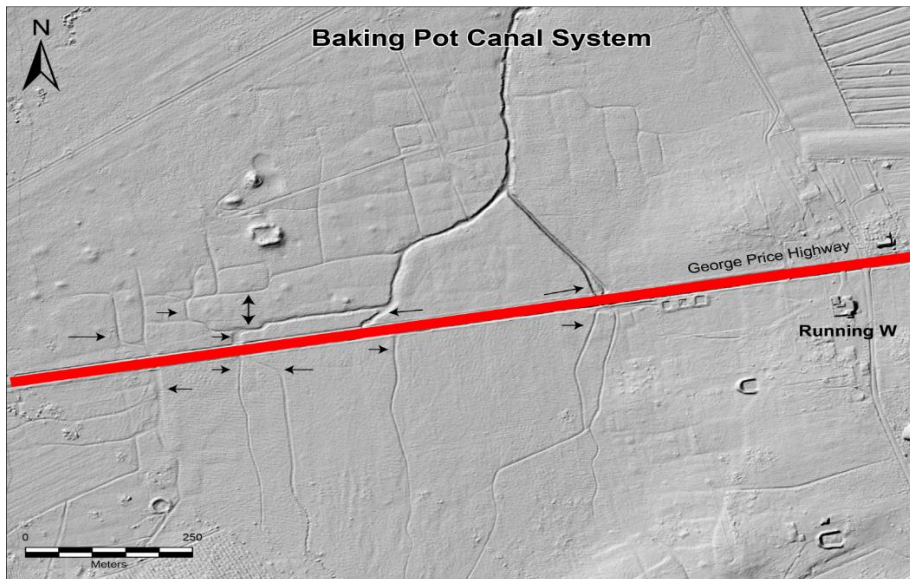
### **Figure 5.33: LiDAR Image of the Baking Pot Canal System**

Neither the Baking Pot site core or Esperanza are located adjacent to the Highway, thus it is unlikely that they will be affected by planned construction. In contrast, however, there are several ancient canals in the Running W property that can be affected by future construction. These canals are connected to a mound group designated as the Bedran Group that are located on the north side of the Highway, just west of the Running W Meatshop, Figure 5.33. The mounds were previously investigated by Awe's BVAR Project and reported in several publications (see Conlon 1993; Conlon and Powis 2004; Collas et al. 2002).

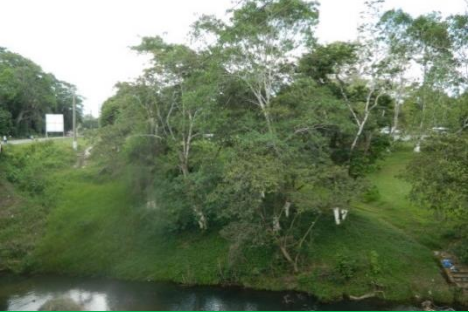
Road Section/ Significance	Community	Type and Description of Property	Image
<b>RS I Proposed location of new Roaring River crossing</b>	Belmopan	Lands located adjacent to the Agriculture Show Grounds in the south-eastern quadrant of the Roaring Creek bridge; portion lies within the existing road buffer and the other portion lies within the actual Show Grounds. Public Land

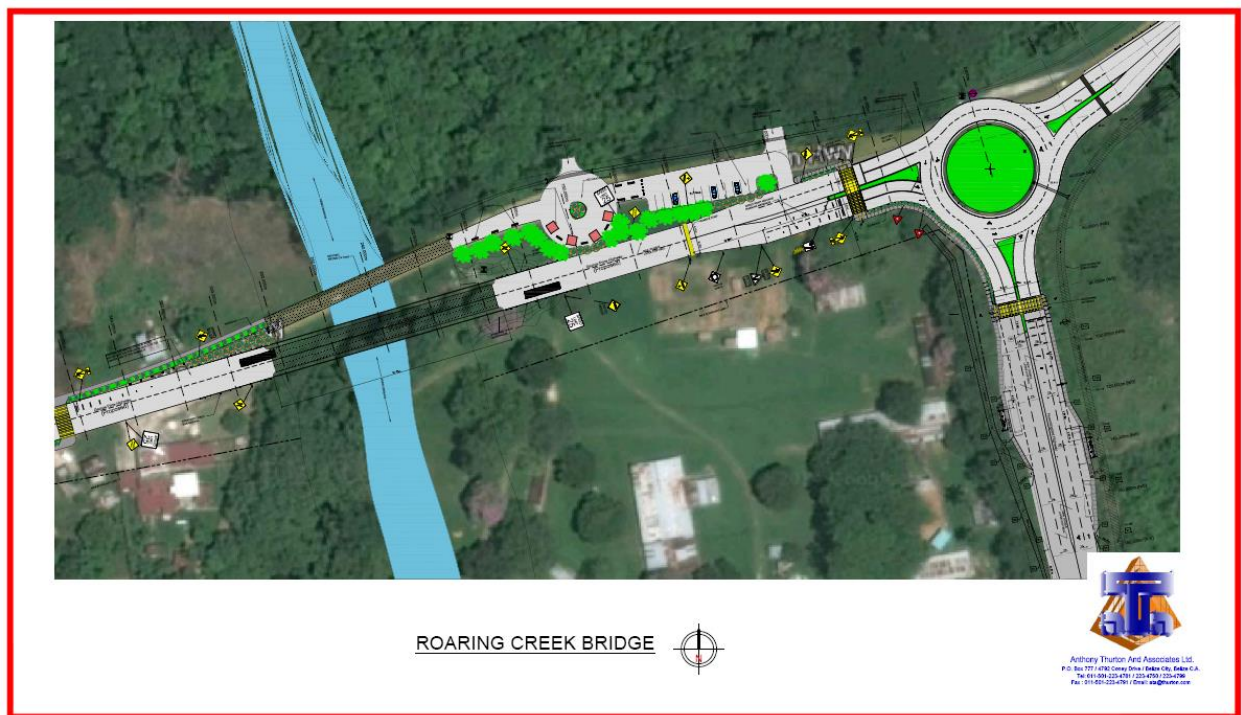
**Figure 6.1: Proposed Realignment and New Crossing at Roaring Creek**

This alternative would require that a small narrow section of the Agriculture and Trade Show grounds be acquired as well as two narrow strips of private property on the other side of the bridge to allow for realignment of the highway at the Roaring Creek crossing. The new bridge is proposed to be constructed 1m above the high water level and would be of the required width of 43 feet including sidewalks.

This alternative would also allow for maintaining the old Roaring Creek Bridge as a by-pass during construction, a tourist attraction and historical landmark, and as a pedestrian and cycle crossing after construction. It would also allow for the relocation of the Guanacaste Park

entrance allowing for safer access and egress and the beautification of the remaining open space area, Figure 6.1.
