# **Environmental and Social Impact Assessments for the Rehabilitation of the George Price Highway from Miles 47.9 - 79.4**

Final Report on the  
Environmental and  
Social Impact Study

**Ministry of Works and Transport  
Belmopan,  
July 27, 2014**

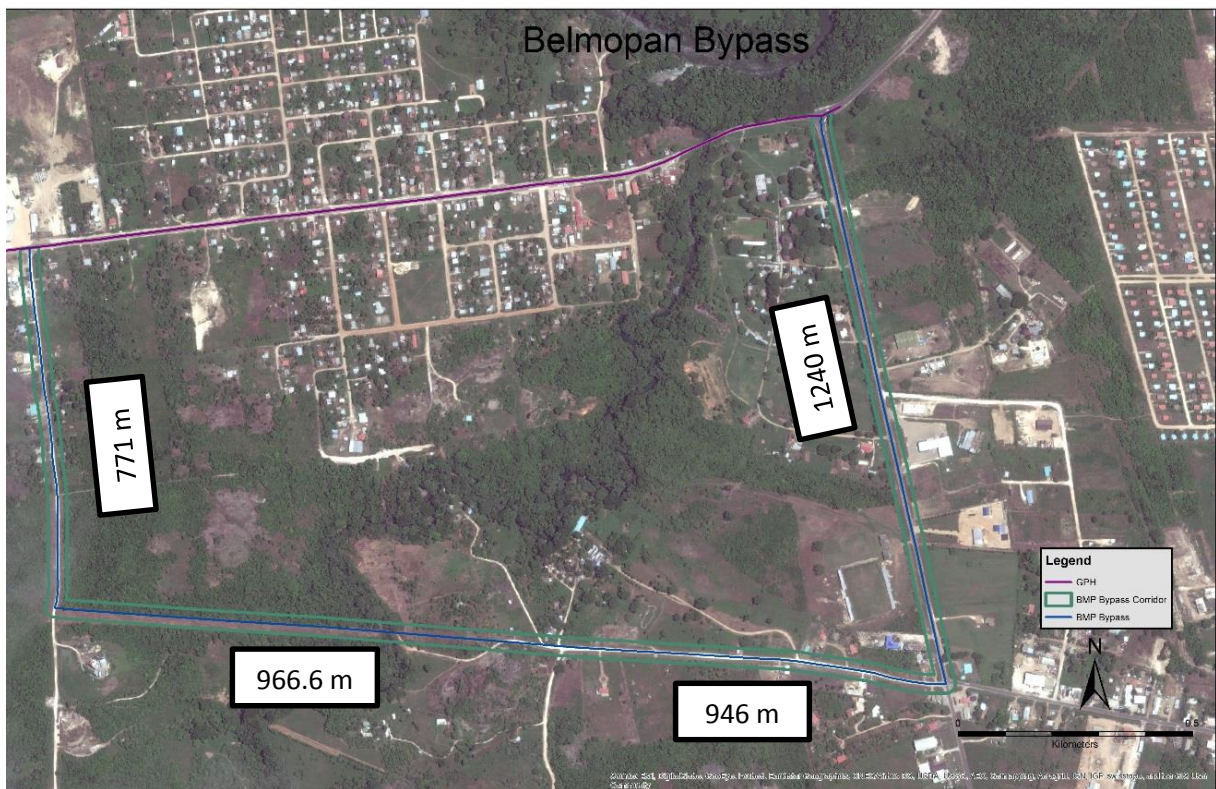
**Figure 6.2: Belmopan – Roaring Creek Bypass**

### Alternative 3: Detour

This means that this option would require the acquisition of approximately 967m of road ROW from private land owners. On a positive note, this land for the most part is free of any

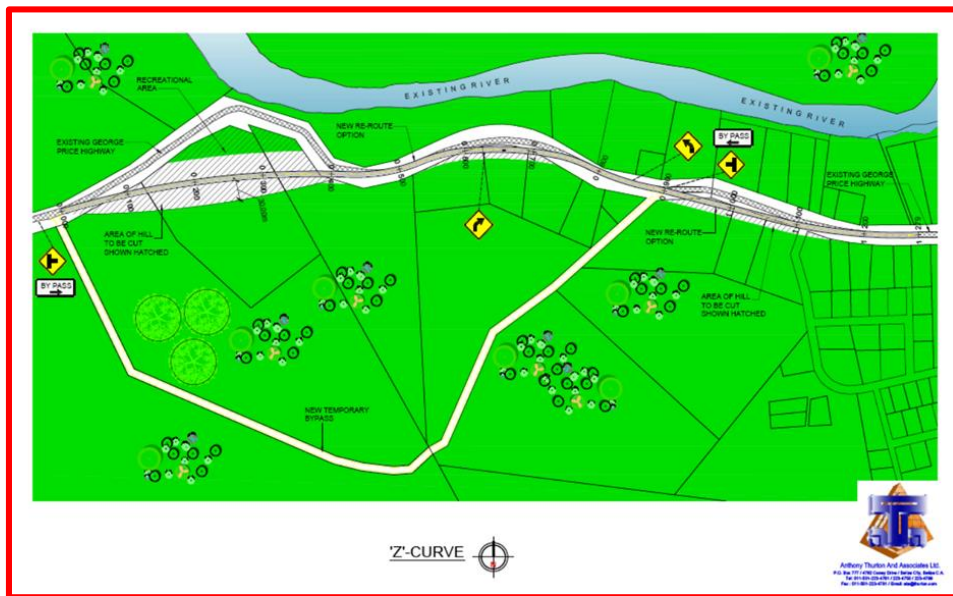
**Figure 6.3: Option 2: Proposed Realignment of Road through Z-Curve Hill.**

Alternative 2 involves cutting through the hill such that the horizontal curve is no longer an issue. Again, the old road that goes around the hill is proposed to be used as temporary bypass while this activity is taking place.

This option will require a significant amount of cutting and earth moving activities to allow for the 100 feet ROW and the proper sloping and stabilization on both sides of the cut with a minimum gradient of 1.5 to 1 ratio.

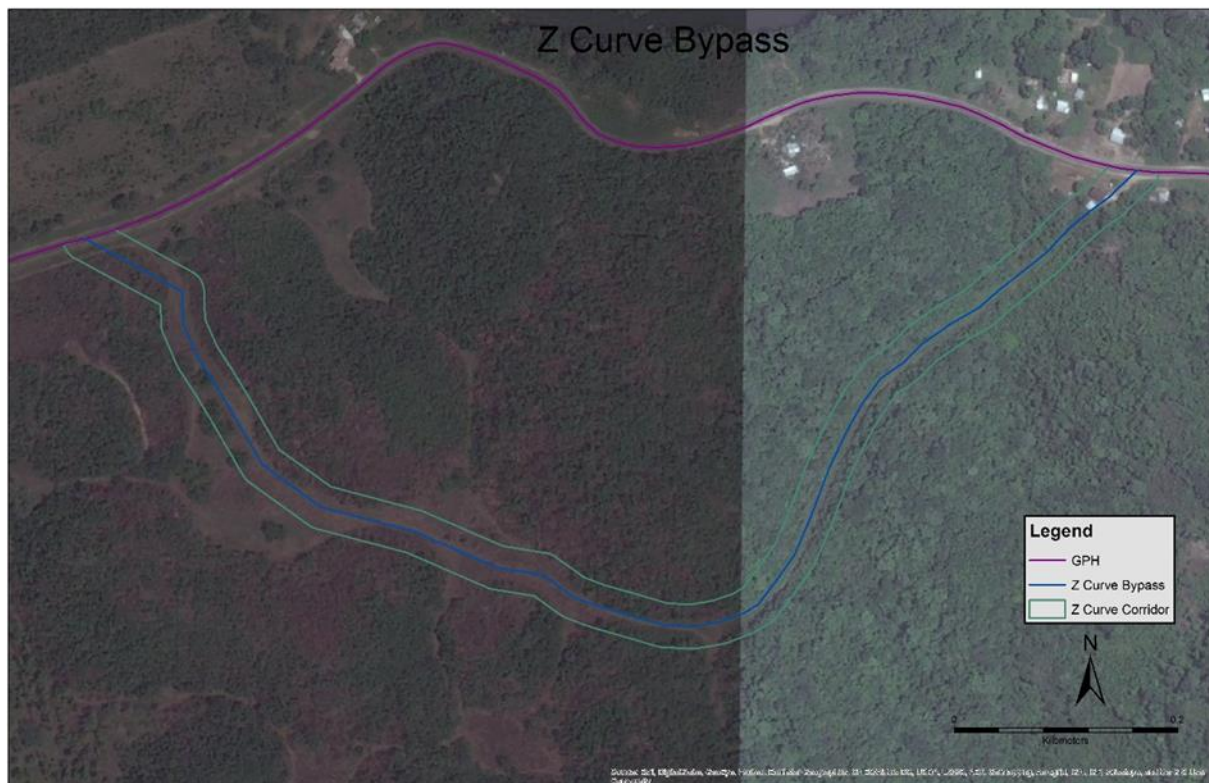
**Figure 6.4: Proposed Bypass/Detour around Z-Curve**

This alternative proposes to use an old road that goes around the Z-Curve area, which is also proposed in Alternatives 1 and 2, to be utilized as a temporary bypass during construction. The possible route identified encompasses an old road access starting just east of the Z-Curve and diverting to the south along the base of 'Lucy' Hill to the west of the Z-Curve; this bypass area encompasses a total length of 1,283m, Figure 6.4.

This alternative considers the upgrading of the old road to provide for a permanent detour allowing for the flow of traffic in opposite directions around the hill. This option would require the acquisition of considerable amounts of land for the approximately 1,283m length of ROW. This also has the potential for having the highest biodiversity impact of all the alternatives, as it would cut through one of the few remaining forested areas within the Project Area. In addition, this option also has the potential to adversely impact the hydrology of the area if the appropriate mitigation measures are not implemented.

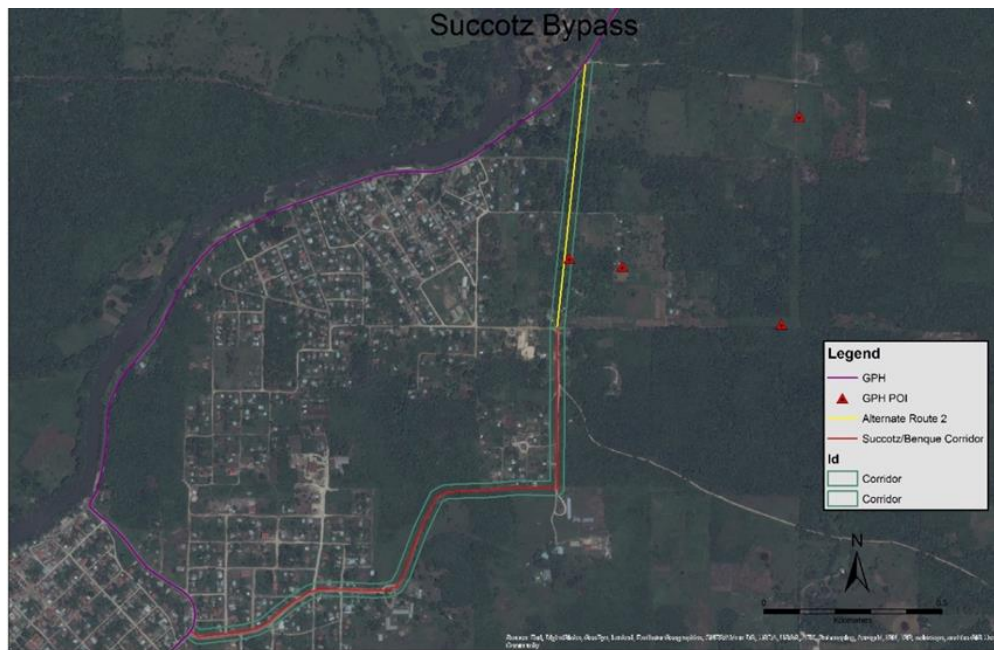
**Figure 6.5: Succotz Alternate Route 1**

This option provides a simple link between the highway and the existing road network located in the higher areas in Succotz that would bypass the flood prone areas of the GPH. It starts at the old Negroman Road and extends for 741.6m south where it converges with the streets behind Succotz as shown in figure 6.5.

This option would require the acquisition of land for the ROW and the construction of a bridge. It would also require that the existing streets be paved to allow for climate proofing and the all-weather use of these roads during flood events on the GPH. It would also require mitigation for two archaeological points of interest identified in the area of the proposed ROW. It is recommended that this bypass be designed and constructed to allow for easy and safe access in line with MOWT Street Standards as opposed to international highway specifications..

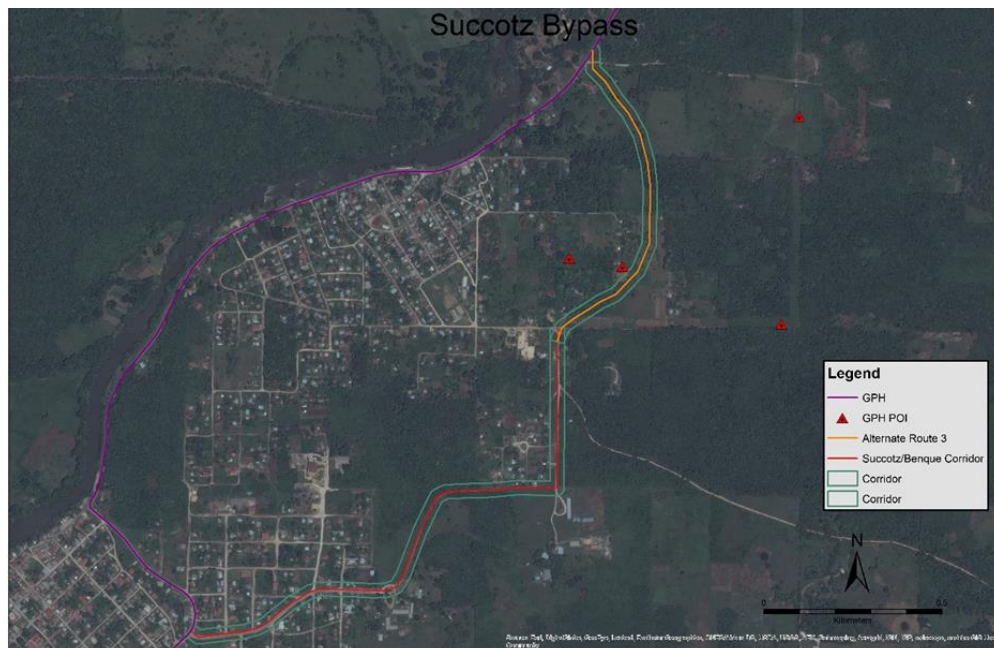
**Figure 6.6: Succotz Bypass Option 2**

Alternative 3 is somewhat similar to alternative 2 and also starts at the old Negroman road and extends to the south in the form of an arc to the point of convergence with the streets behind Succotz as shown in Figure 6.6.

This route measures 910m in length and would require the construction of a bridge but would allow for the avoidance of existing buildings and archaeological points of interest. This option would however require the acquisition of more land in comparison to the Succotz Bypass Option 1 but would also require that the road be paved. It is recommended that this bypass be designed and constructed to allow for easy and safe access in line with MOWT Street Standards as opposed to international highway specifications.

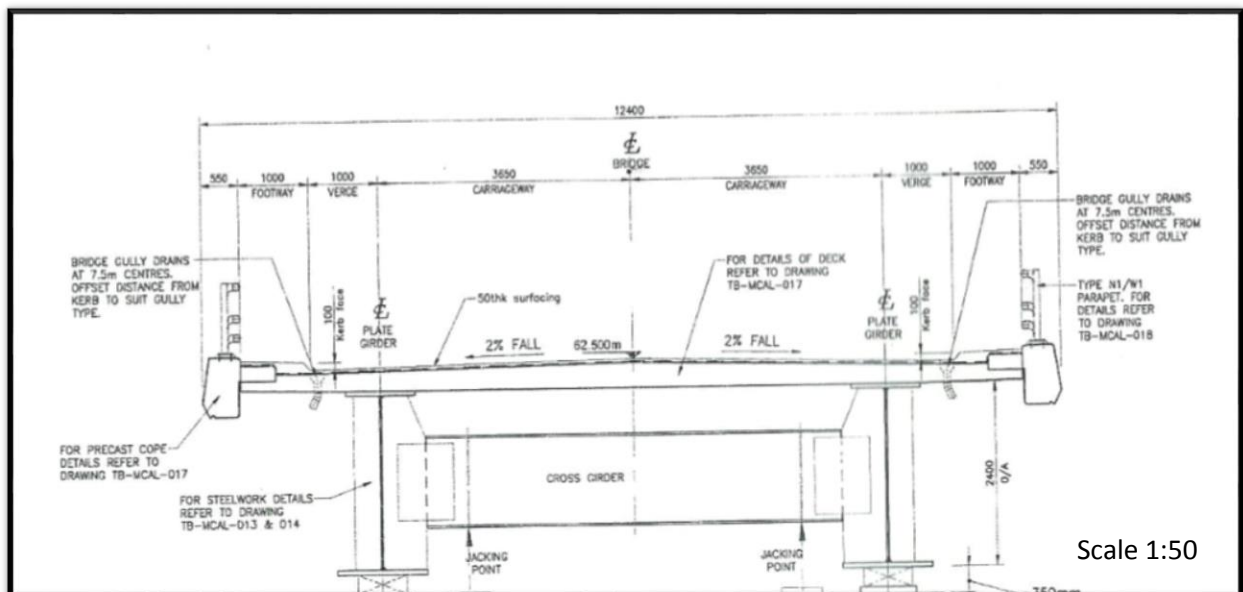
Figure 7.2: Typical Bridge Cross-Section; Source Anthony Thurton and Associates

A typical cross-section of the proposed bridges at the Roaring River, Barton Creek, Garbutt Creek, and Red Creek crossings consistent with international standards and taking into account key environmental, social and economic considerations is depicted in Figure 7.1. In this regard, it is proposed that all these bridges be raised above the existing flood lines and their river banks stabilized to mitigate against flooding and erosion respectively. In addition measures are being proposed for upstream and downstream obstruction to allow free flow thereby reducing the potential for flooding. It is also recommended that MOWT explores performance service contracts with local governments for the maintenance of these streams, creeks and drains. In particular, the proposed bridge at Roaring Creek will be a 3-span length bridge raised one-meter above the flood line designed for a 1 in 100 flood return cycle; abutments of the bridge are to be located outside of the main river flow (banks of the Roaring Creek) with stabilization of the river banks to prevent erosion.

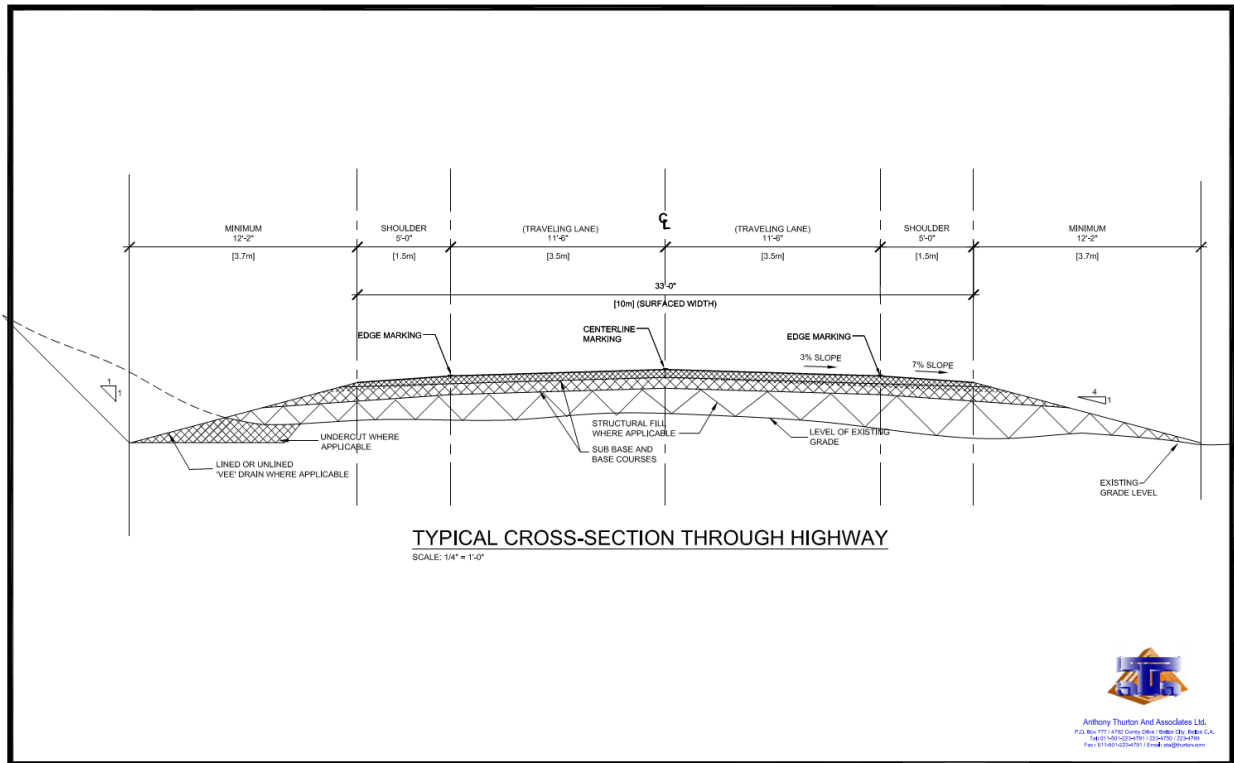
Figure 7.2: Typical Cross-Section Through Highway, Source Anthony Thurton and Associates

In similar manner, typical general road cross-section and cross-section through populated communities of the rehabilitated GPH are depicted in Figures 7.2 and 7.3 respectively. As noted in the Figures, road safety designs for pedestrians are completely considered.

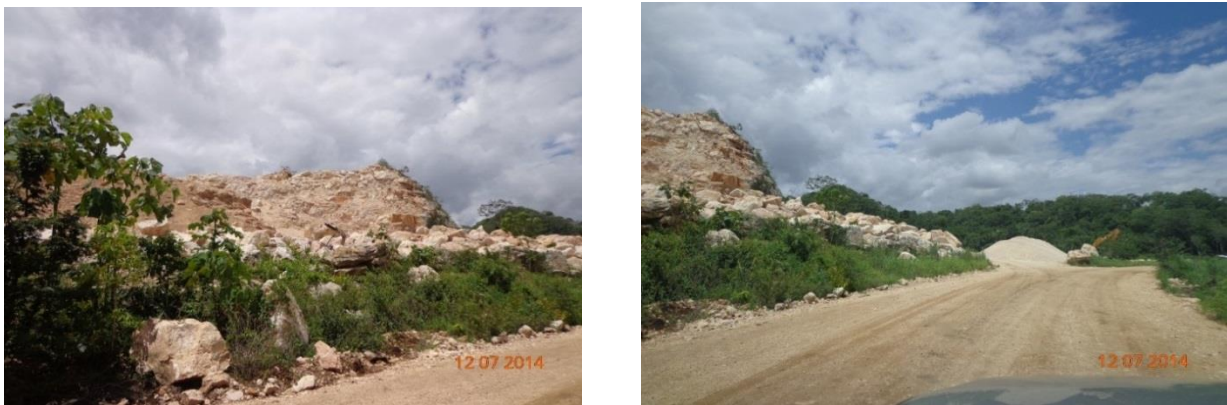
**Figure 7.4: Western Sanitary Landfill/Benque Quarry**

#### **1. MOWT site in Western Sanitary Landfill/Benque Quarry, Figure 7.4**

- Located within Section III of the road works, it is operated by MOWT.
- Consists of massive limestone beds with some minor inclusions of marl and clay
- Tan to white in color, microcrystalline
- Can provide materials for all stages of road works; base and sub-base, due to high presence of consolidated limestone and the low percentages of clay and marl inclusions, except wear coarse.

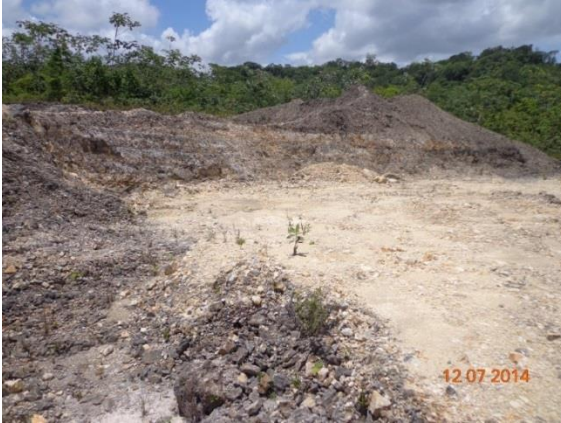
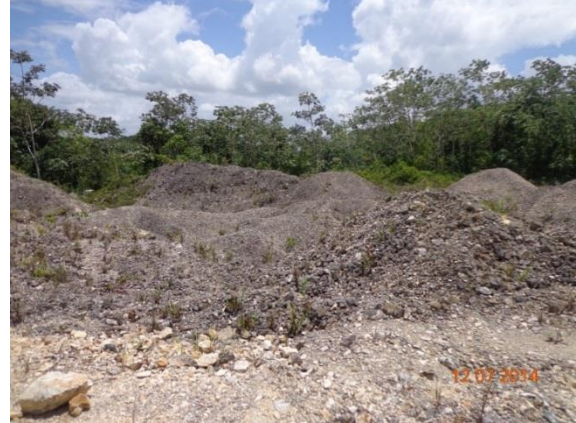
**Figure 7.6: Society Hall Blackman Eddy**

## **3. Society Hall Blackman Eddy ( Private), Figure 7.6**

- Located within Section I of the road works, operated by Belize Roadway Construction
- Active quarry site
- Consists of thin to medium bedded limestone with some inclusions of marl or clay
- Material can be acquired by ripping; crushing and screening would be required.

- On site assessment would limit the use of this material to sub-base only; further detailed testing would be required to evaluate suitability for use as base, as the initial hardness observed along with the high percentage of marl and clay would be an area of concern.
- Not suitable for wear coarse.

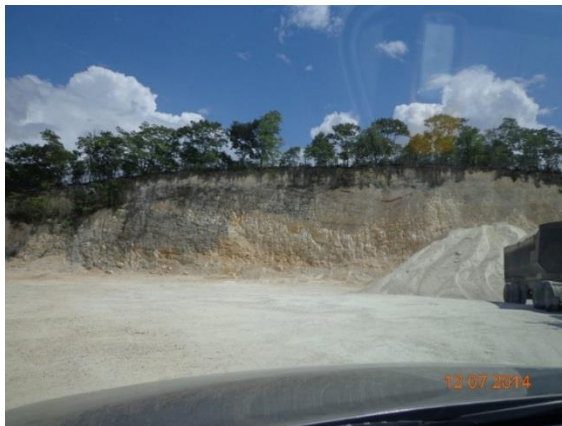
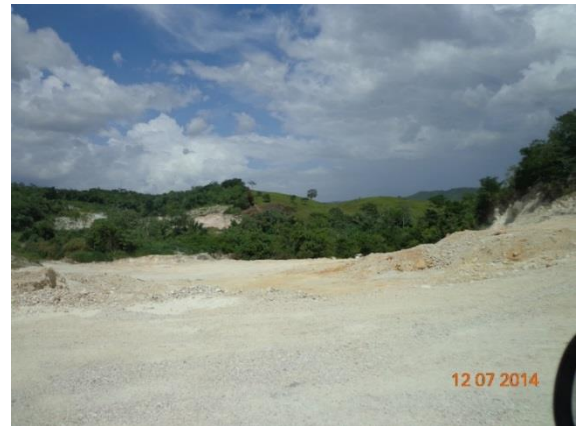
**Figure 7.7: Agua Viva, Hummingbird Highway**

### **7.5 Agua Viva, Hummingbird Highway (Private), Figure: 7.7**

- Although this site is located outside of the immediate zone of influence, it was still identified as it is readily accessible and has the capacity to yield high volumes of high quality crushed limestone material.
- Active quarry site operated by Belize Road Way Construction.
- Consists of thinly bedded limestone ranging in thickness from 0.5m to 1 m with little to no marl or clay
- Material can be acquired by ripping; crushing and screening would be required.

- Material can be acquired by ripping; crushing and screening would be required.
- This site has been evaluated as it has the potential to yield materials for both base and sub-base, the low presence of marl and clay and the initial onsite assessment of hardness, indicate that this site should meet or exceed the required strength and compressibility requirements for crushed aggregate for base and sub-base.
- Not suitable for wear coarse.

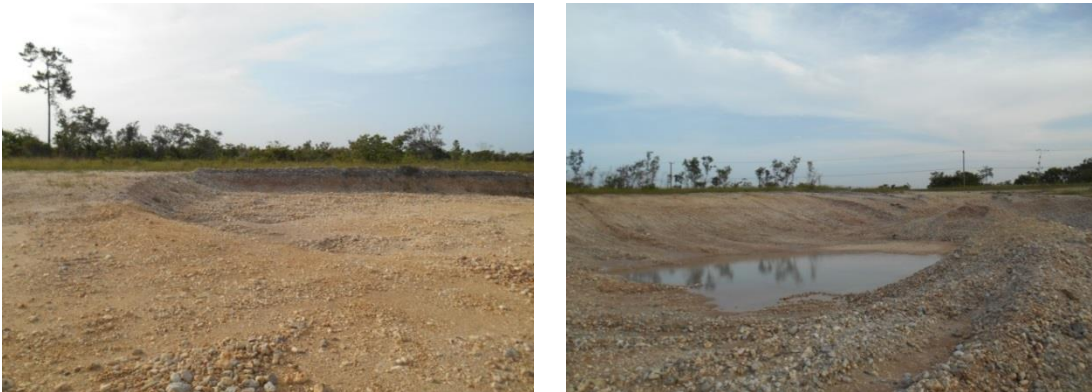
**Figure 7.8 Iguana Creek Area Gravel Beds**

A general area with multiple locations has been identified for the supply of on-land gravel, Figures 7.8.and.7.9). The lower areas of Spanish Lookout in the Iguana Creek area, has been identified as the preferred site for the supply of wear coarse material for asphalt mix. This material type is quartz in the form of chert nodules with some agate ranging from cobble to boulder size, unconsolidated material associated with a red to grey mottled clay.

The deposits range in depth from 2m to in excess of 12m and can be quarried by simple scraping and removal, requiring screening and crushing. This material has been shown to have superior wear and skid resistance (Tunich Nah 2004) in other applications and is currently being used by the Ministry of Works in other road upgrade/maintenance projects along the GPH.

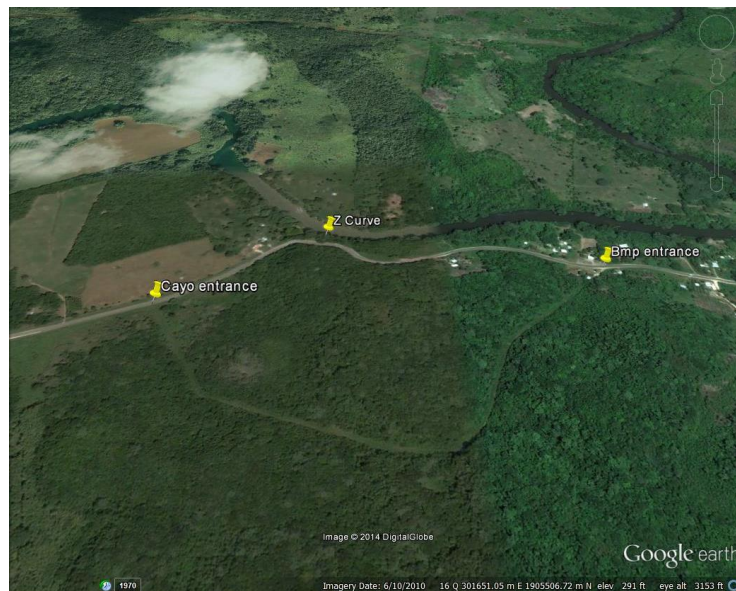
**Figure 7.10: Z- Curve**

One site (Z-Curve) however, requires major realignment and excavation for the GPH upgrade Figure 7.10. The lateral exposure along the existing road is in excess of 30m and the material varies from overburden (5m+/-) and then grades from marl to limestone and marl at depths exceeding twenty five feet, (final boreholes along proposed road cut will indicate exact stratigraphic column and composition. It is assumed from the current exposure that 90+ % of this material can be incorporated in the base and sub base.

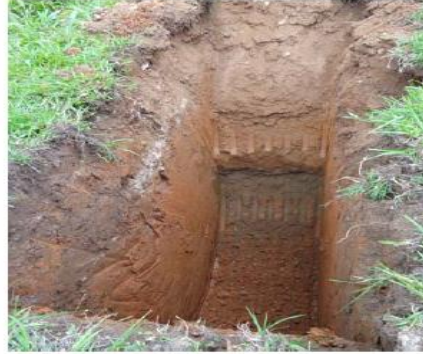
Plate 1

INSPECTION PIT 2		
TYPE OF BORING : TRENCH EXCAVATION		
DIAMETER OF BORING : NA		
WATER TABLE : NONE FOUND		
DEPTH FT / INS	SOIL LEGEND	DESCRIPTION OF STRATA
0'-0"		BLACK SOIL
0'-6"		ORANGE - BROWN CLAY WITH SOME STONE AND BOULDERS.
1'-0"		
1'-6"		
2'-0"		GRAY CLAY
2'-6"		
3'-0"		
3'-6"		
4'-0"		
4'-6"		
5'-0"		
5'-6"		
6'-0"		
6'-6"		
7'-0"		
7'-6"		
8'-0"		
8'-6"		
9'-0"		
9'-6"		
10'-0"		
10'-6"		
11'-0"		
11'-6"		
11'-8"

**DESCRIPTION:** NO WATER TABLE WAS OBSERVED, HOWEVER SIGNIFICANT FUMES (PRESUMED TO BE GASOLINE) WAS DISSIPATED DURING AND AFTER THE EXCAVATION.

In general, two different soil types/profiles were encountered along the GPH, these are consistent with the underlying geology. The areas overlaying the late Tertiary Red Bank Group exhibited thin to moderate black organic rich soils, overlaying grey to red mottled clays, with some areas showing higher percentages of sands. The clays grade downward into stiffer clays with cobble to boulder size inclusions of cherts, and various river deposits (igneous derived cobbles and pebbles), some areas exhibited limestone boulders in the clay matrix. (See below extracted test pit results that show typical soil profile- Plates 1 to 6).

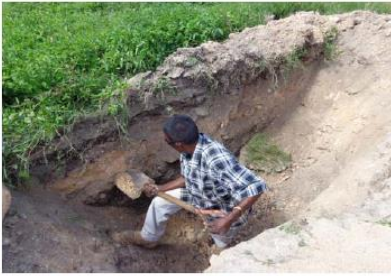
Plate 2

INSPECTION PIT 4		
TYPE OF BORING : TRENCH EXCAVATION		
DIAMETER OF BORING : NA		
WATER TABLE : NONE FOUND		
DEPTH FT / INS	SOIL LEGEND	DESCRIPTION OF STRATA
0'-0"

BLACK SOIL WITH SOME GRAVEL AND CLAY.
5'-0"		
5'-6"		
6'-0"		
6'-5"

DESCRIPTION: NO WATER TABLE WAS ODSERVED.

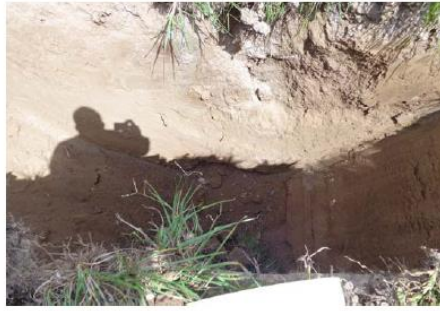
Plate 3

INSPECTION PIT 12		
TYPE OF BORING : TRENCH EXCAVATION		
DIAMETER OF BORING : NA		
WATER TABLE : NONE FOUND		
DEPTH FT / INS	SOIL LEGEND	DESCRIPTION OF STRATA
0'-0"

BROWN CLAY WITH GRAVEL AND BOULDERS.
4'-0"		
4'-6"		
5'-0"		
5'-6"		
6'-0"		
6'-6"		
7'-0"

DESCRIPTION: NO WATER TABLE WAS ODSERVED.

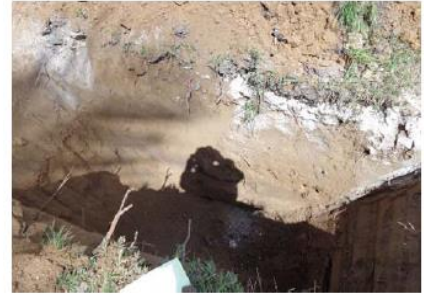
Plate 5

INSPECTION PIT 11		
TYPE OF BORING : TRENCH EXCAVATION DIAMETER OF BORING : NA WATER TABLE : NONE FOUND		
DEPTH FT / INS	SOIL LEGEND	DESCRIPTION OF STRATA
0'-0"		BLACK SOIL
0'-6"		BROWN SAND WITH GRAVEL AND BOULDERS.
1'-0"		
1'-6"		WHITE MARL WITH GRAVEL.
2'-0"		
2'-6"		
3'-0"		BROWN SAND WITH GRAVEL, COBBLE STONE AND BOULDERS.
3'-6"		
4'-0"		
4'-6"		ROCK FRAGMENTS.

DESCRIPTION: NO WATER TABLE WAS ODSERVED.

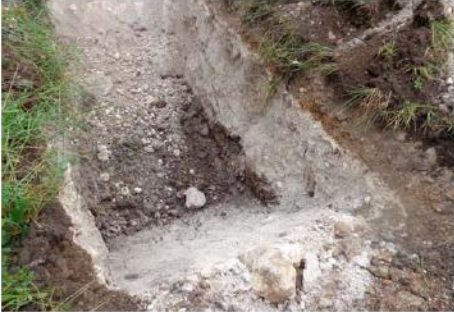
Plate 6

INSPECTION PIT 9		
TYPE OF BORING : TRENCH EXCAVATION		
DIAMETER OF BORING : NA		
WATER TABLE : NONE FOUND		
DEPTH FT / INS	SOIL LEGEND	DESCRIPTION OF STRATA
0'-0" 0'-6" 1'-0" 1'-6" 2'-0" 2'-6" 3'-0" 3'-6" 4'-0" 4'-6" 5'-0" 5'-6"

BLACK SOIL BROWN SAND WITH GRAVEL AND COBBLE STONE. WHITE MARL GRAVEL WITH COBBLE STONE AND BOULDERS. BROWN SAND WITH GRAVEL, COBBLE STONE AND BOULDERS.

DESCRIPTION: NO WATER TABLE WAS ODSERVED.

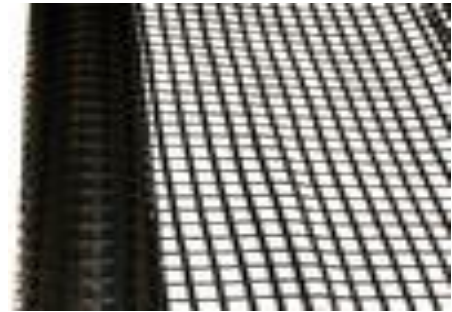
- Road side slopes and cuts should have slopes of 1.5:1 ratio to prevent land slippage from road cut embankments and rock fall from thinly bedded fractured limestone/dolomite outcrops exposed by road cuts, especially at the Z-curve. In Section 2, there is evidence of microslides in areas underlain by clays with gypsum inclusions.
- Erosion Control Blankets or the use of fiber-web geo-synthetics, Figure 7.11 are recommended for the stabilization of the cut slopes at the Z-curve. The use of these materials are to enhance the growth of natural vegetation important in providing long-term stability to the slopes.

**Figure 7.11 Geo/synthetic mesh**

- Erosion Control Blankets or the use of fiber-web geo-synthetics are recommended for the stabilization of the cut slopes at the Z-curve. The use of these materials is to enhance the growth of natural vegetation important in providing long-term stability to the slopes.
- To prevent excessive siltation during the cutting of the Z-curve, storm-water will be diverted away from construction area and storm-water generated within the construction area will employ the use of check dams along the storm-water drains before discharging into the receiving environment.
- Proper storage of waste oil, grease and other contaminant shall be available on all construction camps to avoid the entry of such material into streams, watercourses, or other surface water.
- Have a designated and secure site for dumping stripped pavement and excavated soil away from riverbank and streams.

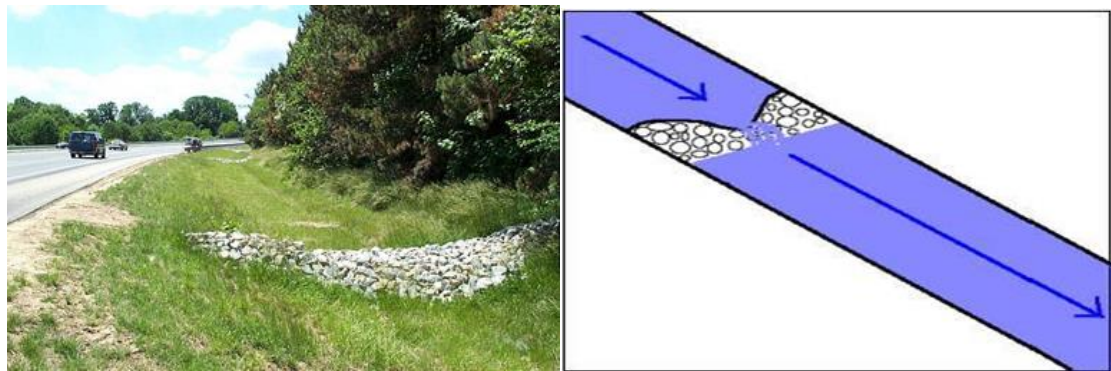
- To prevent excessive siltation during the cutting of the Z-curve, storm-water will be diverted away from construction area and storm-water generated within the construction area will employ the use of check dams, Figure: 7.12, along the storm-water drains before discharging into the receiving environment.

**Figure: 7.12 Check dam made of gravel**

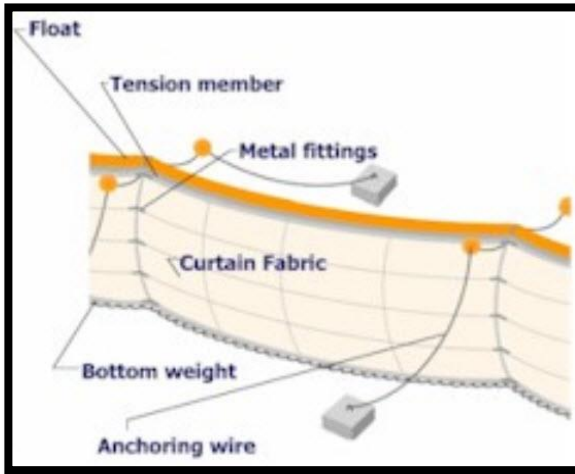
- The construction of bridge abutments for the proposed Roaring Creek Bridge will involve the installation of mitigation structure such as wing dams made of sand bags or the use of silt curtains, Figure 7.13, to prevent excessive siltation of the Roaring Creek. These structures will be deployed to enclose the construction area within a semi-circle that extend to no more than the mid- point of the width of the creek to allow for unimpeded

**Figure 7.13: Wing Dams**

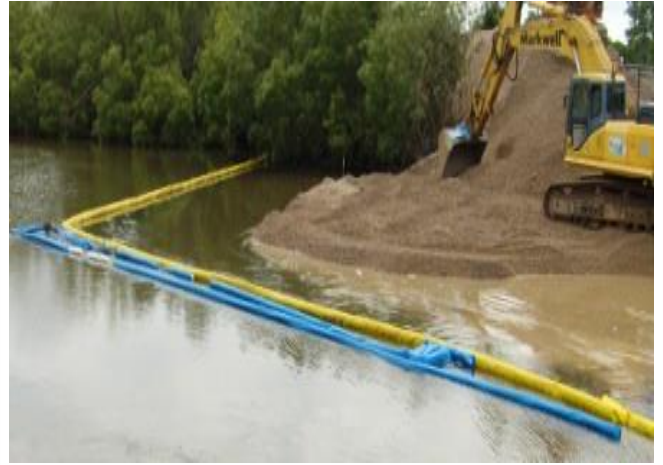
water flow Figure 7.14. Following construction work, the silted area within the wing dam or silt curtain will be cleared of excessive sediments before their removal. In addition, these activities will be programmed to take place during the dry periods.

**Figure 7.14: Installed Dam**

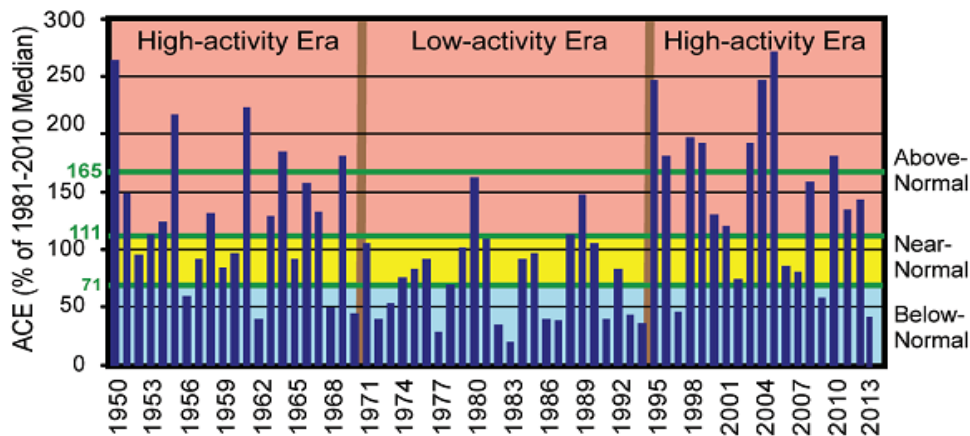
**Figure 7.15: NOAA's Accumulated Cyclone Energy (ACE) index expressed as percent of the 1981-2010 median value. ACE is calculated by summing the squares of the 6-hourly maximum sustained wind speed (kt) for all periods while storm is at least tropical storm strength. Pink, yellow, blue shadings correspond to NOAA's classification for above – near -, and below-normal seasons, respectively. The 165% threshold for a hyperactive season is indicated. Vertical brown lines separate high – and low-activity eras.**

The climatology for North Atlantic hurricane activity indicates a cyclical trend in periods of high and low hurricane activity in the Basin. Figure xx shows NOAA's seasonal Accumulated Cyclone Energy (ACE) since 1950. It highlights the recent surge of ACE in the Basin, which started in 1995 and began phasing out after 2012 (Table 7.13). The previous period of high ACE was from 1950 to 1969. Hence, there is an 18-years cycle of high and low hurricane activity in the North Atlantic Basin. This high ACE periodic cycle will very likely be shortened in the projected warmer climatic conditions of the 21<sup>st</sup> century. Meanwhile, another analysis from NOAA show an increasing trend from 15 to 22% in the percentage of Cat 4 and Cat 5 hurricane for the period 1985-2005 for the North Atlantic Basin (Figure 7.14). In short, it is very likely that over the next few decades tropical cyclone frequency, intensity and spatial distribution globally, and in individual basins, will vary from year to-year and decade-to-decade (SPM-WG I, IPCC, 2013). Recent research has shown that we are experiencing more storms with higher wind

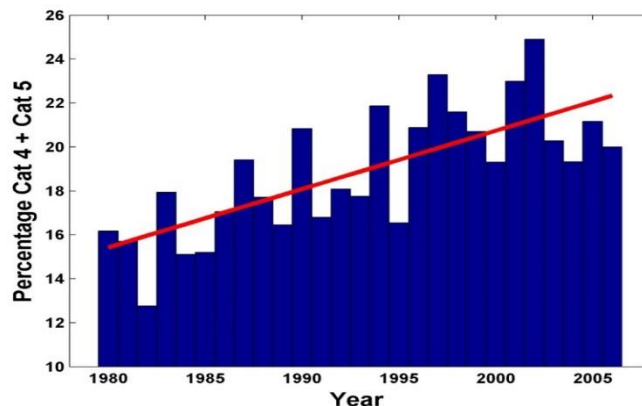
**Figure 7.16: Percentage increase in Cat 4 and Cat 5 hurricane for the North Atlantic Basin**

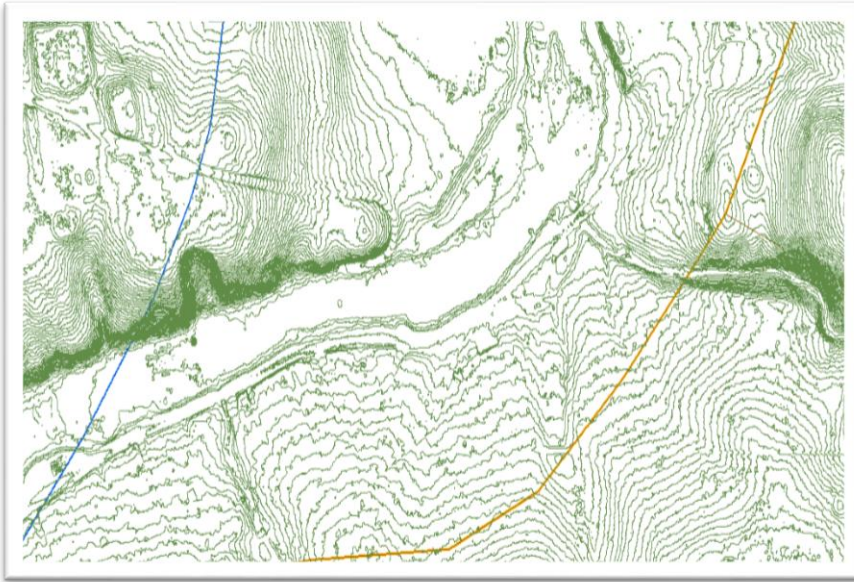
**Figure 7.17: 1-meter resolution Lidar generated map of the Succotz Village flood zone, showing the Mopan River channel, the adjacent GPH, the track up to the Xunantunich Maya Ruins two main stream channels in the Village. The Blue and Yellow lines are the GIS map Mopan River and GPH projections.**

Another recommendation to reduce the impacts of future floods in Belize is to improve flood mapping in all watersheds using modern technology such as Lidar generated high-resolution digital elevation maps (DEMs), at 1 m to 0.5 m resolution. By over-laying Lidar DEM maps with flood stage maps using the ArcGIS software, the hydrologist can produce higher resolution flood maps that can be used in planning, development and disaster risk management. Figure 7.17 and Figure 7.18 are LiDAR generated 1-meter resolution maps of the flood zone along the GPH in Succotz Village, that help the EIA preparers and engineers determine the actions needed for the road upgrade in this section and determining an alternative route from Succotz to Benque Viejo during an emergency.

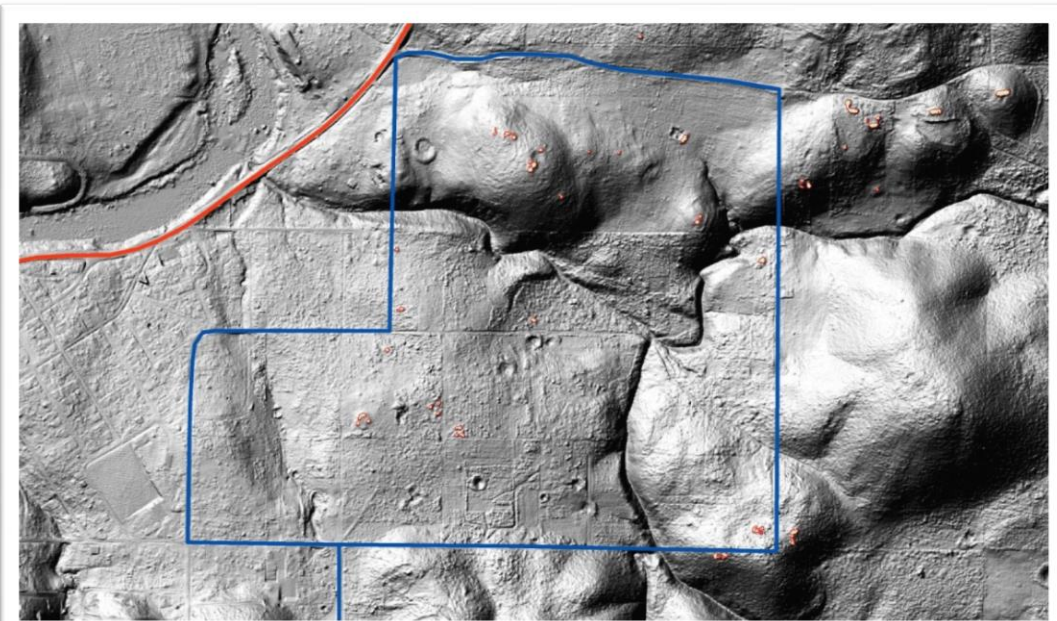
**Figure 7.18: High-resolution LiDAR image of the landscape in Succotz Village showing options for the Succotz Village – Benque Viejo del Carmen By-pass.**

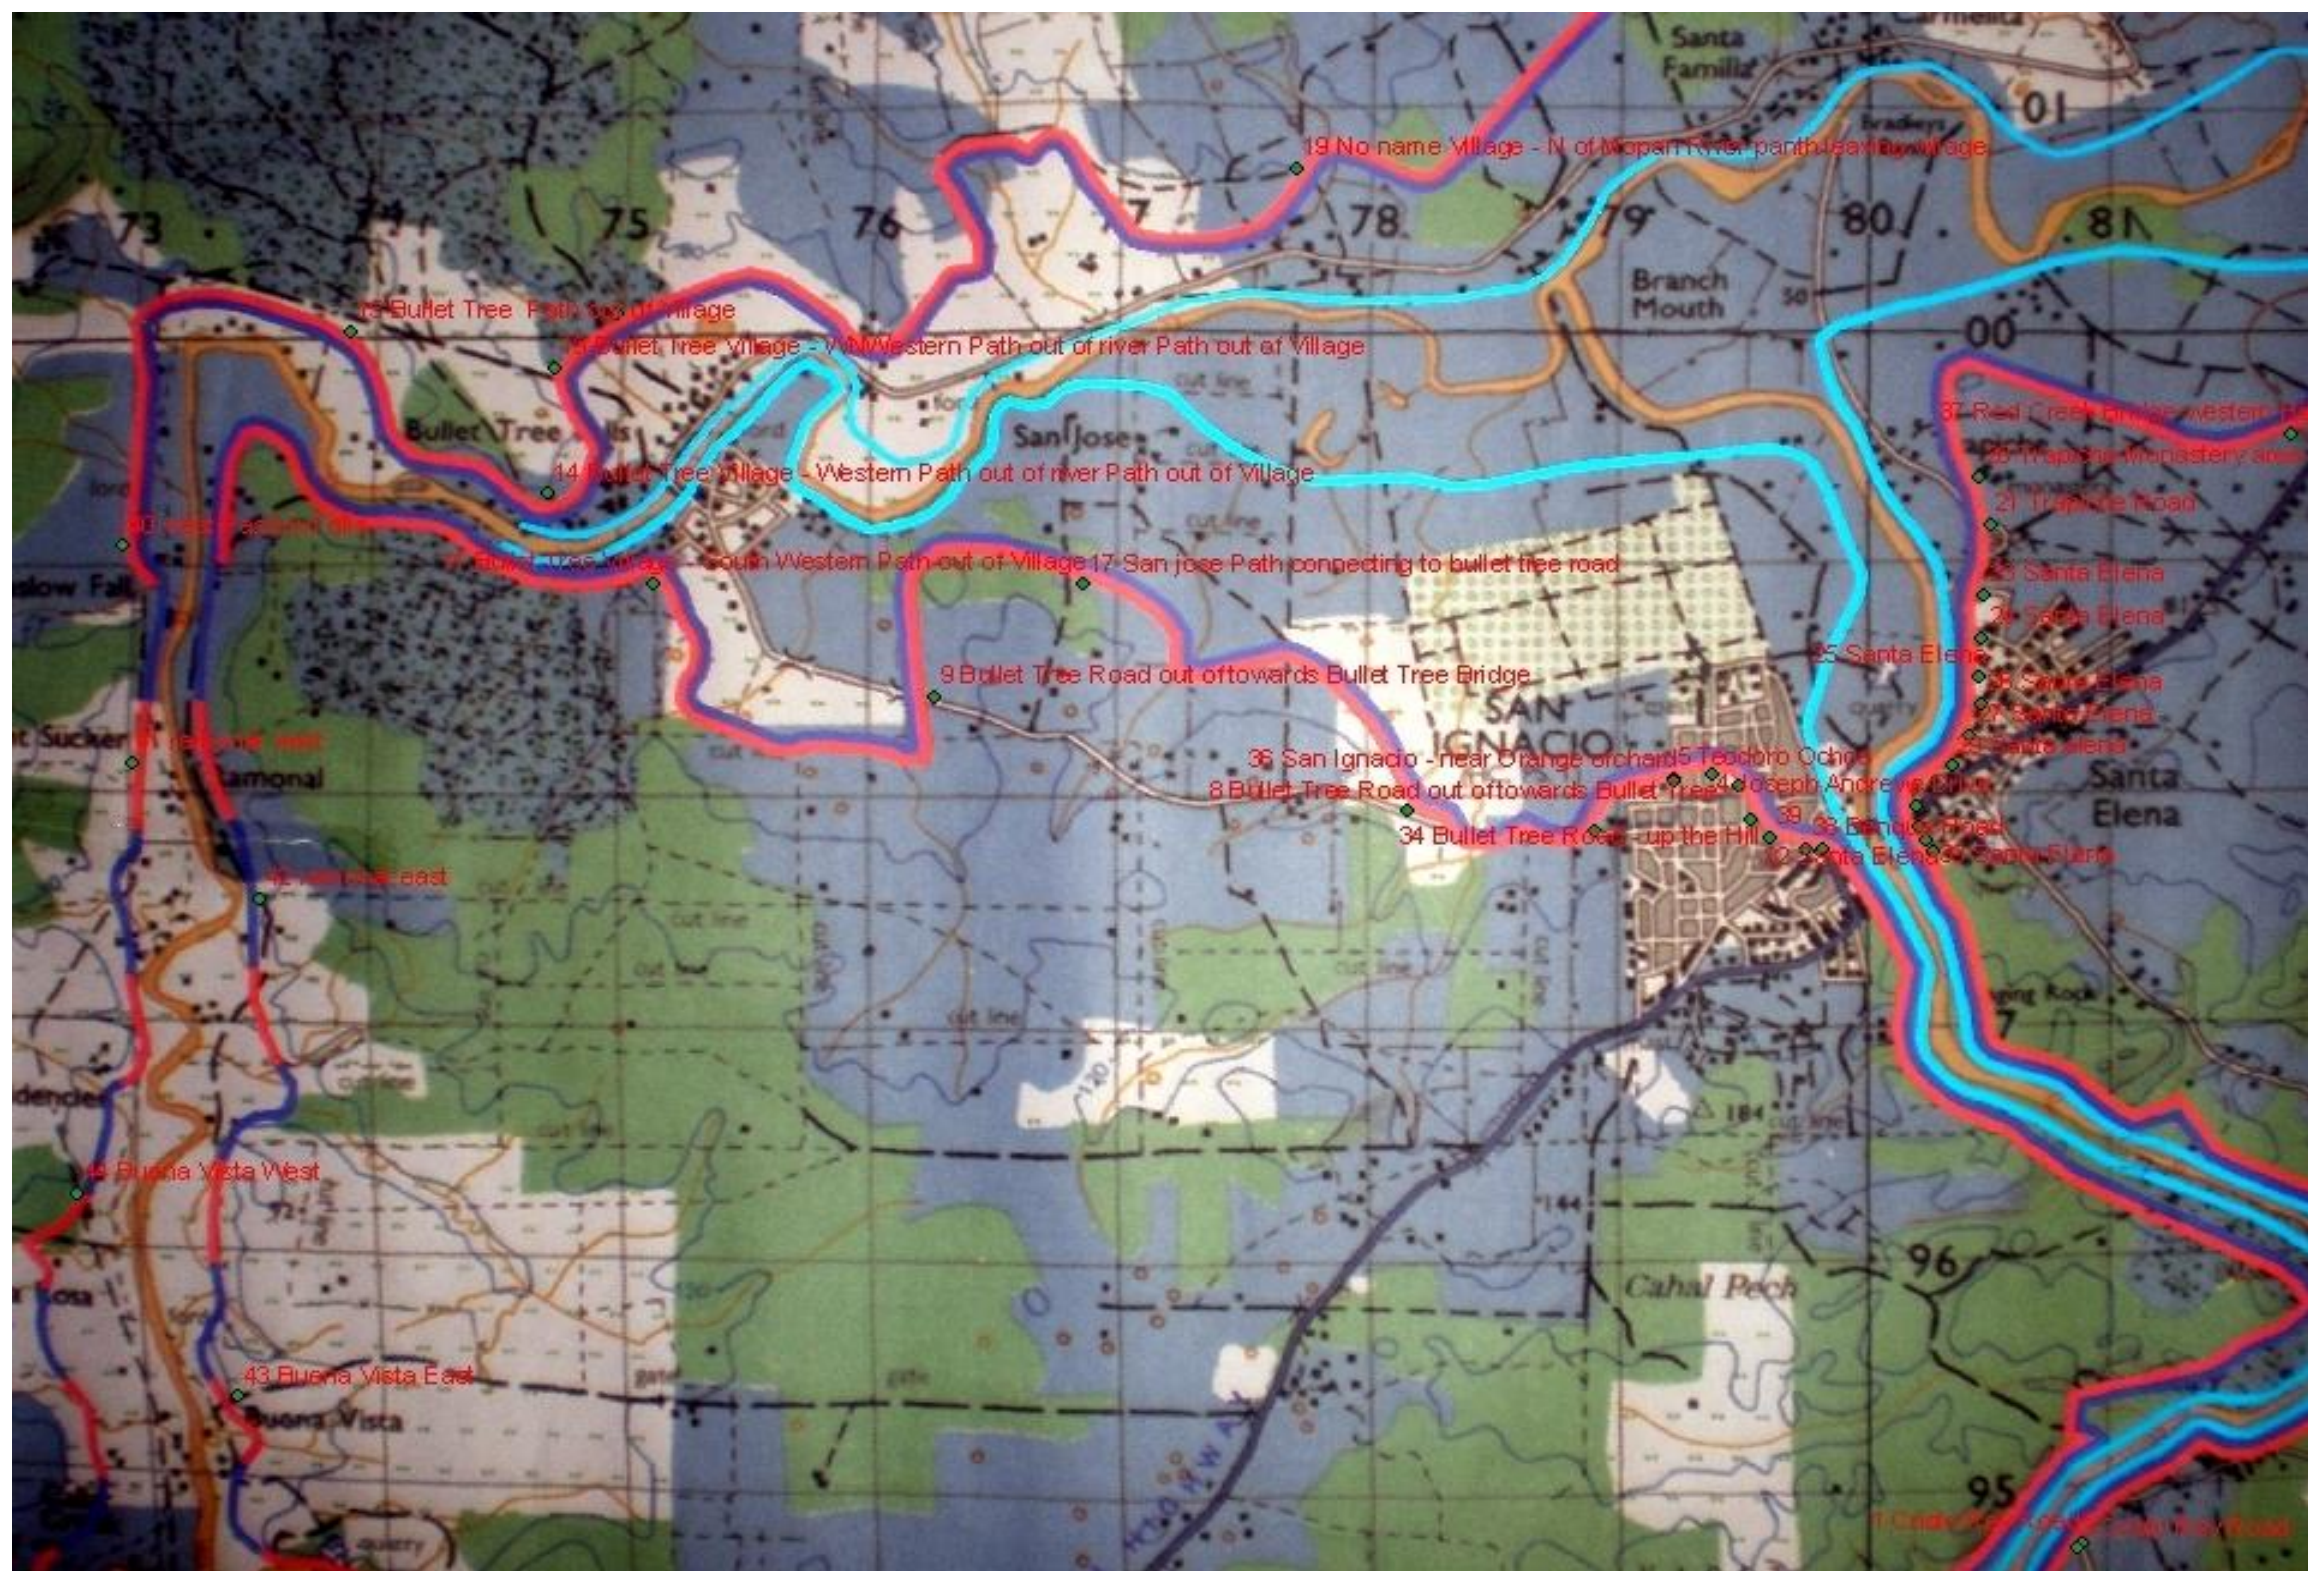
Figure 7.19: Spatial extent of a dam break flood in the San Ignacio/Santa Elena area

There are sections of the upgraded GPH that are at high risk to a dam break flood event. Although the probability of such an event is small throughout the projected 50-year lifespan of the Chalillo dam, the possibility of such an event still hangs over the head of all communities and interests downstream of the dam. Figure 7.19 above shows the predicted extent of the dam break flood in the San Ignacio-Santa Elena area in connection with a dam break scenario. Dam Break flood maps for areas downstream of San Ignacio / Santa Elena have been prepared. The worst case scenario with the greatest extent of flood is projected for a dam break at full capacity during a major storm event affecting Belize is depicted in with the red line.

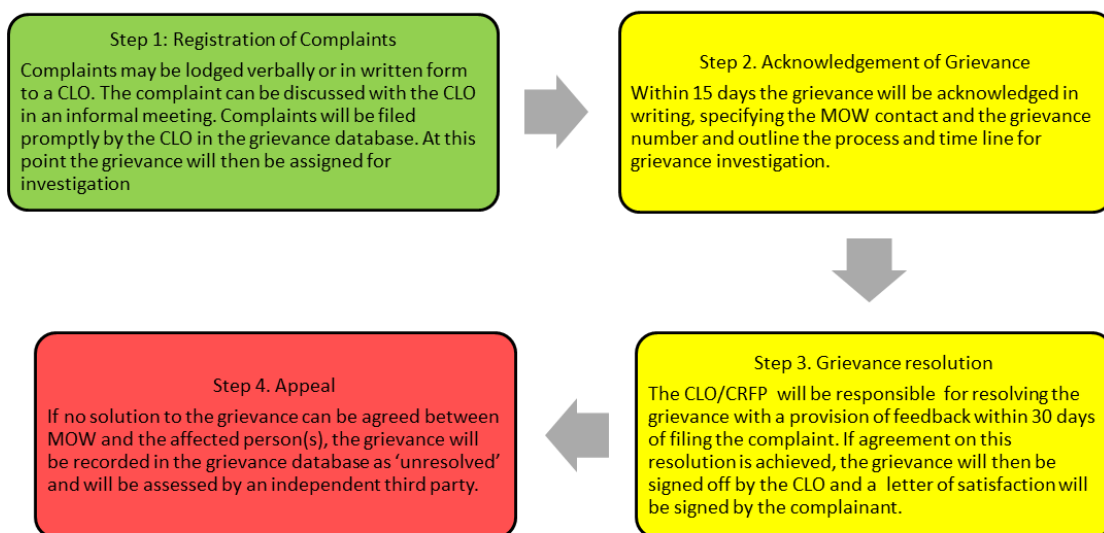
**Figure 8.1: Grievance Mechanism Process Flow**

Notwithstanding, the Grievance Mechanism is the official process by which people affected by the Project can bring their comments, concerns and grievances to the CLOs and the MOWT management team. The Grievance Mechanism specifies: the Purpose; Scope and Target Group; Procedure; Management Structure and Tracking; and Monitoring and Reporting, the overall process flow is outlined in figure 8.1.

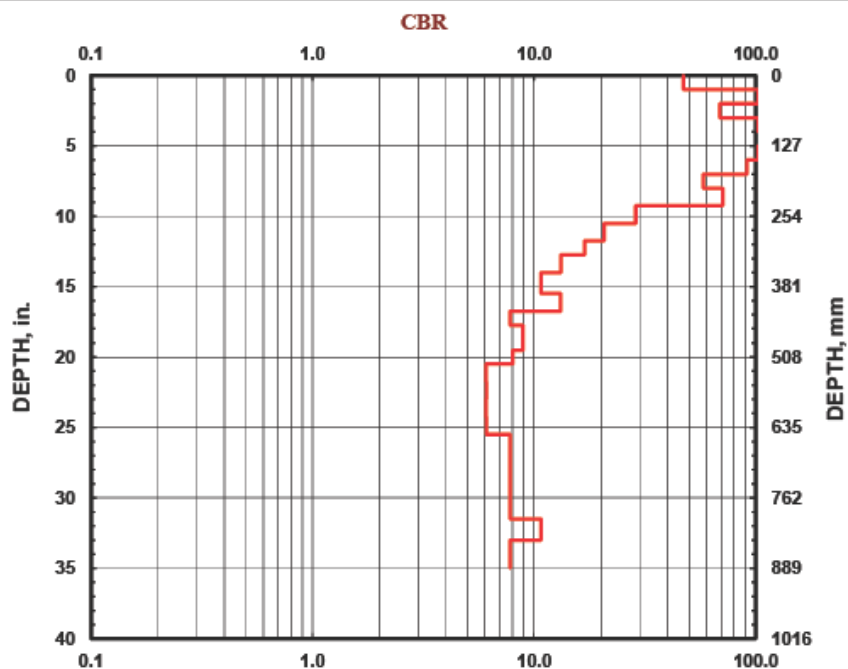
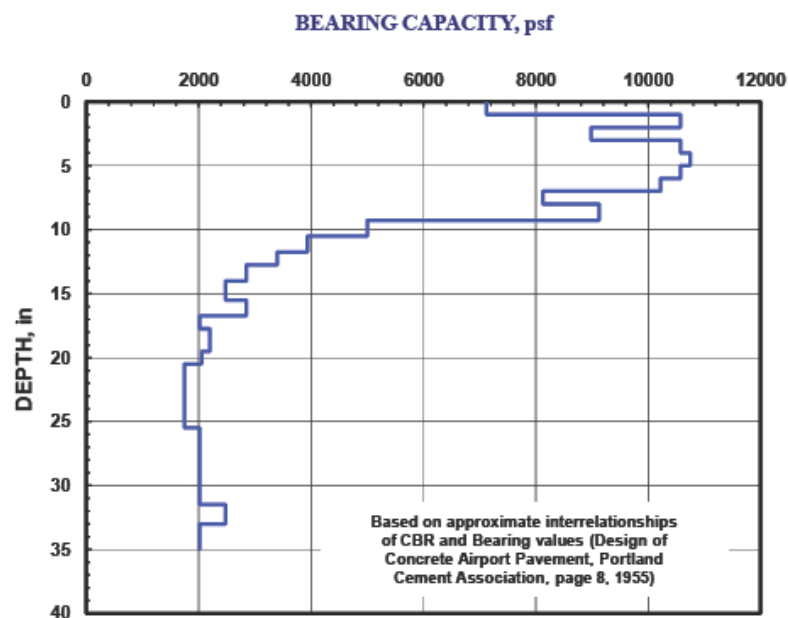
Based on approximate interrelationships of CBR and Bearing values (Design of Concrete Airport Pavement, Portland Cement Association, page 8, 1955)

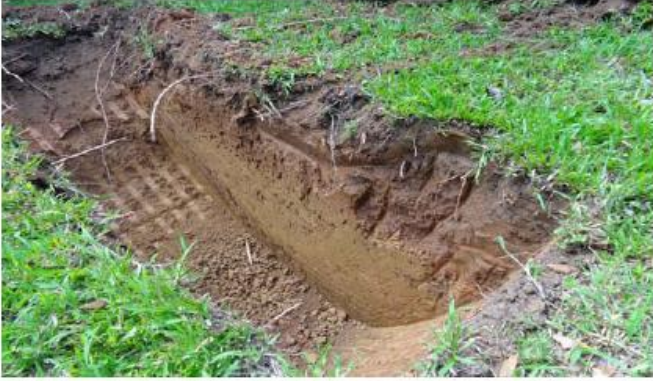
BLACK SOIL  BROWN CLAY (Lean).  CREAM - BROWN CLAY (Stiff).

**DESCRIPTION:** NO WATER TABLE WAS ODSERVED.

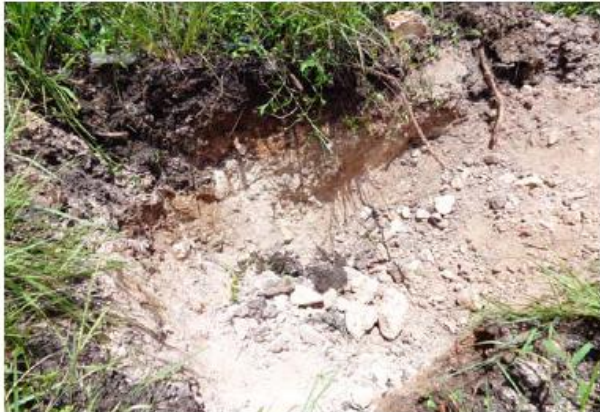
INSPECTION PIT 5		
TYPE OF BORING : TRENCH EXCAVATION		
DIAMETER OF BORING : NA		
WATER TABLE : NONE FOUND

DEPTH FT / INS	SOIL LEGEND	DESCRIPTION OF STRATA
0'-0" 0'-6" 1'-0" 1'-6" 2'-0" 2'-6" 3'-0" 3'-2"	 	BLACK SOIL  LIGHT BROWN CLAY, SAND AND GRAVEL WITH BOULDERS.  CREAM CLAY, SAND AND GRAVEL WITH BOULDERS.  ROCK FRAGMENTS.

**DESCRIPTION:** NO WATER TABLE WAS ODSERVED.
