# **Environmental and Social Impact Assessments for the Rehabilitation of the George Price Highway from Miles 47.9 - 79.4**

Final Report on the  
Environmental and  
Social Impact Study

**Ministry of Works and Transport  
Belmopan,  
July 27, 2014**

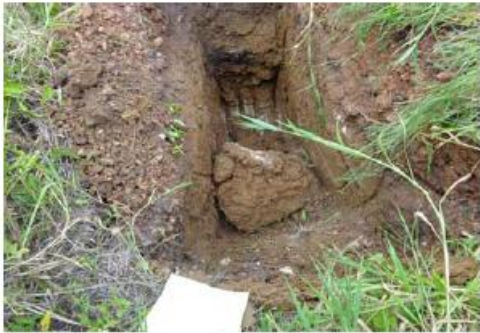
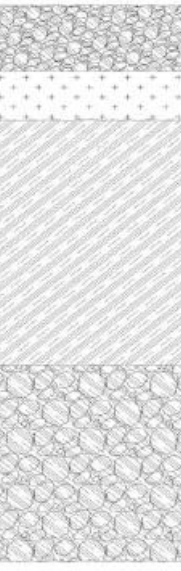
INSPECTION PIT 7		
TYPE OF BORING : TRENCH EXCAVATION		
DIAMETER OF BORING : NA		
WATER TABLE : NONE FOUND

BROWN CLAY WITH SAND AND GRAVEL.
0'-6"		
1'-0"		
1'-6"		
2'-0"		
2'-6"		
3'-0"		
3'-6"		
4'-0"		
4'-6"		
5'-0"		
5'-6"		
6'-0"

WHITE CLAY AND STONE.
6'-6"		
7'-0"		
7'-6"		
8'-0"		
8'-6"		
9'-0"		
9'-6"		
10'-0"		
10'-6"		
11'-0"		
11'-6"		
11'-10"

**DESCRIPTION:** NO WATER TABLE WAS ODSERVED.

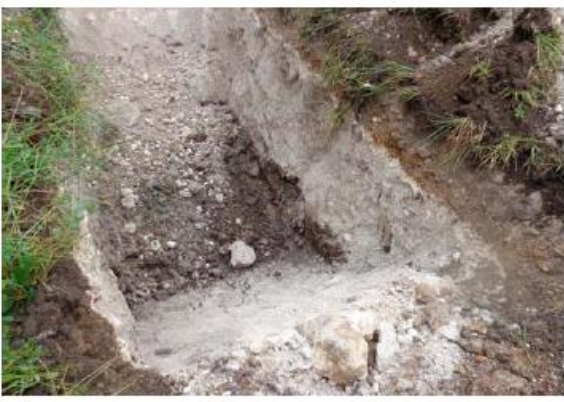
BLACK SOIL BROWN SAND WITH GRAVEL AND COBBLE STONE.  WHITE MARL GRAVEL WITH COBBLE STONE AND BOULDERS.  BROWN SAND WITH GRAVEL, COBBLE STONE AND BOULDERS.

**DESCRIPTION:** NO WATER TABLE WAS ODSERVED.

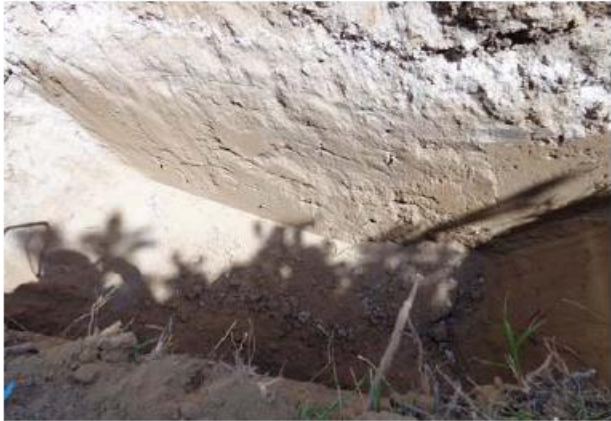
BLACK SOIL
0'-6"		BROWN SAND WITH GRAVEL, COBBLE STONE AND BOULDERS.
1'-0"		
1'-6"		
2'-0"		WHITE MARL WITH BOULDERS.
2'-6"		
3'-0"		
3'-4"		ROCK FRAGMENTS.

**DESCRIPTION:** NO WATER TABLE WAS ODSERVED.

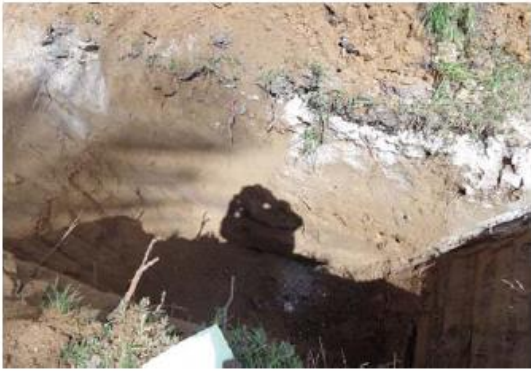
BLACK SOIL  BROWN SAND WITH GRAVEL AND BOULDERS.  WHITE MARL WITH GRAVEL.  BROWN SAND WITH GRAVEL, COBBLE STONE AND BOULDERS.  ROCK FRAGMENTS.

**DESCRIPTION:** NO WATER TABLE WAS ODSERVED.

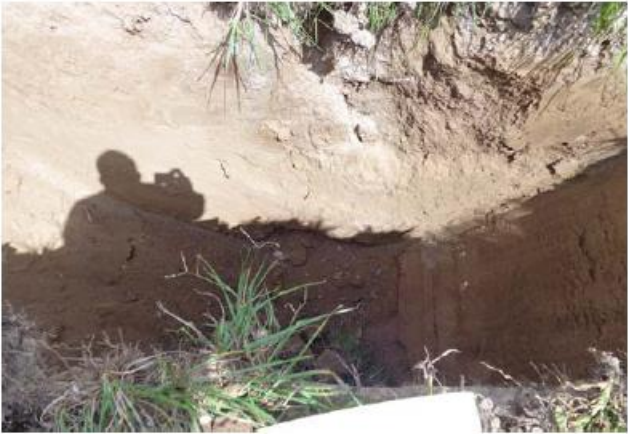
<p>BLACK SOIL</p> <p>SOME WHITE MARL, CRUSHED SAND, GRAVEL WITH COBBLE STONE AND BOULDERS.</p> <p>BROWN CLAY WITH GRAVEL AND BOULDERS.</p>

**DESCRIPTION:** NO WATER TABLE WAS ODSERVED.

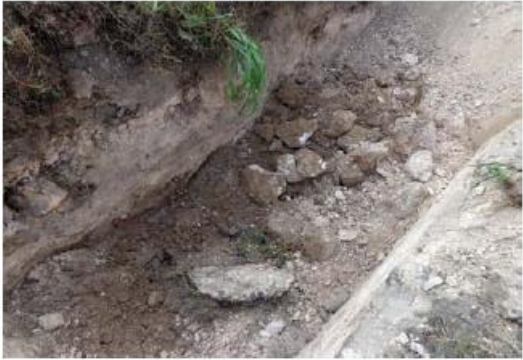
0'-6"		BLACK SOIL
1'-0"		WHITE MARL, GRAVEL WITH COBBLE STONE AND BOULDERS.
1'-6"		
2'-0"		BOULDERS WITH SOME SAND AND GRAVEL.
2'-6"		
3'-0"		WHITE MARL WITH GRAVEL AND BOULDERS.
3'-6"		
4'-0"		BROWN SAND WITH GRAVEL, COBBLE STONE AND BOULDERS.
4'-2"

**DESCRIPTION:** NO WATER TABLE WAS ODSERVED.

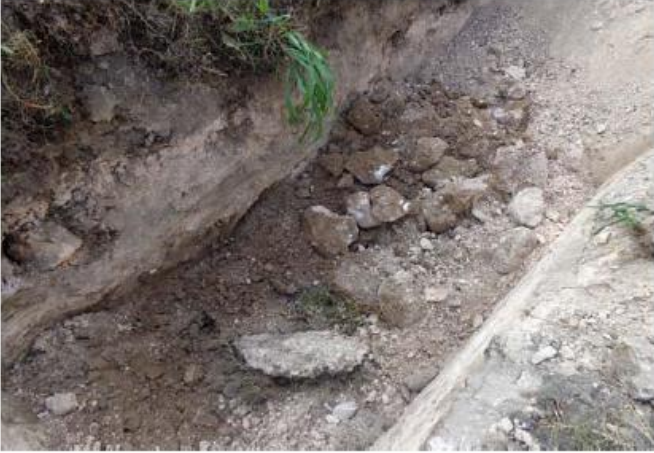
INSPECTION PIT 14		
TYPE OF BORING : TRENCH EXCAVATION		
DIAMETER OF BORING : NA		
WATER TABLE : NONE FOUND

DEPTH FT / INS	SOIL LEGEND	DESCRIPTION OF STRATA
0'-0"		BLACK SOIL
0'-6"		RIVER SAND AND GRAVEL.
1'-0"		
1'-6"		SANDY GRAY CLAY WITH LIME STONE ROCKS.
2'-0"		
2'-6"		SANDY BROWN CLAY.
3'-0"		
3'-6"		
4'-0"		
4'-6"		
5'-0"		
5'-6"		
6'-0"		
6'-5"

**DESCRIPTION:** NO WATER TABLE WAS ODSERVED.

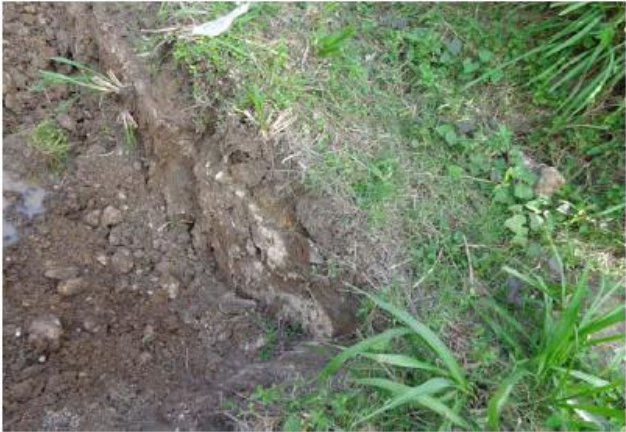
INSPECTION PIT 16		
TYPE OF BORING : TRENCH EXCAVATION		
DIAMETER OF BORING : NA		
WATER TABLE : NONE FOUND		
DEPTH FT / INS	SOIL LEGEND	DESCRIPTION OF STRATA
0'-0"

BLACK SOIL
0'-6"		WHITE MARL WITH GRAVEL AND BOULDERS.
1'-0"		
1'-6"		
2'-0"		
2'-6"		
3'-0"		
3'-6"		FINE BROWN SAND WITH A HINT OF BROWN CLAY.
4'-0"		
4'-6"		
5'-0"		
5'-6"		
6'-0"

DESCRIPTION: NO WATER TABLE WAS ODSERVED.

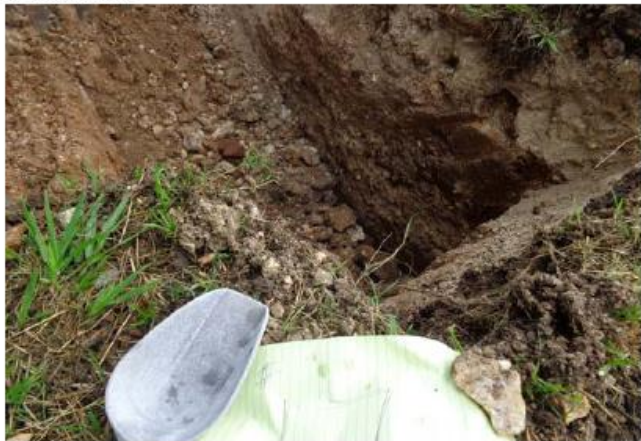
INSPECTION PIT 17		
TYPE OF BORING : TRENCH EXCAVATION		
DIAMETER OF BORING : NA		
WATER TABLE : NONE FOUND		
DEPTH FT / INS	SOIL LEGEND	DESCRIPTION OF STRATA
0'-0"

FINE BROWN SAND.
1'-6"		
2'-0"		
2'-6"		
3'-0"		
3'-6"		
4'-0"		
4'-6"		
5'-0"		
5'-6"		
6'-0"

DESCRIPTION: NO WATER TABLE WAS ODSERVED.

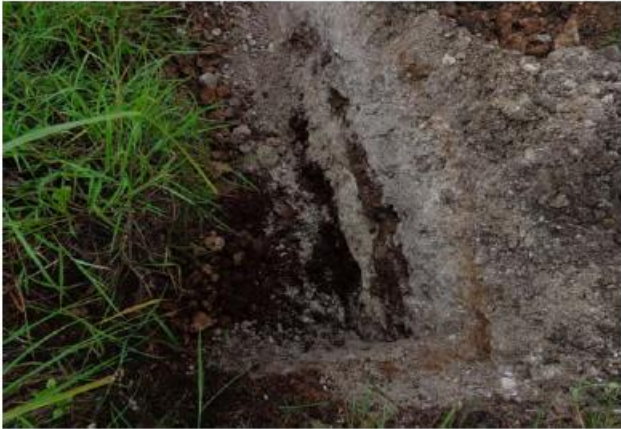
INSPECTION PIT 18		
TYPE OF BORING : TRENCH EXCAVATION		
DIAMETER OF BORING : NA		
WATER TABLE : NONE FOUND

DEPTH FT / INS	SOIL LEGEND	DESCRIPTION OF STRATA
0'-0"		
0'-6"		BLACK SOIL
1'-0"		WHITE MARL WITH GRAVEL AND BOULDERS.
1'-6"		
2'-0"		
2'-6"		
3'-0"		
3'-3"		ROCK FRAGMENTS.

**DESCRIPTION:** NO WATER TABLE WAS ODSERVED.

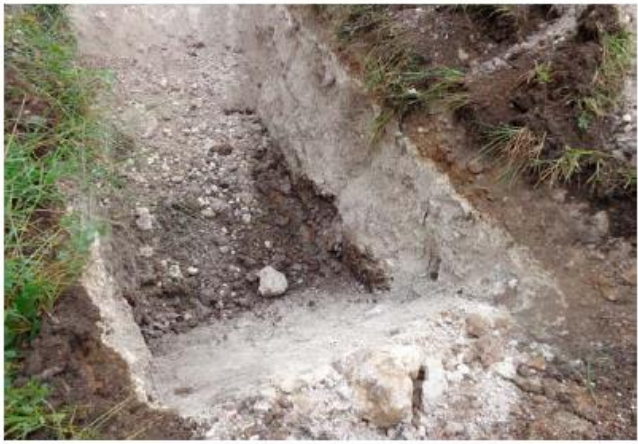
INSPECTION PIT 19		
TYPE OF BORING : TRENCH EXCAVATION		
DIAMETER OF BORING : NA		
WATER TABLE : NONE FOUND

BLACK SOIL  WHITE MARL WITH GRAVEL AND BOULDERS.  BROWN CLAY, SAND & GRAVEL WITH BOULDERS AND COBBLE STONES.

**DESCRIPTION:** NO WATER TABLE WAS ODSERVED.

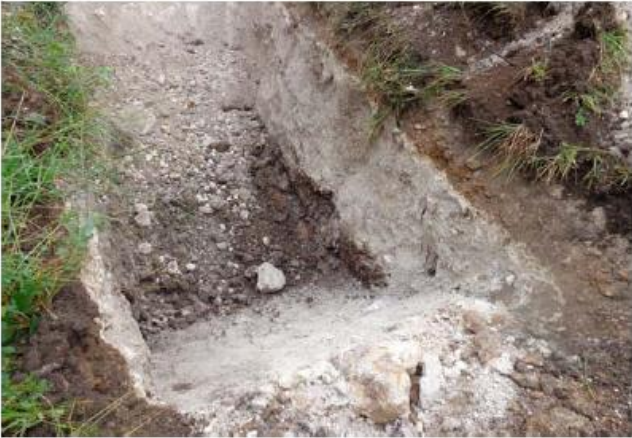
INSPECTION PIT 20		
TYPE OF BORING : TRENCH EXCAVATION		
DIAMETER OF BORING : NA		
WATER TABLE : NONE FOUND

DEPTH FT / INS	SOIL LEGEND	DESCRIPTION OF STRATA
0'-0" 0'-6" 1'-0" 1'-6" 2'-0" 2'-6" 3'-0" 3'-6" 4'-0" 4'-6" 5'-0" 5'-6" 6'-0"	 	<p>BLACK SOIL</p> <p>WHITE MARL WITH GRAVEL AND BOULDERS.</p> <p>BROWN CLAY, SAND &amp; GRAVEL WITH BOULDERS.</p>

**DESCRIPTION:** NO WATER TABLE WAS ODERVED.

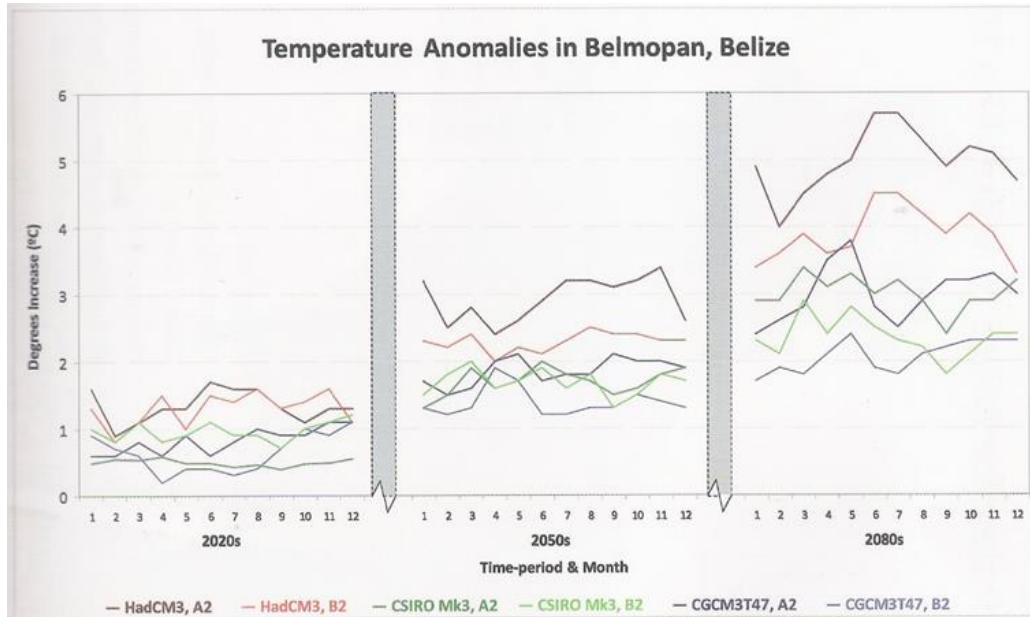
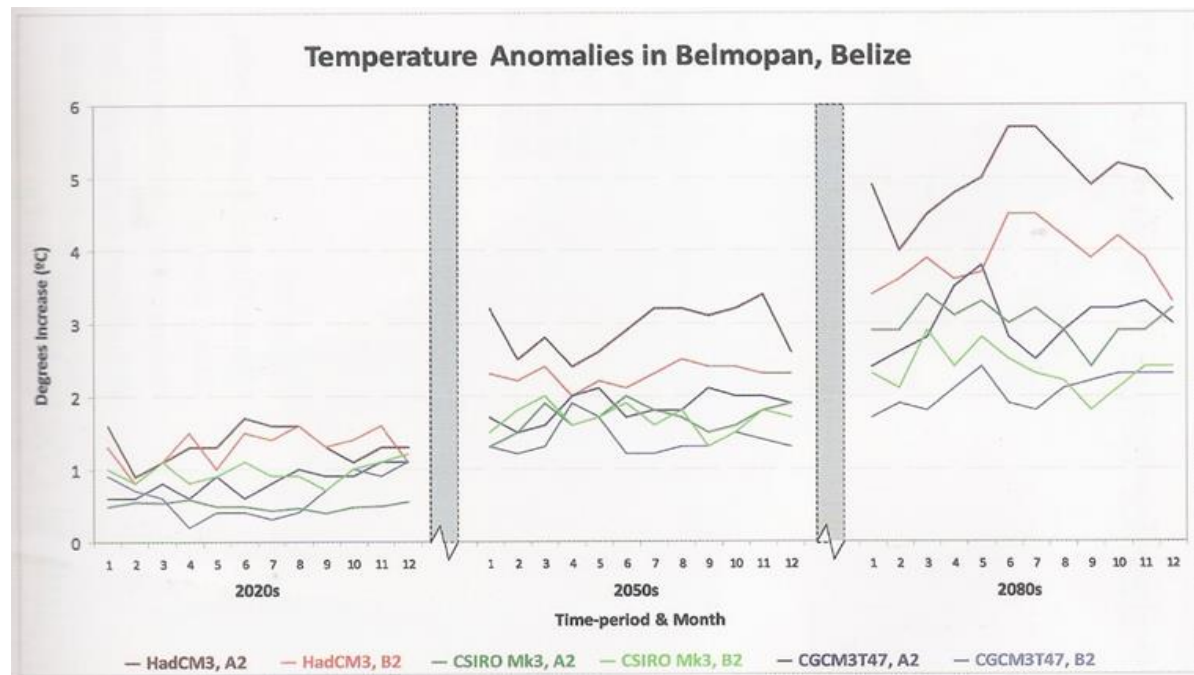
Figure 1 a-b: Temperature and Rainfall anomalies for Belmopan for the 2020s, 2050s and 2080s (Anderson, et. al. 2005)

Downscaled global model projections using the Oak Ridge National Laboratory and NASA Meso-scale Modelling System, version 3.6 for Central America (2005) at a resolution of 12 km, was used to project mean temperature and precipitation for Mexico, Central America and the Dominican Republic by personnel of the Water Centre for the Humid Tropics of Latin America and the Caribbean, CATHALAC (Anderson, *et al.* 2008). Using various GCMs results for boundary conditions and for both the A2 and B2 climate scenarios, the meso-scale model generated monthly temperature anomalies and per cent changes in rainfall from the baseline period 1961-1990 for the 2020s, 2050s and 2080s for Belize. Figure 1a-b shows the monthly anomalies of temperature and per cent change in rainfall for Belmopan, which was one of several outputs from the climate experiments.

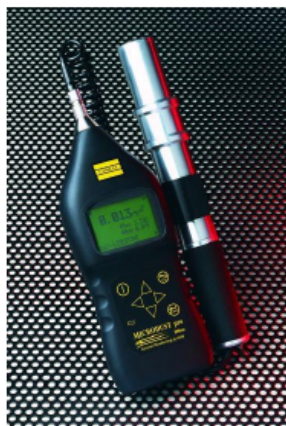
The Microdust Pro measures particulate concentrations using a near forward angle light scattering technique. Infrared light of 880nm wavelength is projected through the sampling volume where contact with particles causes the light to scatter. The amount of scatter is proportional to the mass concentration and is measured by the photo detector. By using a narrow angle of scatter ( $12-20^\circ$ ) the majority of light scattered is in the diffracted and refracted components, which minimizes the uncertainty associated with particle color, shape and refractive index.

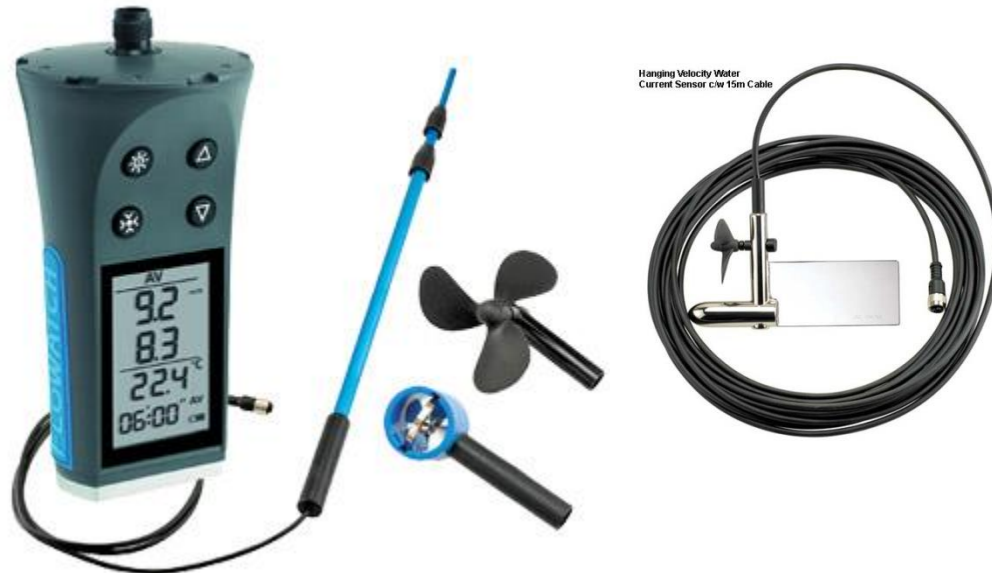
### JDC -Flowatch Flow Meter

The FLOWATCH portable flowmeter is a versatile instrument designed for simple and accurate measurement of air and water flow. This instrument (flowmeter - thermometer) has been developed for use under challenging circumstances. Because of its different impellers, you can use it to measure almost any liquid or gaseous medium. The standard FLOWATCH kit comes complete with a display, 1.2 meter telescoping rod, carrying case and two flow sensors; one for water and one for air. Additional sensors are available, including a hanging water sensor with 15 meter cable.
