Feasibility and Designs of Small Scale, Nature Based Coastal Protection Works in Caye Caulker and Goff Caye, Belize

CSD/RND - Climate Vulnerability Reduction Loan Program (BL-L1028)
Design Phase

Final Report

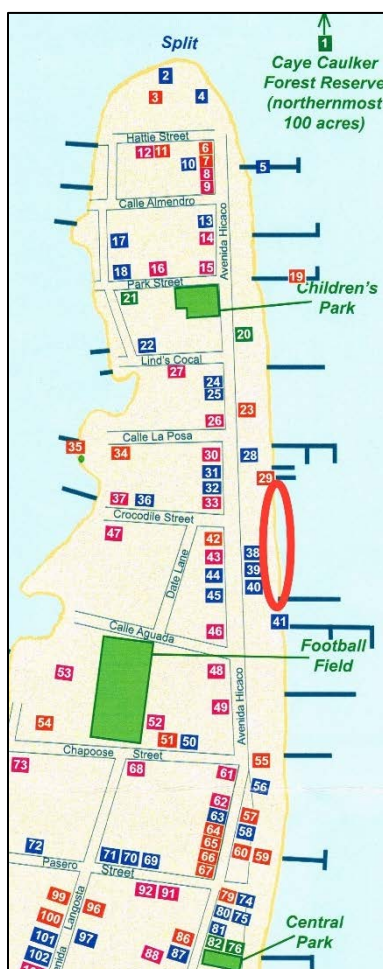
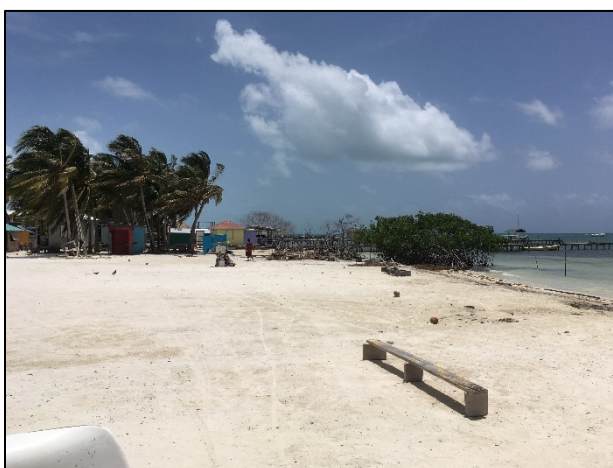
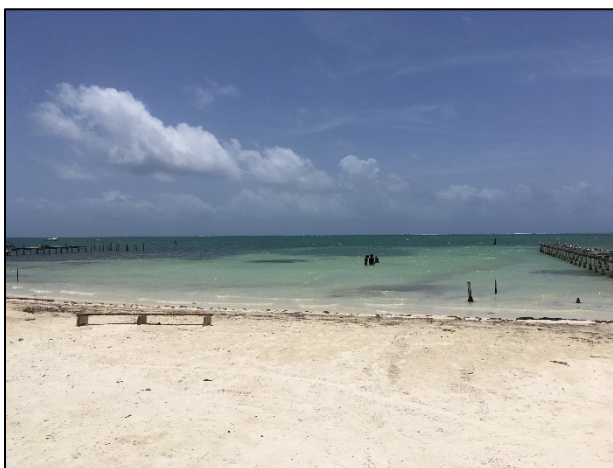
Palapa Gardens is located on the east coast of Caye Caulker. It is presently an open beach with little shading. The geographic locations are 17°44'47.70"N, 88° 1'24.62"W. The intervention location is approximately 50m of beach width from the edge of the coastal road/walkway (estimated at 0.5 m-MSL) to the present location of the shoreline (approximately 40 m).

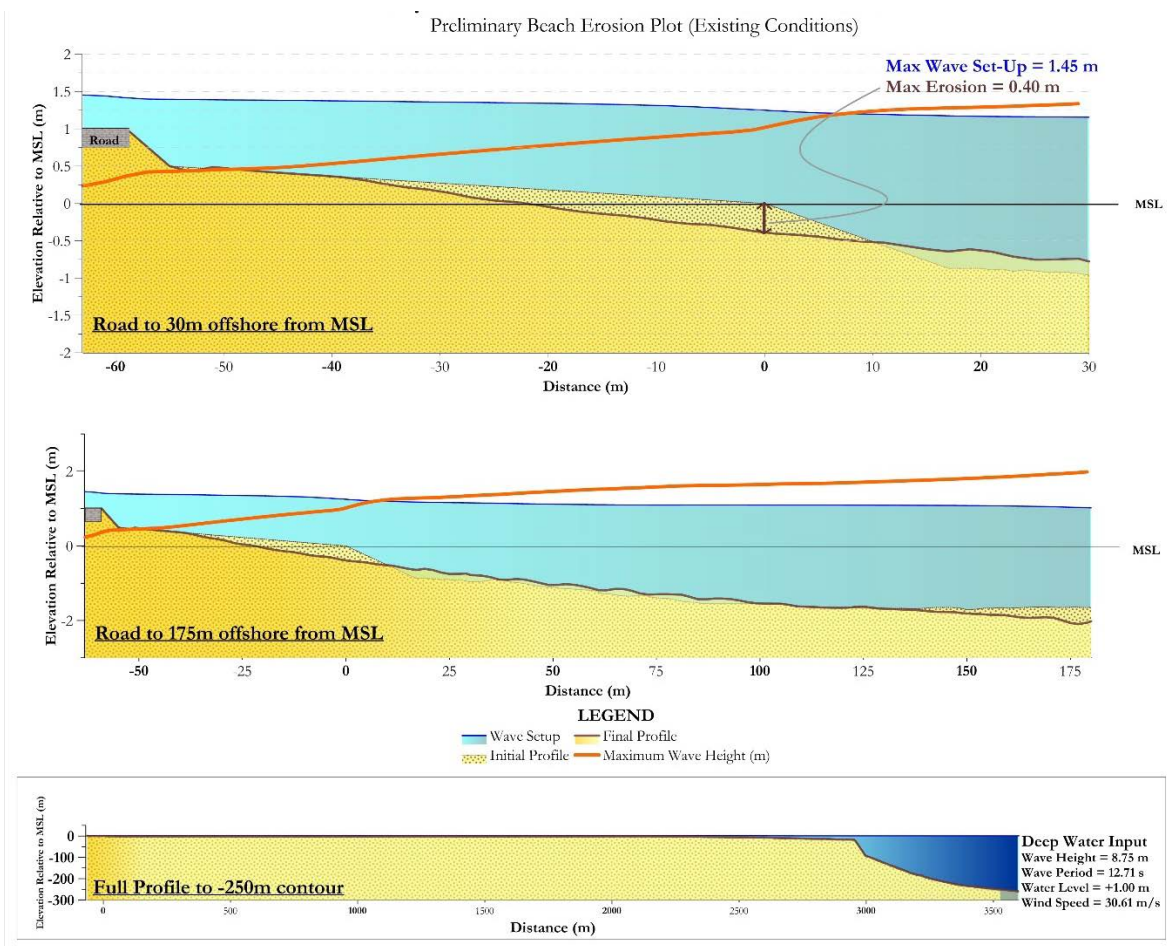
Sbeach Run Results

The sBEACH model was run to produce the inundation levels and the beach profile changes in existing conditions. Results were plotted for the 50-year return period. The wave, inundation levels and extent of erosion predicted by the model over the considered profile are presented Figure below.

Overall results are indicative of a cross-shore movement of sand with a clear mechanism of erosion/deposition along the beach slope. the sand is being deposited up or down the beach slope depending on the intensity of the storm. The sand deposited further offshore does not move beyond the surf zone which indicates that day-to-day wave conditions could be sufficient to bring the sand back up onto the beach.

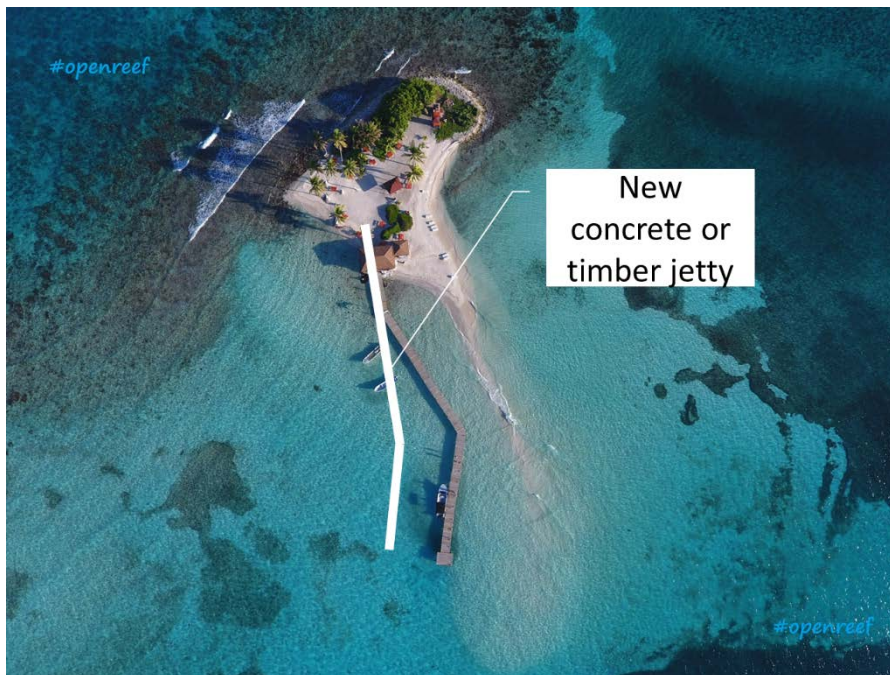
The existing pier is a wooden jetty structure extending ~80 m from the welcome Palapa to deeper waters.

The existing pier is weathered and frequently needs repairs, both from regular wave and atmospheric conditions as well as storm events. The pier does not appear to have been designed for any condition in mind and has been extended a few times over the years.

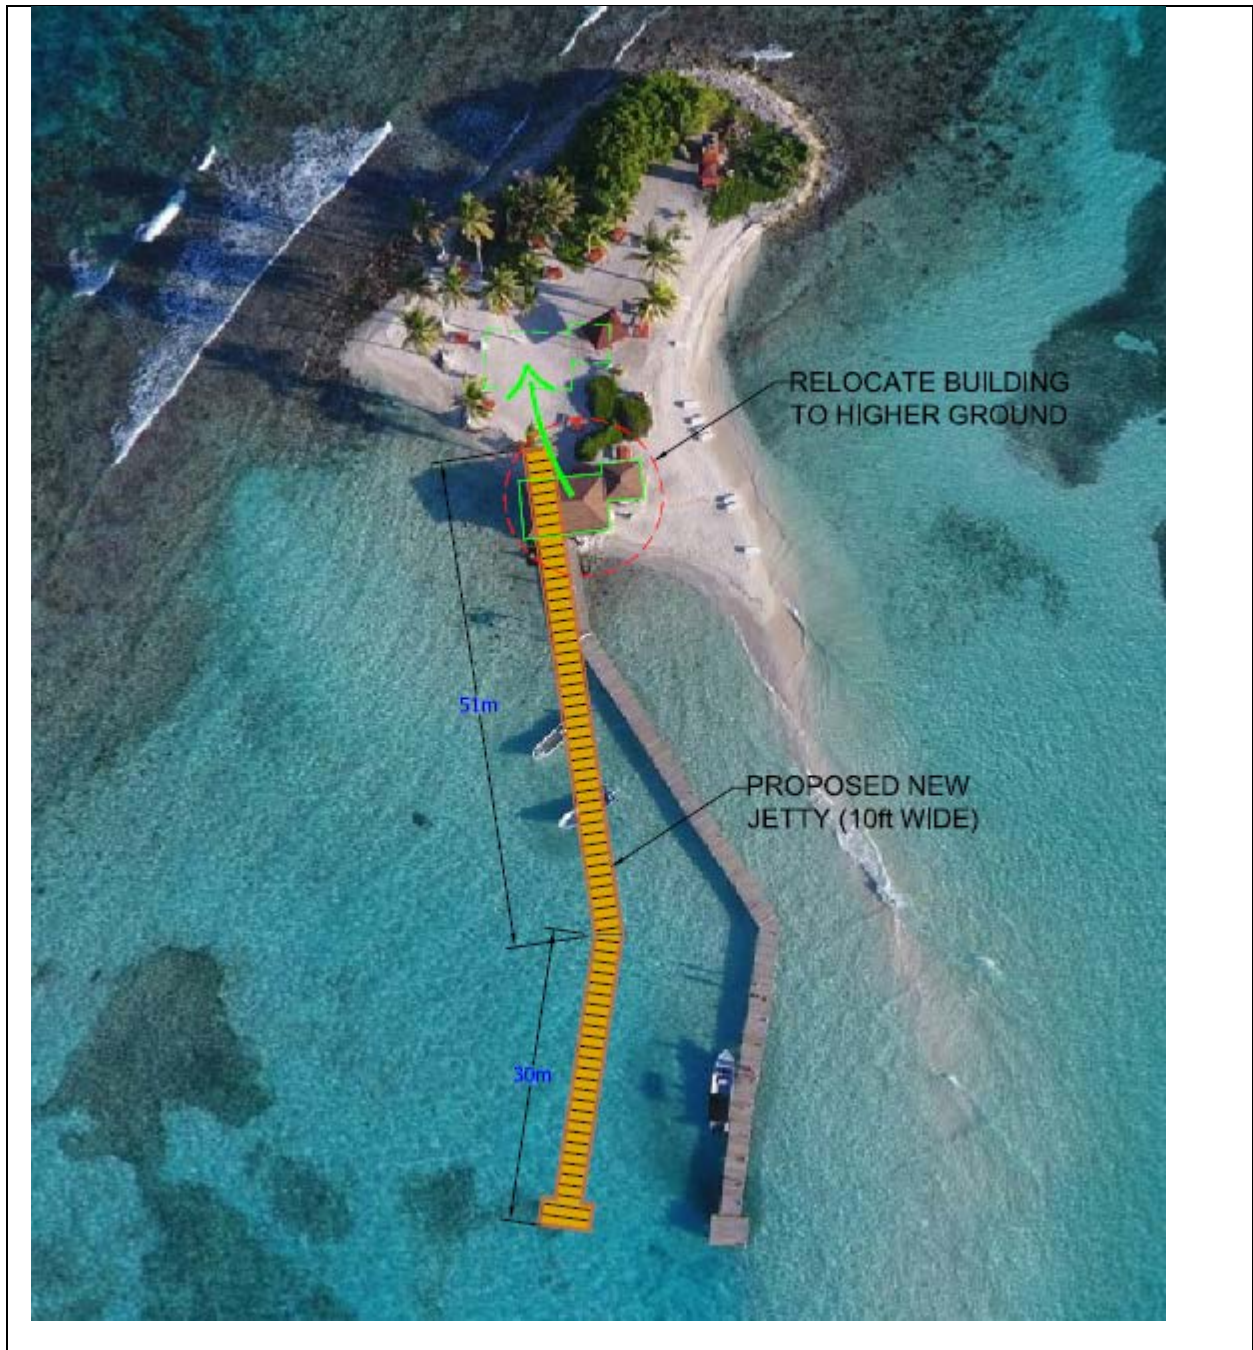
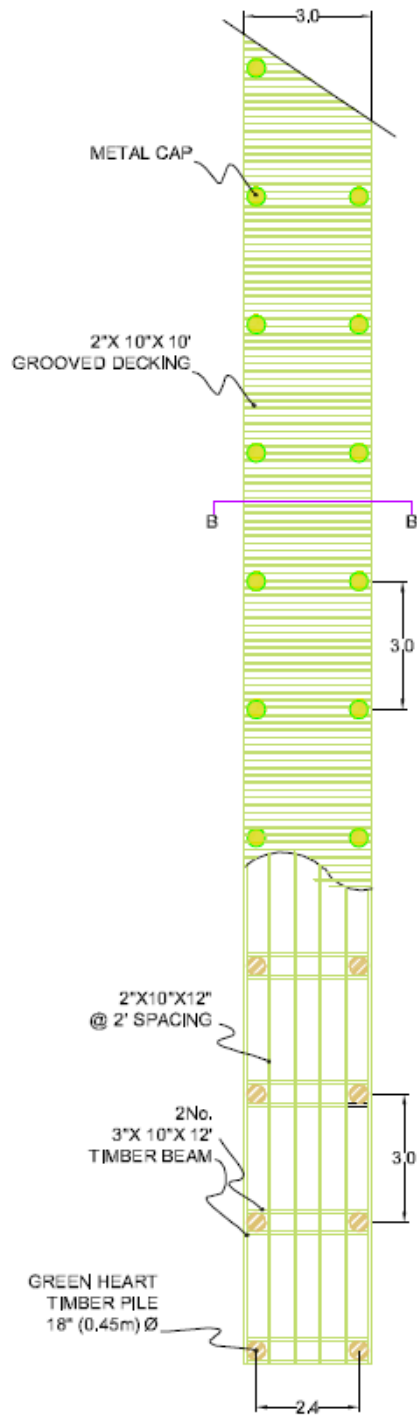
**PLAN OF PROPOSED
TIMBER JETTY**

Timber design for aesthetics 10 ft wide Assumed 1 m surge ((Cat 3 Surge), from Caribbean Disaster Mitigation Project, Belize Coastal Hazard Assessment, OAS/USAID, Figure 15) Top of decking +1.5 m-MSL						
Drawings

A new pier is proposed that is sufficiently robust to minimize maintenance and can withstand a modest storm event without failure.

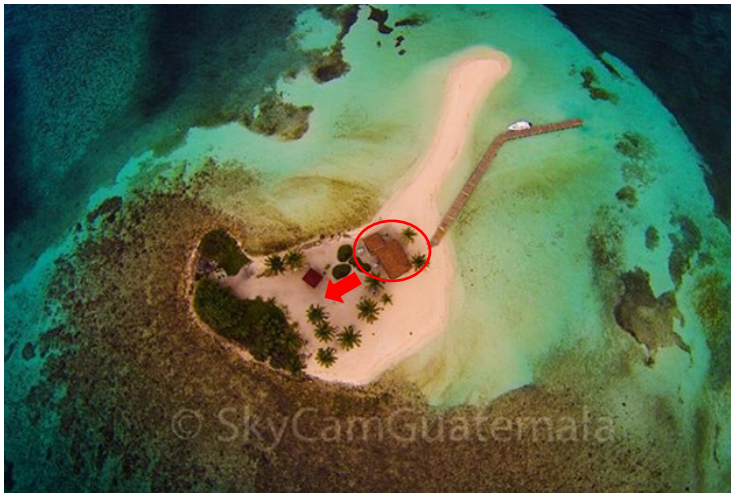
The Palapa is presently a simple structure approximately 10m x 15m located on the northern side of the island adjacent to the active spit feature. Historical information has shown that the area to the south east of Goff Caye has been stable. It is proposed that the palapa is relocated towards the southeast to more stable grounds.

The foundation of the existing “welcome” palapa is exposed during certain times of the year. When the concrete slab is exposed, it acts as an impermeable vertical wall that reflects oncoming wave energy (as opposed to dissipating it) and exacerbates localized erosion.

The palapa is thus located in what is the active and dynamic coastal zone, and is better sited towards the more stable south-eastern side of the island. It is recommended that the palapa is rebuilt in a more suitable and safer location and more appropriate design to minimize damage potential during storm events.

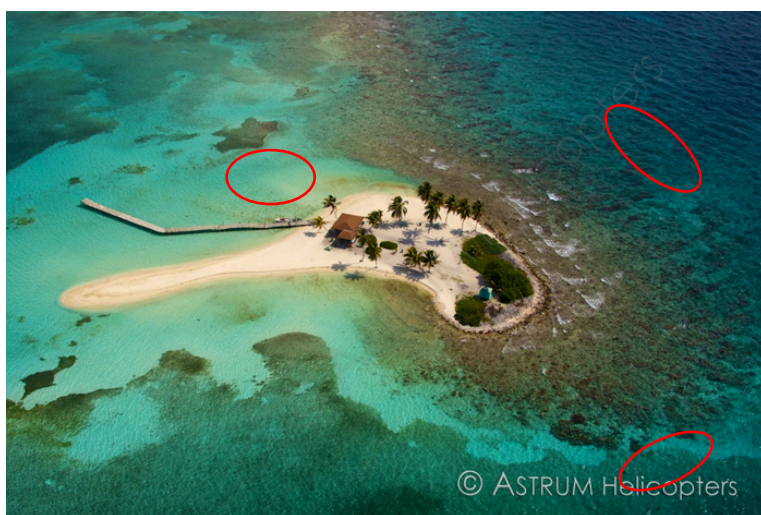
Three locations for mooring fields are proposed: one adjacent to the jetty, and the others adjacent to the popular dive sites. The mooring blocks will likely be a cube of mass concrete approximately 0.5 x 0.5 x 0.5 m. The mooring blocks will be placed on sand or away from the living reef system.

Vessels typically tie up to the existing jetty when visiting Goff Caye. However, it was noticed that vessels who accommodate snorkelers or scuba divers use their anchors on or near the reef. It is proposed that a simple mooring field is developed to avoid damage to reef and seagrass. The mooring field would comprise of concrete blocks, chain, associated hardware and a mooring buoy.
